# MAPPING OF VISUAL DECAY FORMS AND INFRARED IMAGING OF STONE STRUCTURES FOR THE MAINTENANCE AND MONITORING STUDIES

A. TAVUKÇUOĞLU and E.N.CANER-SALTIK

Durability of Building Materials and Components 8. (1999) *Edited by M.A. Lacasse and D.J. Vanier.* Institute for Research in Construction, Ottawa ON, K1A 0R6, Canada, pp. 613-623.  
© National Research Council Canada 1999

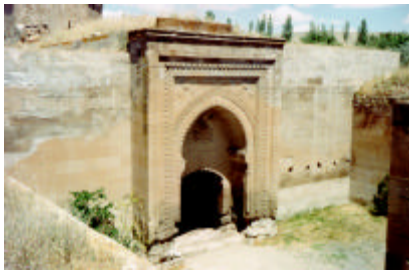
**Fig. 1: General view of the north elevation at the courtyard, Agzikarahan**

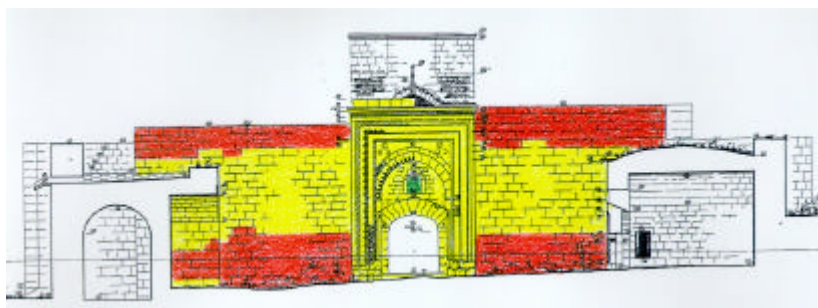
- The distribution of new stone material use indicated the previous severe problems related with the upper structure and the lower part of the north elevation walls in the courtyard. Slight decay observed on these new stone surfaces as discoloration with white staining showed that the problems of the monument continue with the upper structure and the lower part of the north elevation walls in the courtyard. Furthermore, during the survey period of seven months, slight decay forms of discoloration in those areas have developed to medium decay forms as flakes and scales. It showed that monument needed urgent interventions.

**Fig. 2: The map showing the areas of new repair stone and original stone**

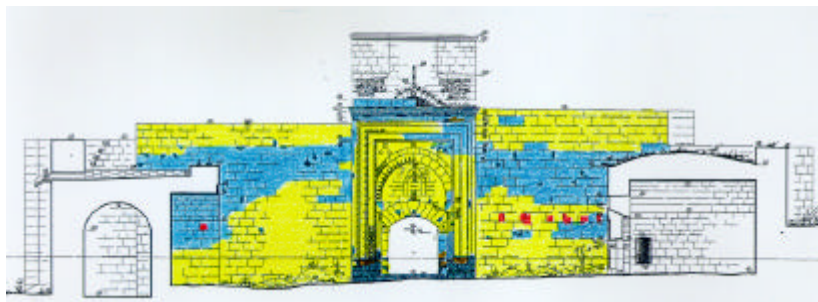
- The most severe decay has been noticed on the original material at the lower parts of the monument up to 130 and 145 cm. height from the ground level as material loss: outburst, together with salt deposits. This situation indicated the existence of continual rising damp problem.

- Severe decay has been observed on the original material at the upper part of the monument as material loss: alveolization, together with lichens. This situation indicated a severe dampness problem at the upper structure which still continues.

**Fig. 3: The map showing the areas of loss and detachment of stone material**

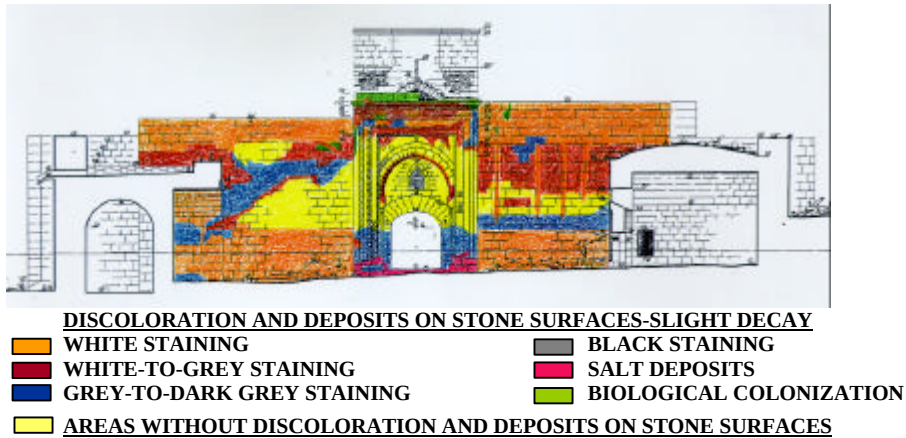
**Fig. 4: The map showing the areas of discoloration and deposits on stone surfaces**

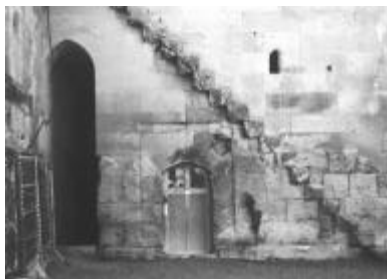
**Fig. 5: Partial view of the south elevation at the courtyard**

- The surface temperature graphics are consistent with the infrared images of the surfaces.
- There is a relationship between the surface temperatures of stones and their decay forms.
- The lower part of the exterior wall surfaces are the coldest areas of the structure. The upper parts of the exterior wall surfaces are the next cold areas. The photograph views and the infrared images of the lower parts and the upper parts of the structure are shown in Figures 5-8.

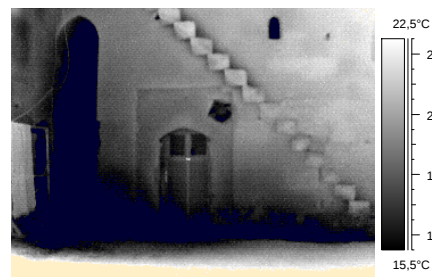
**Fig. 6: Infrared image of the view shown in Fig. 5**

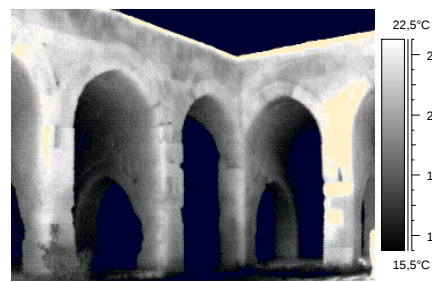
**Fig. 8: Infrared image of the view shown in Fig. 7**

- The infrared images have shown that different materials may have different surface temperatures for the same climatic conditions. In A z karahan, there are differences between the surface temperatures of new repair stone and original stone (Fig.8 and Fig.13). The infrared image of the tomb of Karacabey shows that the surface temperatures of mortar, brick and stone are different (Fig.14).

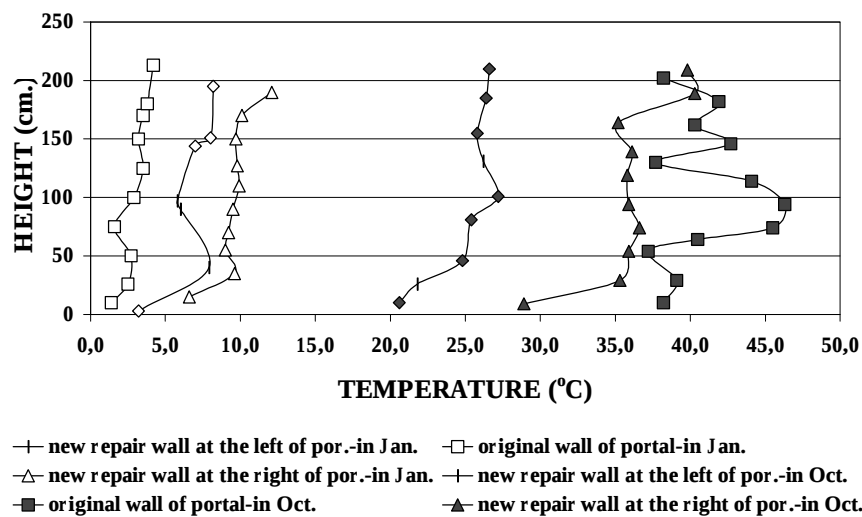
- The surface temperature increases with the increasing height at the lower parts of building according to the measurement taken in winter. The surface temperatures of the original stone with the most severe decay and severe decay are much colder than the surface temperatures of the new repair stones with slight decay (Fig.9). The moisture content in the original stone is very high, approximately 14%, and the same up to the height of 150 cm., according to humidity measurements taken in January. These results have indicated the presence of rising damp problem.
- In the following seasons the surfaces of the original stone at the lower parts of the building with most severe and severe decay are warmer than the surfaces of new repair stone. The extreme drying must have occurred at the surfaces of the decayed original stone in July and October.(Fig.9).

**Fig. 9: The surface temperature curves for three region of the north elevation at the courtyard in January and October**

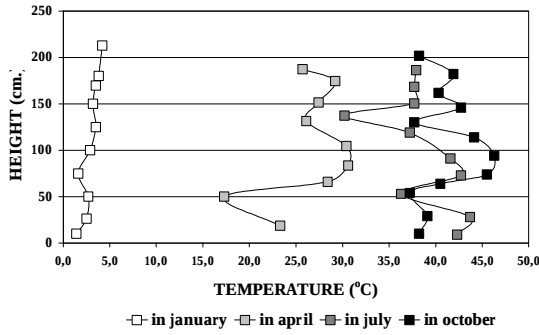
- In the rising damp zone, the surface temperature curves of the original stone surfaces having the most severe and severe decays are inconsistent (Fig.10). Extensive salt deposits have been observed on those areas. One of the reasons of the surface temperature fluctuations should be the hygroscopic properties of soluble salts. In addition, the physical properties of the heterogenously decayed stone should be checked.

**Fig. 10: The surface temperature curves of the original stone at the portal**

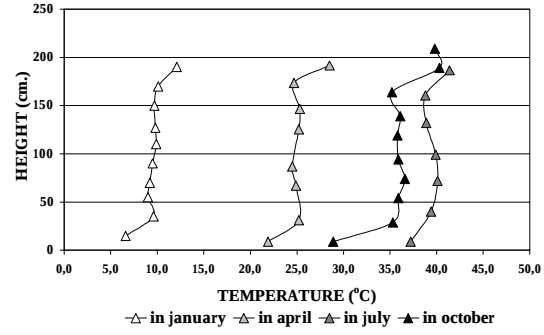
- The surface temperature curves of the new repair stone with slight decay are more consistent in comparison to the original stones. For instance in Fig.11, the temperature curves have shown that the part of the wall up to approximately 35 cm. height is the coldest area, and the temperature is steady on the wall above this height up to 184 cm. The temperature starts to increase after this level where there is the passage from new repair stone to the original stone. Fig.12 is the view of this region and Fig.13 shows the infrared image of that area which is consistent with the temperature curves.

**Fig. 11: The surface temperature curves of the new repair stone at the right of the portal**

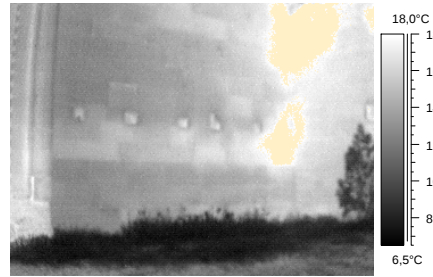
**Fig. 13: Infrared image of the view shown in Fig. 12**

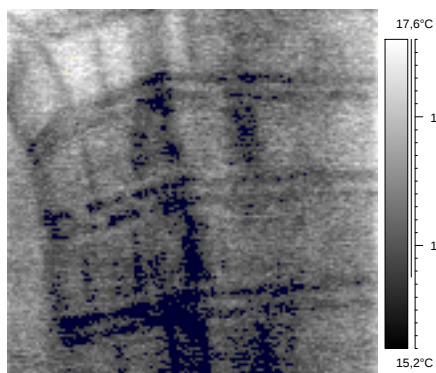
**Fig. 14: The infrared image showing different surface temperatures for different materials**

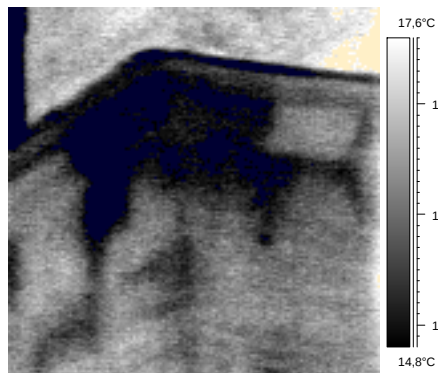
- The infrared images have given information about problem areas on the monument which can not yet be detected by visual analyses. For instance, the infrared image given in the Fig.15, shows that a roof drainage fault has already started in the newly restored monument, the tomb of Karacabey.

**Fig. 15: The infrared image showing a roof drainage fault**
