## **Hurricane Katrina: An Overview of Damage to Timber Structures**

### **ABSTRACT**

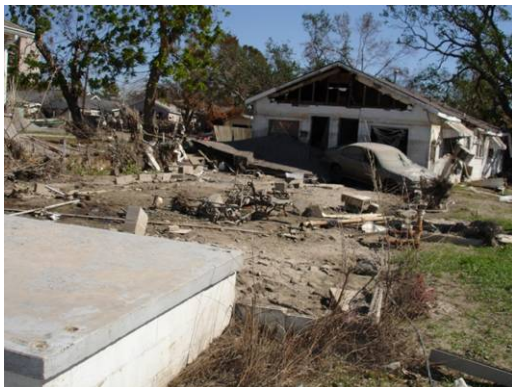
The most readily apparent damage was in the immediate vicinity of the levee breaches. Timber frame structures which were inadequately tied to their foundations were often lifted off their foundations by water passing under the raised floors and/or pushed horizontally. A one story timber framed structure is shown in Fig. 1. There was no evidence of a mechanical connection between this structure and the foundation piers which used to support the floor framing, shown in Fig. 2. This particular structure showed a poor foundation layout, where the concrete masonry unit (CMU) piers were set on a very small concrete “spread footing.” In other instances, sill plates were firmly attached to the concrete foundation with anchor bolts; however, the wall studs framing into the bottom sill plates were only attached with toe nails, as seen in Fig. 3. These toe nails were unable to resist the horizontal forces imposed by the flowing waters.

**Figure 1.** One story timber frame structure pushed away from the concrete porch.

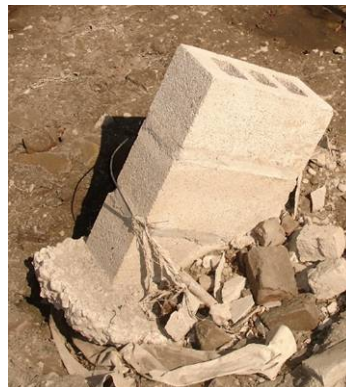
**Figure 2.** Foundation pier without evidence of mechanical connection.

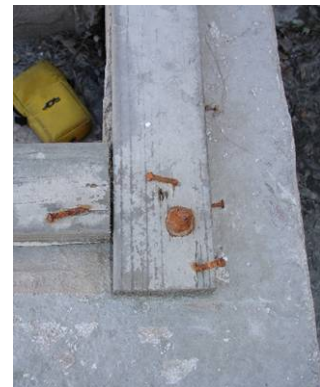
**Figure 3.** Sill plate attached to knee wall with anchor bolt.

The most easily observed type of damage was the rusting of metal fasteners, which can be seen above in Fig. 3. Other metal hardware, such as lintels in brick cladding over windows, exhibited some signs of rusting, which could lead to further water ingress if not repaired along with the rest of the structure.

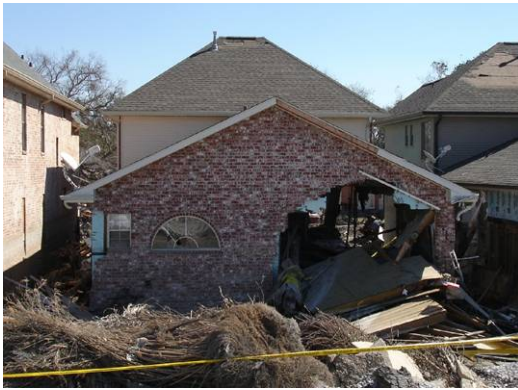
When a structure was adequately attached to the foundation, the rapidly flowing floodwaters often induced failure elsewhere in the structure. Entire sections of wall were destroyed by flowing water. These walls were standard load bearing portions of the timber frame structure. Walls which had brick cladding appeared to be more protected from lower velocity flowing water; however, in the immediate vicinity of a breach brick clad walls exhibited similar damage to walls clad with timber weatherboards or vinyl siding. Often, failures were clearly initiated in the vicinity of large door or windows,

indicating that unsecured or unprotected openings provided a weak point in the structure which allowed propagation of more significant damage. Some examples are shown in Figs 4 & 5.

**Figure 4.** Brick clad wall damaged in vicinity of a levee breach.

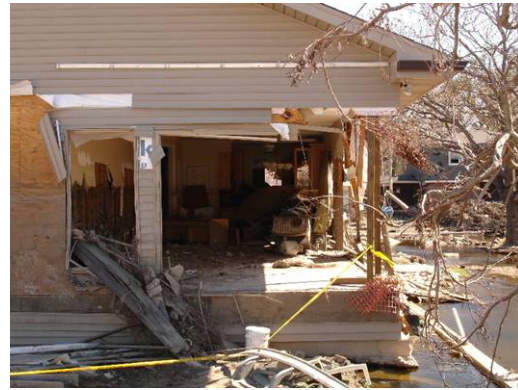
**Figure 5.** Wall clad with vinyl siding damaged in vicinity of a levee breach.

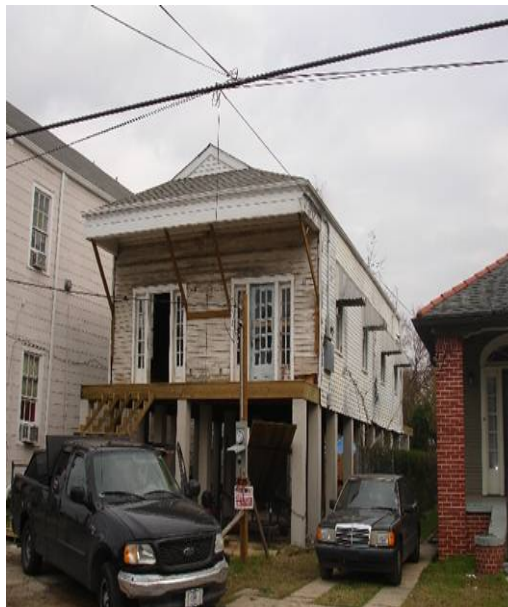
**Figure 6.** Structure recently elevated to above the BFE.

As a result of the damage caused by the floodwaters and the potential for portions of the city to flood, structures in New Orleans that were substantially damaged, substantially improved, or new construction must meet new elevation requirements. These structures must be elevated to either the Base Flood Elevation (BFE) or at least 3 feet above the highest existing adjacent grade elevation at the existing site. The Base Flood Elevation (BFE) represents the average floodwater elevation for a 100 year flood event. These new requirements adopted in the region assumes the U.S. Army Corps of Engineers is actively repairing and improving the flood control systems.

ASCE 24-05 Flood Resistant Design and Construction requires enclosures below the BFE to either have breakaway walls or have openings designed to allow equalization of hydrostatic pressure between the interior and exterior of the enclosure. The aesthetics of raising structures is of concern to many residents. An example of a recently elevated house is shown in Fig. 6.

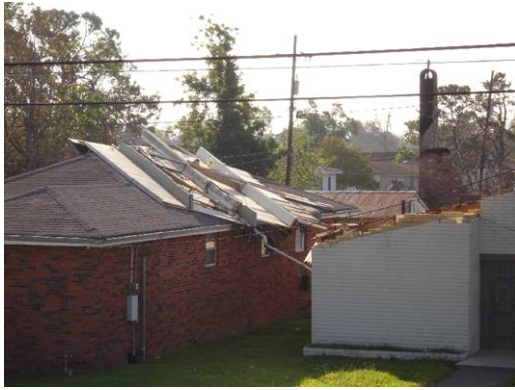
The most spectacular form of this failure was the removal of entire sections of roof. Figure 7 shows the removal of a church roof from the supporting walls. Large uplift pressures on the overhangs helped contribute to the failure in this case; however, there was no evidence of tie downs between the roof rafters and the supporting walls.

**Figure 7.** Removal of a church roof from the supporting walls.

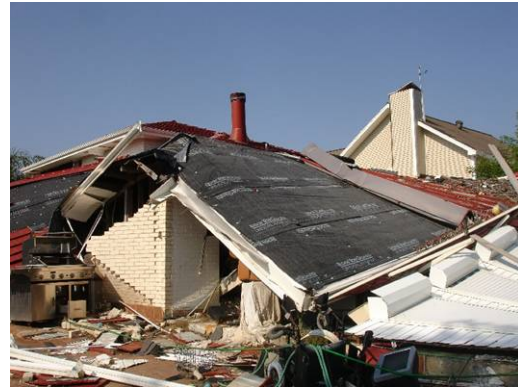
Cases were also observed where porches and carports, which were open to the wind, lifted up off of the support columns. If structurally attached to the primary structure, the porch or carport would cause damage to the primary structure when it collapsed. An example of a collapsed porch is shown in Fig. 8.

**Figure 8.** Porch collapsed from uplift forces and lack of tie downs.

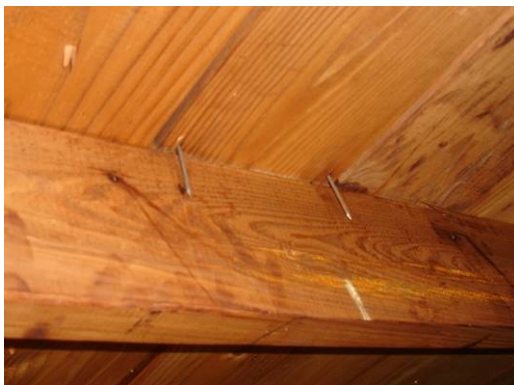
It is sometimes difficult to separate poor construction practices from poor design practices. The decision to construct a building with a gabled roof instead of a hipped roof in a high wind area would be an example of a poor design practice. The lack of adequate fasteners attaching the sheathing to the structure or fasteners driven through the sheathing and missing the underlying framing would be an example of poor construction practices. Often builders use pneumatic nailguns, which do not provide feedback to the user whether or not the nail entered a structural member. Figure 9 shows decking nails that missed the supporting rafter. Figure 10 shows poorly fastened sheathing that was blown off of a gabled end wall. It is important to realize that while some construction practices are poor, they may be typical and accepted for a particular region.

**Figure 9.** Decking nails that missed the supporting rafter.

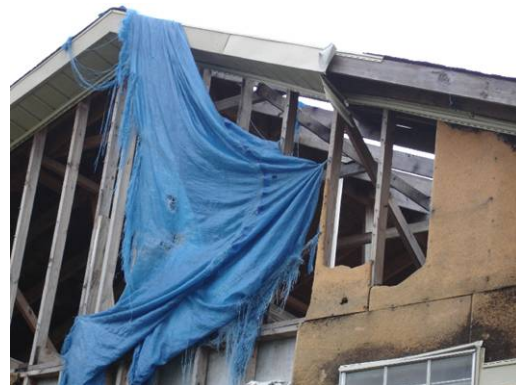
**Figure 10.** Poorly fastened sheathing that was blown off of a gabled end wall.
