Deterioration of flat roof coverings: Experience from field investigations

R. HANSON

Civil engineer (Sweden)

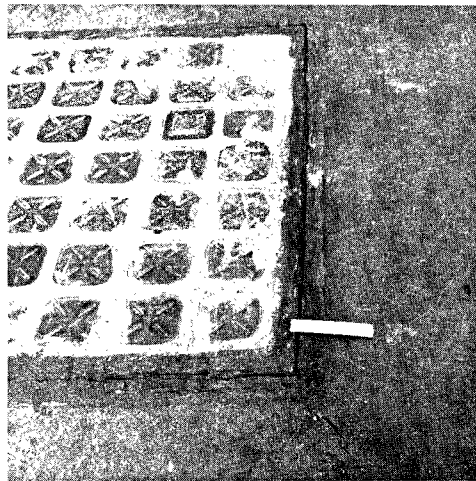
Fig. 8.

Separation along joints occurs easily at hollow glass block windows, entrance stairways and the like (Fig. 8). Mastic asphalt cannot adhere directly without attachment by skirtings to adjacent building walls.

Fifteen of a total of 23 leaking roofs had joint separations. Leaks can be sealed temporarily if the joint cracks are filled with caulking compound, preferably twice a year.

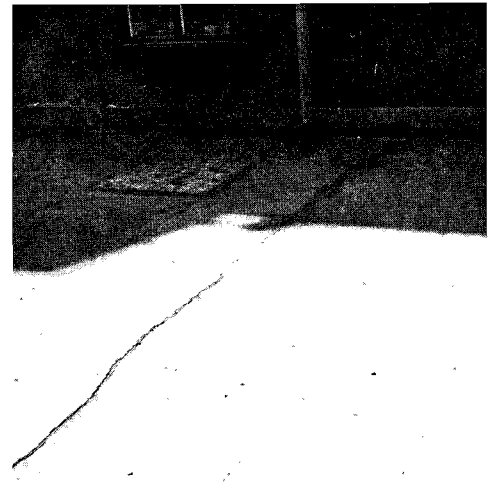
Fig. 9.

In cases where mastic asphalt is to serve both as a covering and waterproofing, it must be prepared with a very firm consistency. There is considerable risk that it will acquire cracks upon cooling (Fig. 9). Even if it is made softer, it will rupture easily if the deck cracks.

Eleven of 23 leaking roofs had ruptures.

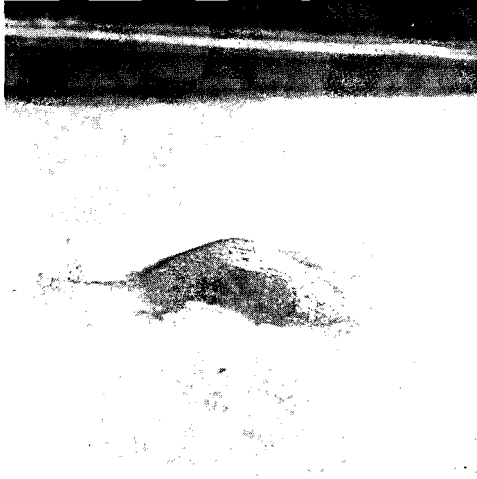
Fig. 10.

The strong daily temperature variation in mastic asphalt “pumps up” entrapped air unless the air comes in contact with a pressure-equalizing layer (Fig. 10). Roofs which are not exposed to sunlight or have a special protective coating over the mastic asphalt do not contain blisters.

Eighteen of a total of 45 roofs investigated contained blisters. Only in exceptional cases did they cause leaks.

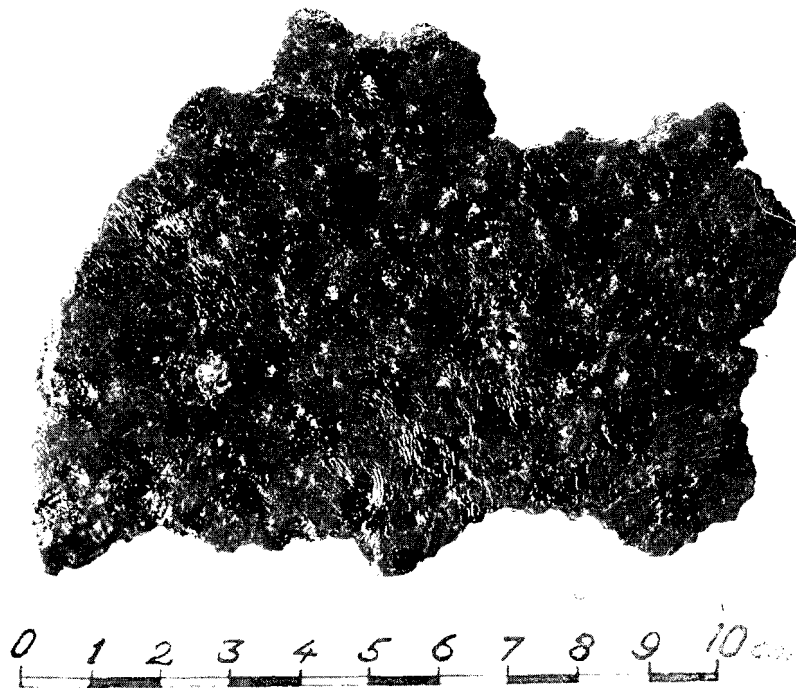
Fig. 12.

Moisture in the under layer is vaporized when the warm liquid asphalt is spread, whereupon permanent pores are easily formed (Fig. 12). The risk is greatest in the case of thin mastic asphalt layers 10-12 mm thick. Pores have not been noted in the old-fashioned type

of mastic asphalt layers, which are much thicker, but on the other hand, they have been found in the modern thin waterproofing layers.

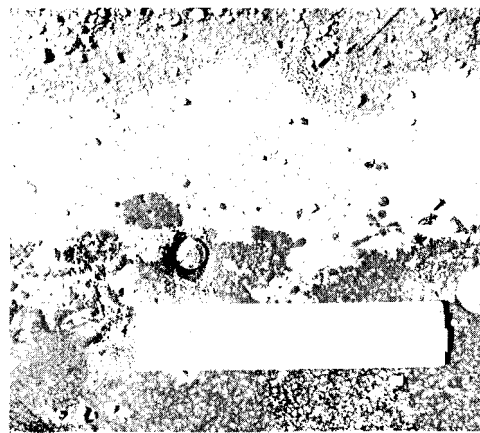
Fig. 13.

The thin felt layers are very sensitive to mechanical injury before and during the application of the protective coating, particularly where the roofing felt layers do not rest directly on the deck (Fig. 13).

Thirteen of 30 damaged roofs had holes or tears when the house was built.

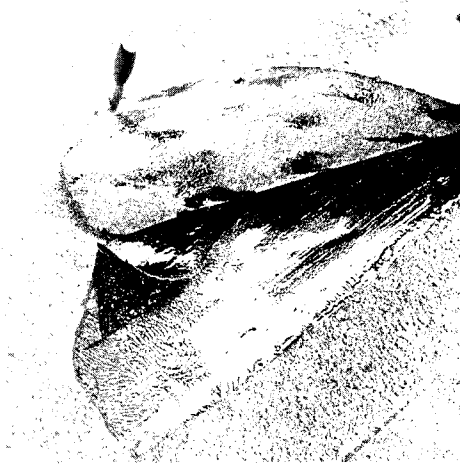
Fig. 15.

Water has penetrated in cases where the space between the layers was only partially filled with bitumen (Fig. 15). The density has, for this reason, been much diminished and the permanency of the roofing felt is reduced.

Twenty-two of 30 investigated damaged multi-layered roofs had so little bitumen between the layers that water could penetrate between them.

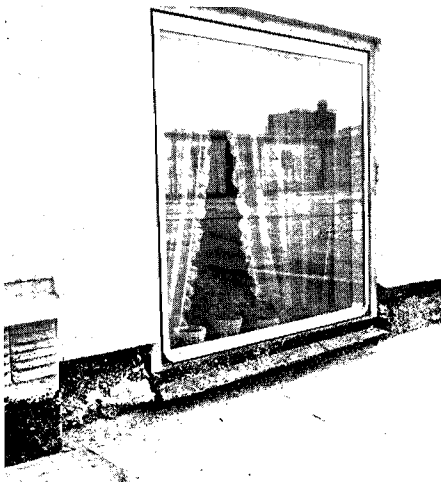
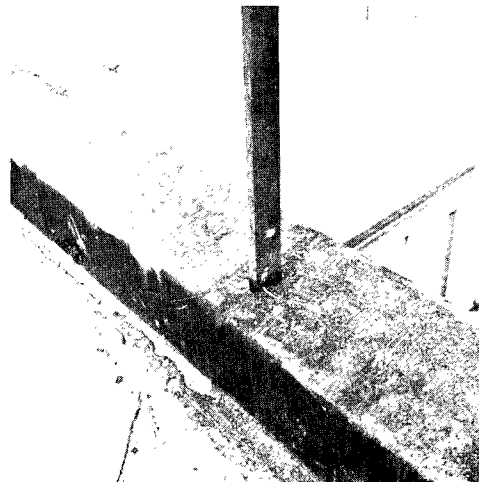
Basic plans of various general features of construction have been nearly non-existent and the necessity has arisen to improvise upon the solution of this problem. Figs. 16 and 17 illustrate examples of defective details, the former a window which is situated too low, and the latter a vertical supporting beam which extends directly through the waterproofing layer without protective collars.

Nine of 30 damaged roof terraces had defectively installed features.
