Case Study of the Cathedral of Aveiro - Defects, Structural Analysis and Rehabilitation Strategies

Abstract

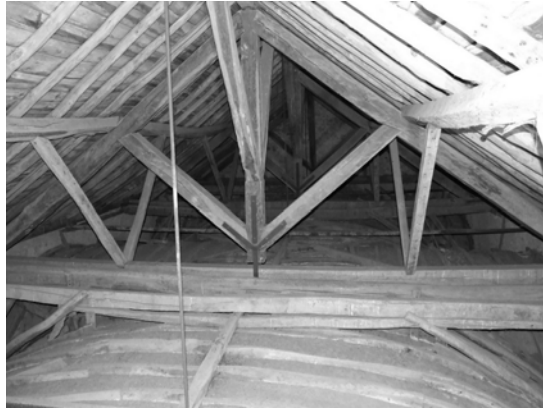
The roofing structure of the central nave consists of two timber trusses that support a timber platform. The platform and its support bars were seriously affected by xylophagous attack, as shown in Figure 3 and so they had to be completely replaced.

Figure 3: Loft of the covering of the central nave (XV century). Distortion of the base of the shear

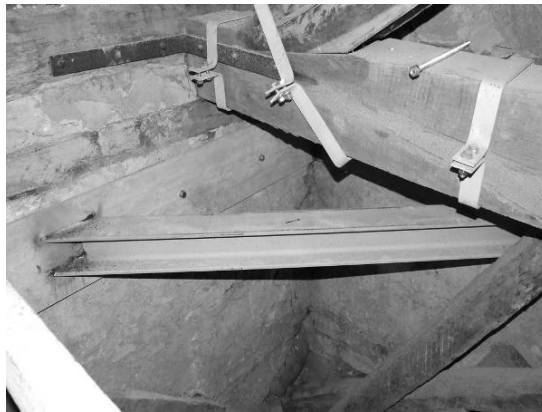
The xylophagous attacks were less serious and more sporadic in the shear bars and some cracks running parallel to wood fibres could be seen. The attacked zones of these bars were treated and all the elements exhibiting cracks were girdled with metal straps. The straps were introduced during

Figure 4: Metal straps

maintenance work and treatment of wood trusses (Figure 4). The supports of the shear plates showed no signs of decay, so it was not necessary reinforce or replace them.

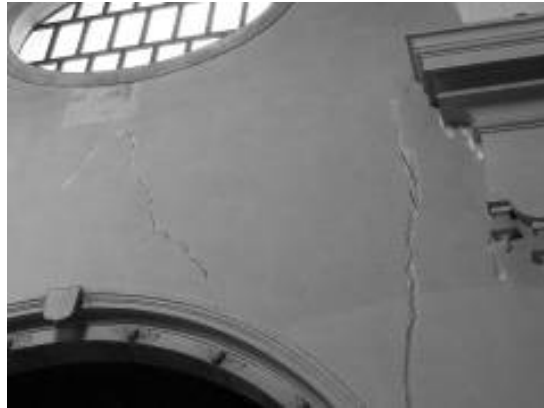
Both of the longitudinal walls of the central nave had interior vertical cracks located between the top of the arcade and the bottom of the oval openings, (see Figure 5). There was a diagonal crack above the high choir door.

Figure 5: Vertical cracks in the interior face of the central nave wall

Therefore, the vertical cracking in the interior face of the masonry wall and in the area between the arch and oval window openings (see Figure 3) is originated by the construction of the tunnel was caused by the combination of high tensile stresses aggravated by the out-of-plane movement of the masonry walls.

Simple and immediate measures to control and monitor the building are desirable: installation of topographical targets so that the wall displacement, particularly the out-of-plane movements, can be measured over time; crack metres should be installed to measure and control important cracks to check their development so that changes in any tensile stresses and deformations that the wall might suffer can be estimated.

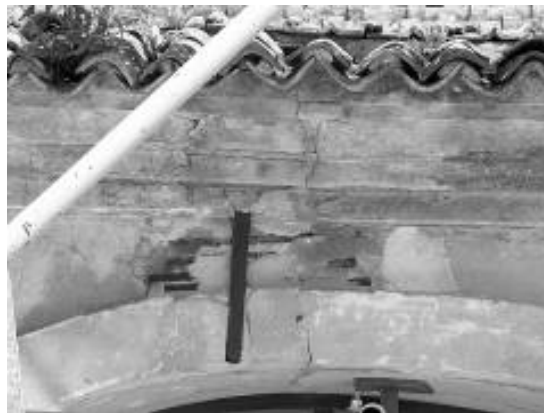
The outer face of the wall had no paint. Part of the wall between the top of the oval opening and the cornice had vertical cracks and exhibited weakness in the upper arches. The fixation zone of the stretcher in the outer face of the walls had several cracks and the mortar had detached, as shown in Figure 6.

Figure 6: External envelope of the central nave.

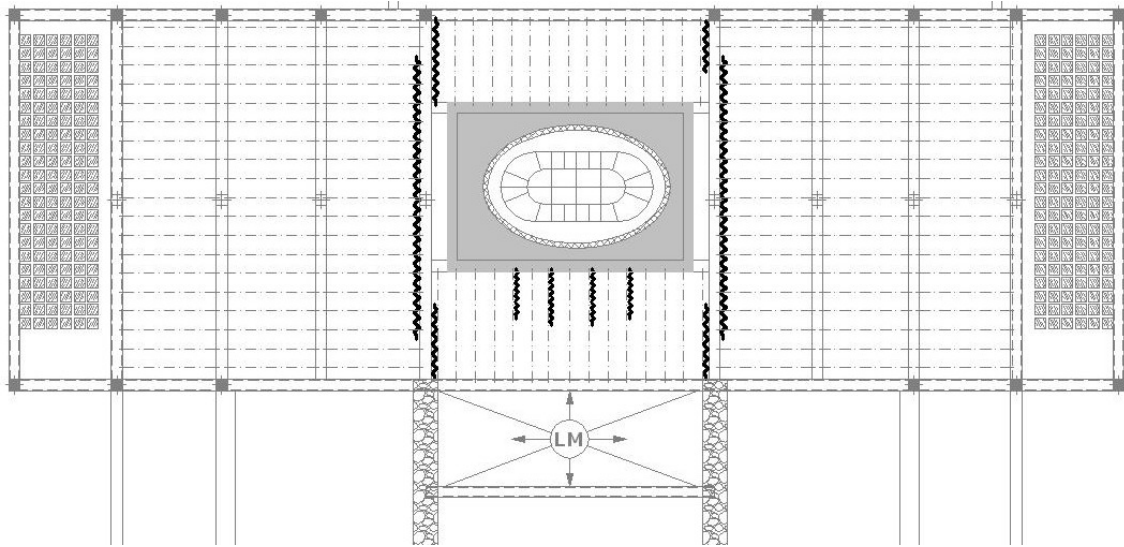
Figure 7: Structural pan of the roof above the altar - indication of the cracked areas

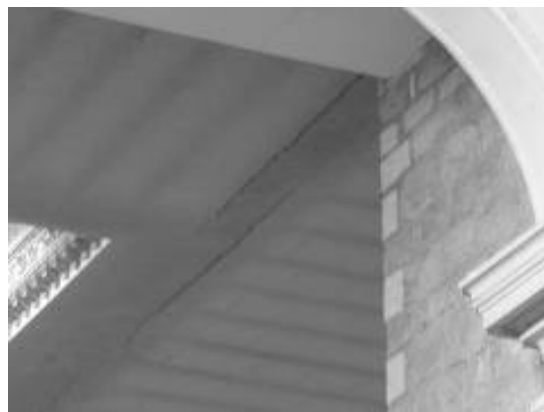
Figure 8: Roof above the Altar (XX century)

There were some longitudinal cracks at the point where the slabs and the two beams of the central porch intersect, near the lower edge of the beams, as we can see in Figure 8. Those beams exhibited considerable deformation and we could see that the area of their longitudinal framework is around 44% less than the area needed (66.03 cm^2) to withstand the applied forces.

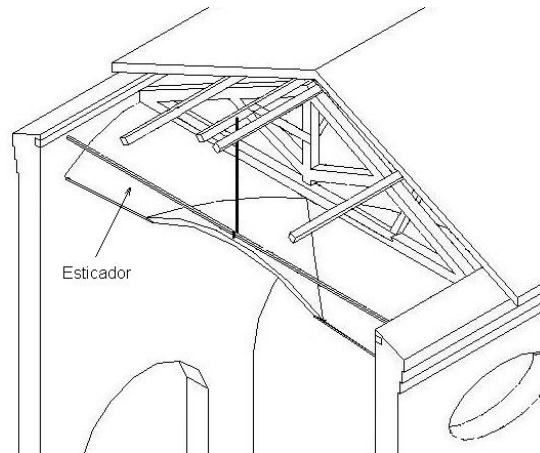
In respect to the behaviour of the roof system, the structure was simulated by essentially modelling the timber shear plates and structure of the arched roof (see Figure 9). The size of the structural elements was reduced by 1 cm for modelling purposes in order to account for the loss of strength due to the xylophagous attack. To take into account the loss of rigidity of the timber elements through aging or decay, the Young's modulus was reduced by 10% ($E=10\text{GPa}$; wood strength class D40)

The safety of the shear plate elements was analysed and verified for both the reduced section and the carbonised section (simulating fire attack). The sections of the legs of the shear plates, mainly in the zone between the purlin support and the shear line, presented compression stresses between 90% and 110% of its ultimate resistant capacity.

Analysis of the timber structure of the arched roof showed that the stress values (tensile and compression) in the different elements is below the maximum allowed values, apart from one zone in the lower support of the vault. In regard to this situation it was proposed that any timber element that exhibited any weakness should be replaced or strengthened.

Figure 9: Structural scheme of the roofing system of the central nave

In order to reduce the excessive stress a strut and a tie-rod was inserted at the mid span between the purlin and the tie beam. This retrofitting action also reduces the shear's leg stress, however a slight increase in the tensile stress in the shear line is expected, although within the limit values.

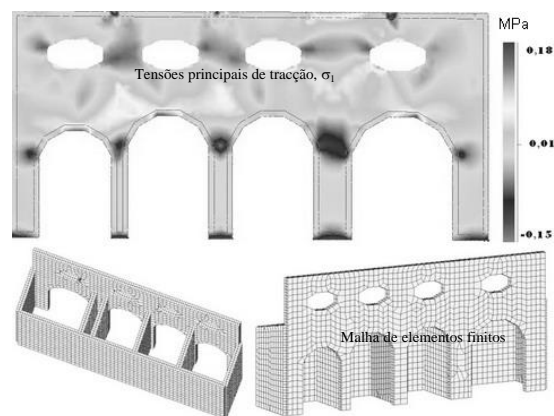
With respect to the masonry walls, the results of the numerical simulation for a combined vertical load (self-weight and vertical live load) show that the tensile and compression stress levels are below the acceptable maximum (tensile = 0.1 MPa; compression = 0.9 MPa). The compressive stress values computed for the masonry walls vary from 0.4 to 0.6 MPa, less than the yield stress for the stone masonry, while the tensile stresses vary from 0.08 and 0.1 MPa, these values are very close to the yield stress limit computed, as shown in Figure 10.

Figure 10: Structural model of the wall

If, for the combination of vertical actions used to evaluate the stress state of the stone masonry walls, a small settlement of 1 mm is added to simplify the simulation of the potential effects of the tunnel construction, it was computed that the compression stresses installed in the walls increase to values close to the yield stress values for compression state of the masonry, while the tensile stresses computed exceed the yield stress limit (see Figure 7). The simulation also confirmed that, due to a possible settlement, a slight out-of-plane movement of the masonry walls can occur.

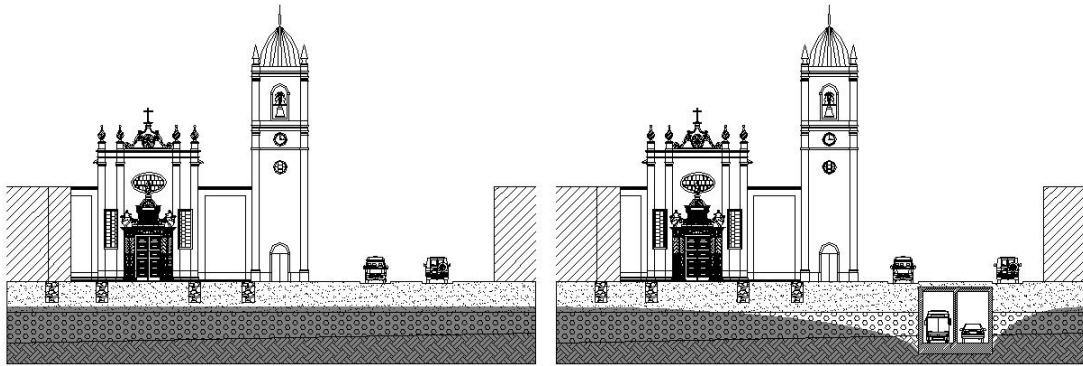
In 2000, the tunnel recently constructed next to the cathedral opened to traffic (about 10 metres from one side of the cathedral). The construction work on the tunnel and continuous traffic could have altered the initial stress state of the foundations of the cathedral by lowering of the water level underneath the cathedral. This was caused by the artificial barrier created during the tunnel construction and continuous drainage through permanent pumping along the whole length of the tunnel. The underground pressure in the tunnel was thus kept low, avoiding the risk of uplift by the underground water level which might induce higher effective stress in the foundation soil. This phenomenon would have increased the settlements of the cathedral foundations nearer to the tunnel, causing to slightly tilt on the tunnel side. This problem has in fact occurred and been confirmed in many similar situations.

Figure 11: Geological profile

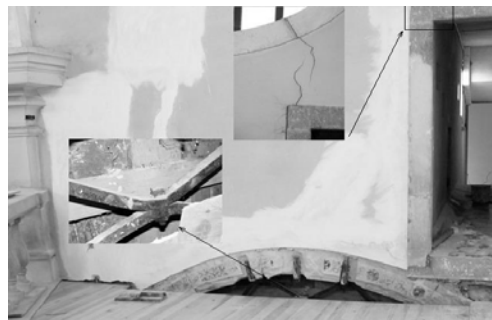
Figure 12: Demotion and structural reinforcement

During the maintenance works on the cathedral a structural reinforcement was found in the arch adjacent to the access to the high choir. This structural reinforcement consists of squared iron bars with a cross-section of about 32 mm fixed by 20 mm diameter screws (see Figure 12).

This structural reinforcement might have been built when the access to the high choir was built, or it may have been a later structural intervention to correct the deflection of the arch. This problem is still unsolved and continues to cause cracking. A first analysis suggested this deflection is caused by the progressive deterioration of the arch stiffness due to the creep of the iron structure and loss of the cross-section of the iron bars due to the corrosion over time. The typical cracking generated by the foundation settlements of a masonry wall can also be seen near the access door; it consists of diagonal cracks that initiate and spread from the corners of the door openings.
