Technical Condition of Prefabricated Concrete Large Panel Apartment Buildings in Estonia

ABSTRACT

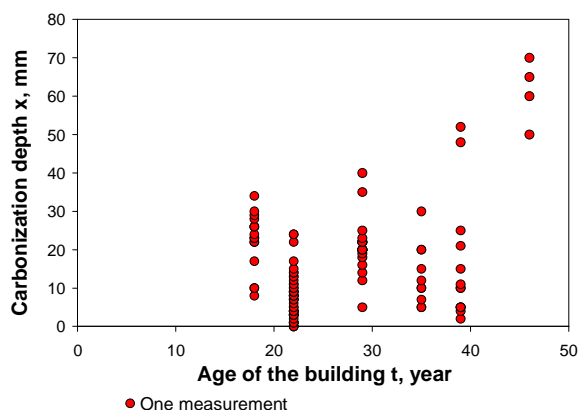
Despite the overall acceptable condition of external surface of external walls, serious problems with joints between panels (lack of wind- and water-tightness) exist. This was somewhat surprising because earlier studies have already highlighted this problem and proposed solutions for renovations. Unmade renovations indicate passivity of occupants to deal with renovation works that will directly repair dangerous defects or that are not directly cost-effective (some energy saving renovation works). Carbonization depth was 2...3 cm from the external surface (Figure 1, left). The small corrosion depth could be the reason because of corrosion of the reinforcement existing only when the reinforcement was very close (<1 cm) to the surface of the panel (Figure 1, right). As carbonization depth depends strongly on the age of the building, it is a question of time when the neutralization of the concrete takes place and the alkaline protection for the reinforcement finishes. Therefore, facades need to be protected.

Figure 1. Carbonization (left) and corrosion of the reinforcement of the concrete facade (right).

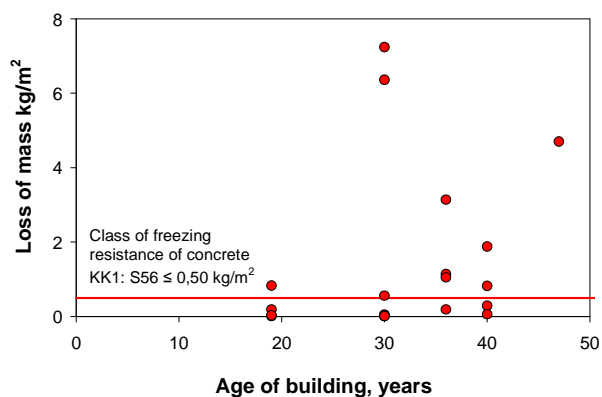
The frost resistance of facade concrete was studied based on the loss of mass after 56 cycles of freezing and thawing. For the facade (frost resistance class KK1), the loss of mass should be $\leq 0.5 \text{ kg/m}^2$. Both the laboratory tests (Figure 2, left) and visual inspection of buildings (Figure 2, right) indicated to a small remainder frost resistance of the facade concrete and balcony elements (Figure 3). Only half of the specimens fulfilled the criteria for the frost resistance: loss of mass $\leq 0.5 \text{ kg/m}^2$. None of the buildings fulfilled the criterion for the frost resistance. Status with the frost resistance of the concrete of the facade and balcony elements is of high concern. Facades need to be repaired, reinforced and/or protected.

Figure 2. Loss of concrete mass of the facade panel during frost resistance tests (left) and decay of the facade due to low frost resistance (right).

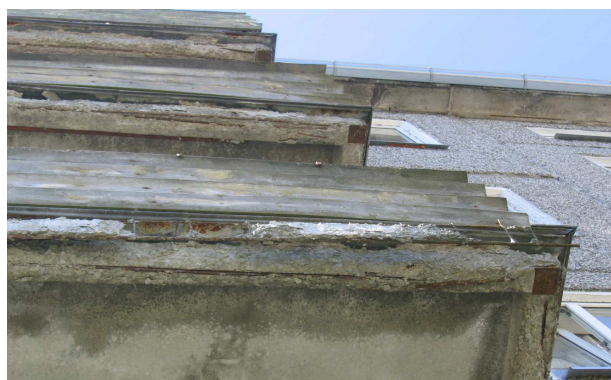
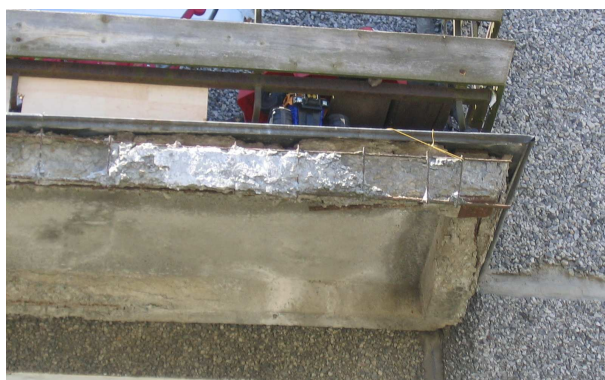
Figure 3. Damages of balcony elements.

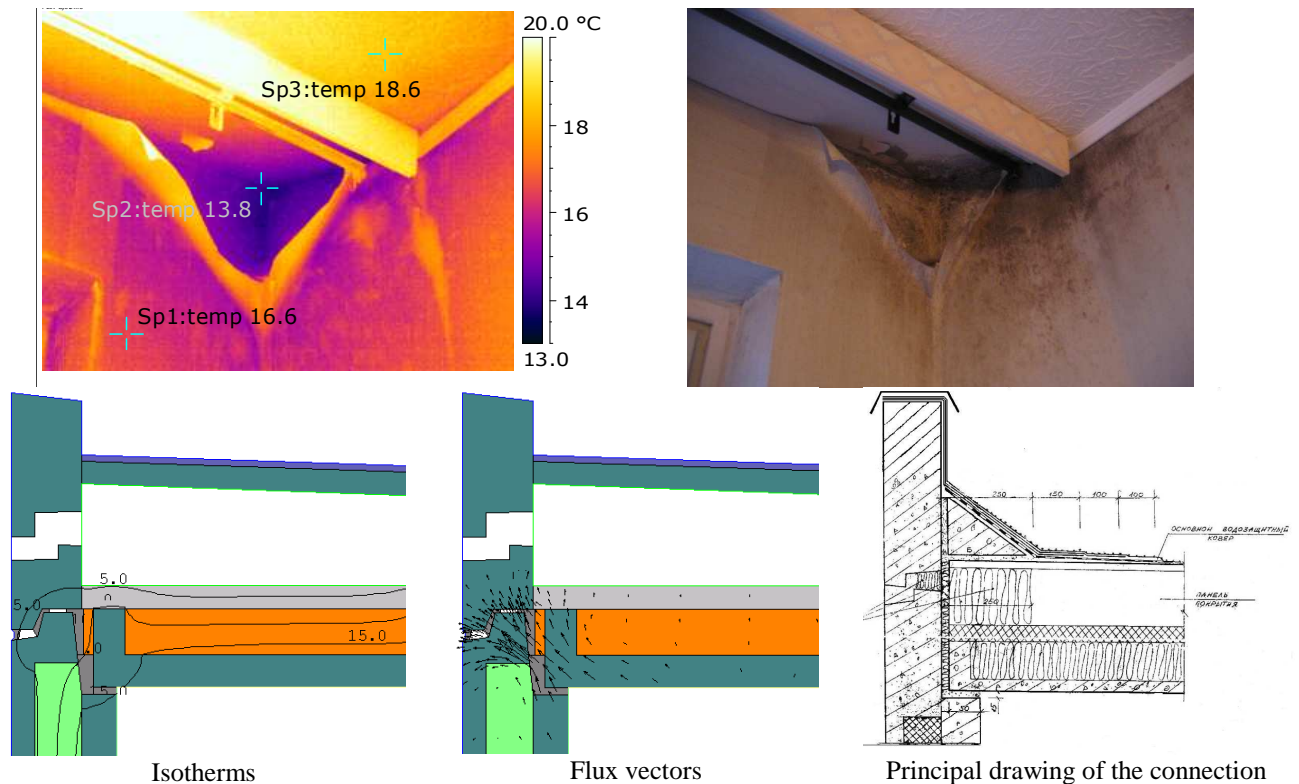
Serious thermal bridges are a major problem in old PCLPAB, resulting in mould growth, surface condensation, soiling of surfaces, larger energy loss etc. Field measurement showed that the main locations of thermal bridges in PCLPAB are: horizontal and vertical joints between external wall panels, junction of the external wall and the balcony slab, junctions of the external wall (especially end sides) and the roof, bonds between panels' inner and outer layers of the external walls, socket panels. The problem of thermal bridges is emphasized due to high indoor humidity loads (low

ventilation rate and high moisture production) that are typical of PCLPAB. An average temperature factor $f_{Rsi} = \frac{R_T - R_{si}}{R_T} = \frac{t_{si} - t_e}{t_i - t_e}$ was between 0.56 and 0.73. The limit value of the temperature factor is between 0.65 and 0.8 depending on indoor humidity loads [Kalamees 2006]. Mould growth and surface condensation on the internal surfaces of thermal bridges are unavoidable without additional external insulation and/or lowering internal humidity loads.

Figure 4. An example of the thermal bridge in the external wall and roof connection: thermographic investigation (above, $t_i=3^\circ\text{C}$, $t_e=19^\circ\text{C}$), numerical simulation (below).

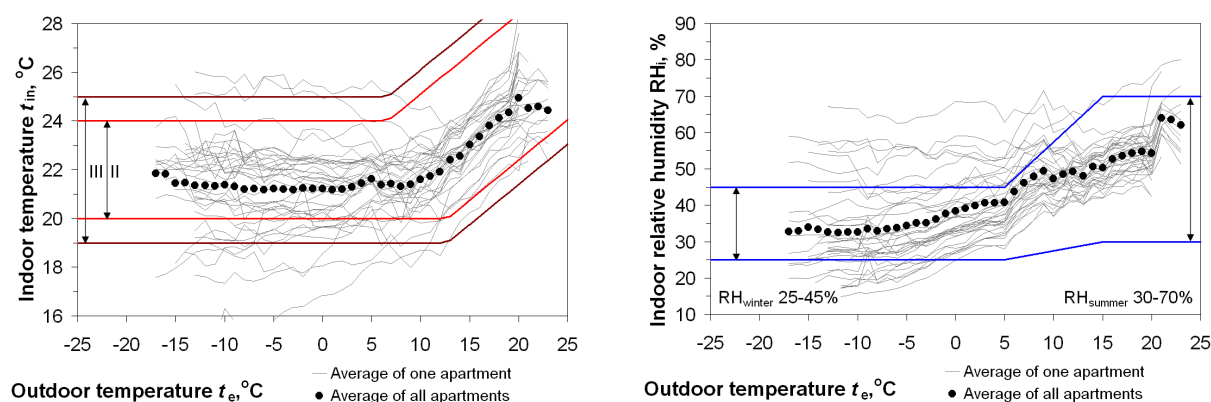
Indoor temperature and RH were continuously measured in 39 apartments in 20 buildings at 1-h intervals over a 1-year period. Figure 5 shows the overall view of the indoor temperature (left) and relative humidity (right) dependence on the outdoor temperature. The one-pipe (less pipe material) heat distribution system is typical of old apartment buildings. Typically there are no room thermostats on radiators and the system is typically fitted from standpipe valves. Room temperature was regulated in the boiler room based on the outdoor temperature. This results in large variations of indoor temperature and low correspondence of the indoor thermal conditions to the target values of the indoor climate standard. In 41% of the apartments the room temperature did not correspond to the

lowest indoor climate category. Other problems concerning the heating system are: incorrect water flow rate of the heating system or risers, lack of direct room temperature control, difficulties to balance the one-pipe heat distribution system, lack of maintenance and improper modifications.

Figure 5. Dependence of the indoor temperature (left) and relative humidity (right) on the outdoor temperature in all rooms.
