Diagnosis of Pathological Manifestations and Service Life Estimation of Reinforced Concrete Structures of Water Reservoirs with Different Ages: Case Study

Fuad Carlos Zarzar Júnior¹
Elaine Cristina da Rocha Silva²
Mauro José Araújo Campelo de Melo³
Rafaella Larissa Santos Ribeiro⁴
Arnaldo Manoel Pereira Carneiro⁵

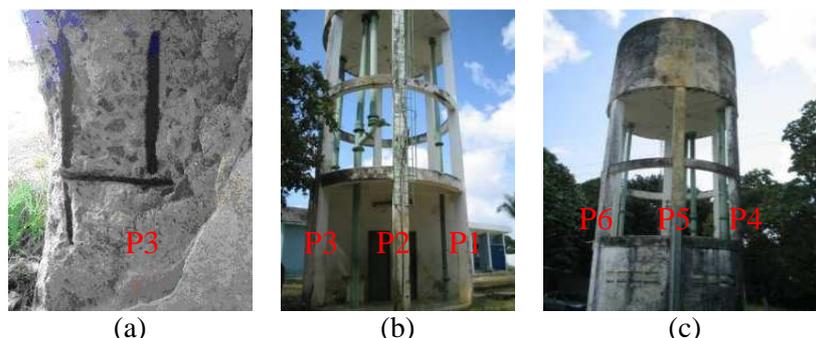
Figure 3. Visualization of pathologies from the 20 years old reservoir structure.

It was observed in the columns, cross-section reduction of the reinforcement bars, stains and sludge on the surrounding of the reservoir, see 'Figs. 3 a, b and c'.

The rebound hammer had an index below 20, presenting a separated concrete layer near the surface with fissures.

The tests were performed with phenolphthalein in columns P1, P2 and P3 showing carbonation depth, 4.46 cm, 4.74 cm and 2.20 cm, respectively. All bars have started the process of corrosion due to carbonation.

The test was carried out at the columns P1 (- 236 mV), P2 (- 275 mV) and P3 (- 271 mV), and according to standard [ASTM C 876 / 87] the probability of corrosion was uncertain. It is important to note that the visual analysis showed that the corrosion process had already started.

The classification levels of the concrete deterioration of the columns P1, P2 and P3 were D, C and D, respectively, requiring immediate intervention [CEB 1983].

The deteriorated structure presented rust stains, loss of cross-sections bars around 25% and longitudinal cracks in beams and columns. According to Ripper [1998] strengthening of the reinforcement bars is recommended when loss of steel reinforcing bars is greater than 15%. However, this value is arguable for more serious cases. The recommendation is to structurally reinforce the steel bars that showed loss of cross-section in the columns and beams and follow the procedures in the literature, in particular Ripper [1998] and Helene [1992]. For the slab, which is less deteriorated, it is recommended an application of sealing and an appropriate maintenance plan, see 'Figs. 3b and c'.

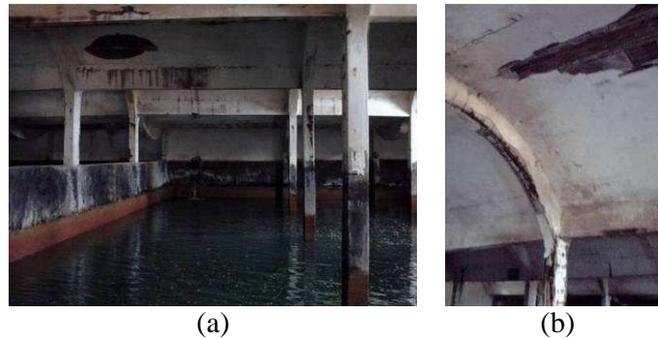
Figure 4. deteriorated components.

It was observed small cracks in the coating, stains, sludge and mould on painting outside the reservoir. In the inner area mould stains, detachment of the plaster coating, exposing the masonry covering, and the arch beam with loss of section of the ties, and probably of the main reinforcement bars were visible, 'Figs. 4 a and b '.

According to the CEB [1983], the levels of deterioration of the concrete columns P1 and P2 were evaluated as A. The interior of the reservoir has also been investigated and classified as D.

The external investigated columns showed no need for intervention. However, visual inspection of the inner area showed the need for further investigation, and likely, prompt intervention followed by structural strengthening. Because of the chlorination of water, the reservoir has high levels of chloride which leads to reinforcement corrosion. For the arched beams in the inner side, structural strengthening of the deteriorated structure with materials resistant to chloride ions is recommended. The implementation of sealing and an appropriate maintenance plan are also necessary.

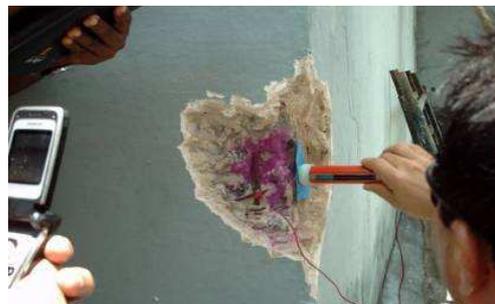
The average electrochemical potential of the external columns P1 and P2 were -271 mV and -332 mV, respectively. Again, the visual analysis showed that the corrosion process had already started, as shown in 'Figure 6 '.

Figure 6. Application of the positive electrode on the face of wet concrete and connected to negative reinforcement in the column P1.
