CIB2007-010

Advances in *ETICS* Behaviour Analysis and Consequences for Planning Maintenance

J. A. Raimundo Mendes da Silva
Jorge G. F. Falorca

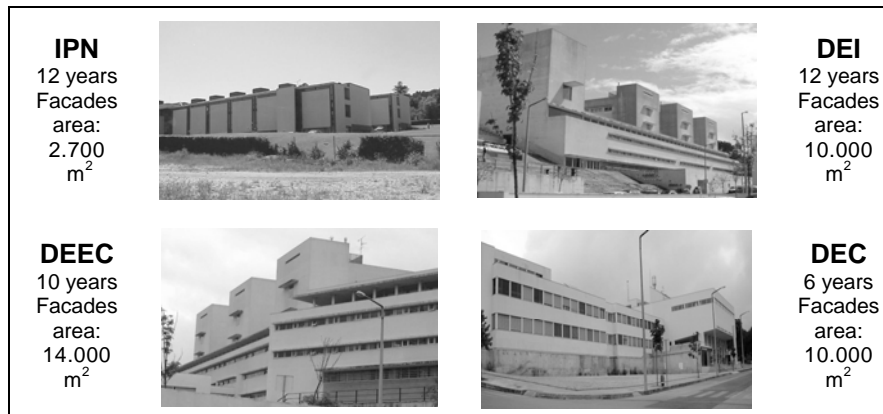
Figure 2.2 Selected buildings and their facades

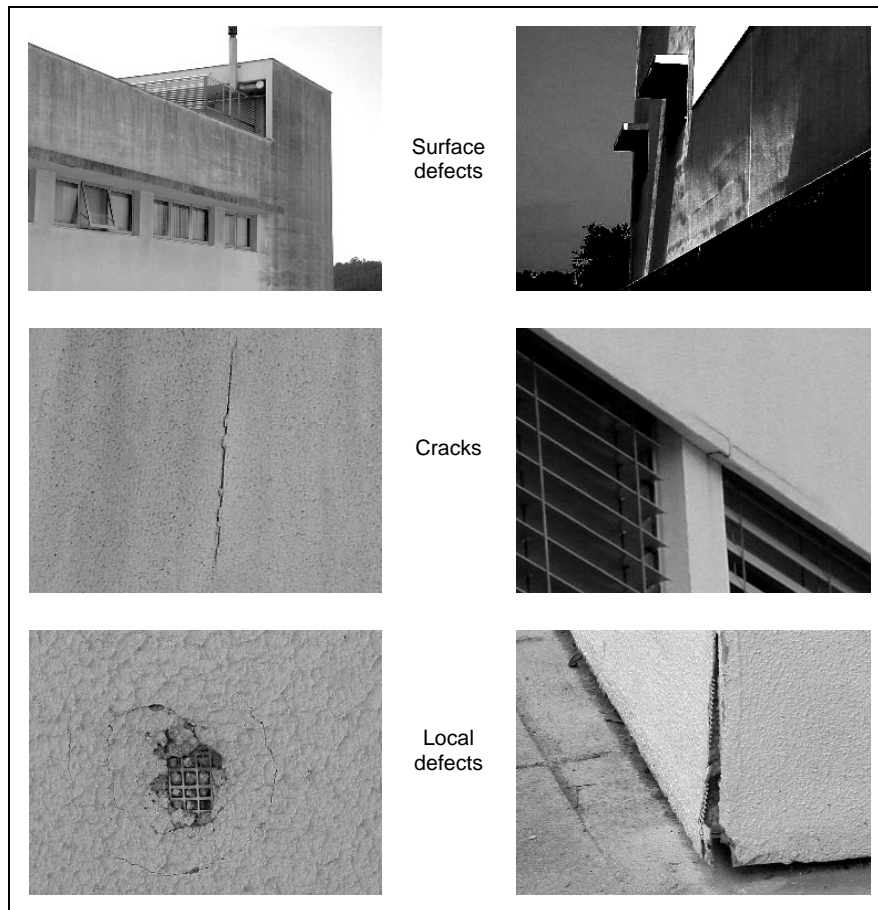
Three groups of defects have been observed during both inspections: (i) surface defects, (ii) cracks and (iii) local deterioration. Figure 2.3 illustrate some of these defects.

Surface defects – like parasitic vegetation, rain water dirty areas and irregular surfaces -, that affect a wide area of the facades, are particularly inconvenient in what concerns visual comfort and aesthetics, but there is no evidence of their consequences on physical performance of the wall (thermal insulation, waterproof, mechanical strength and cohesion).

Cracks occur in 60% of facades, but they affect only a small area. The more relevant are the cracks between insulation boards (due to inadequate materials or construction errors) and local cracks over metal reinforcements of *ETICS* system. Unlike surface defects, cracks promote a progressive deterioration of *ETICS* and of the facade physical performance.

Local defects result mainly of mechanical actions – unpredictable use or vandalism – that perforate the thin external mortar layer and the reinforcement mesh, leading to a progressive degradation of *ETICS*. These phenomena occur at confined areas but they can be responsible for a general degradation. It is important to remember that the most relevant function of the reinforced external mortar layer of *ETICS* is to protect the insulation boards against rain water, to prevent the migration of humidity to the wall, the deterioration of insulation material and the thermal conductivity increase. Local perforation often affects this basic function.

Figure 2.3 Examples of different groups of defects
