DECONSTRUCTION OF EARTHQUAKE-DAMAGED BUILDINGS IN TURKEY

Author: Soofia Tahira Elias-Ozkan (METU, Ankara, Turkey)

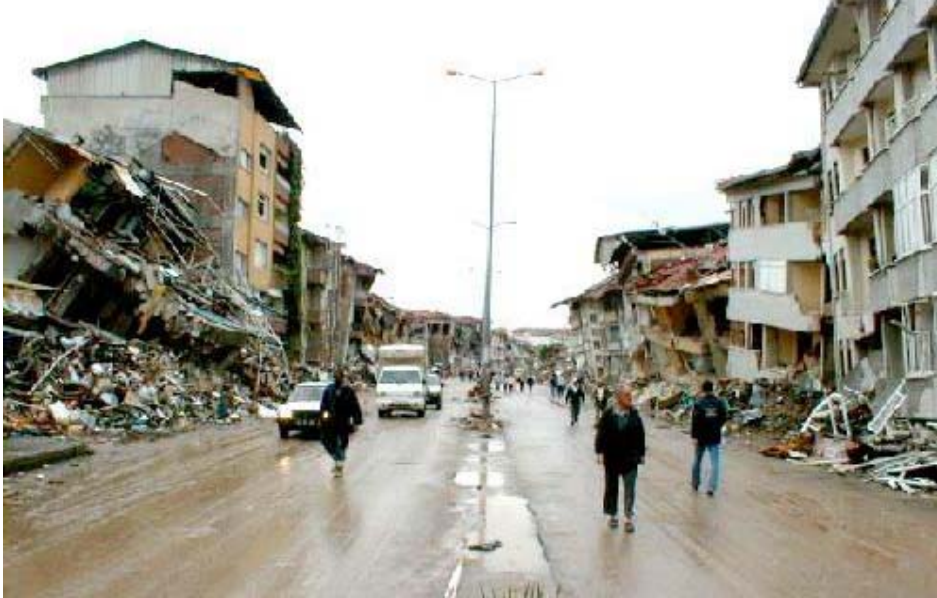
Figure 1: Extensive damage caused to the buildings located on one of the main roads in Adapazari, as a result of the devastating earthquake of 1999 in the Marmara region [ii].

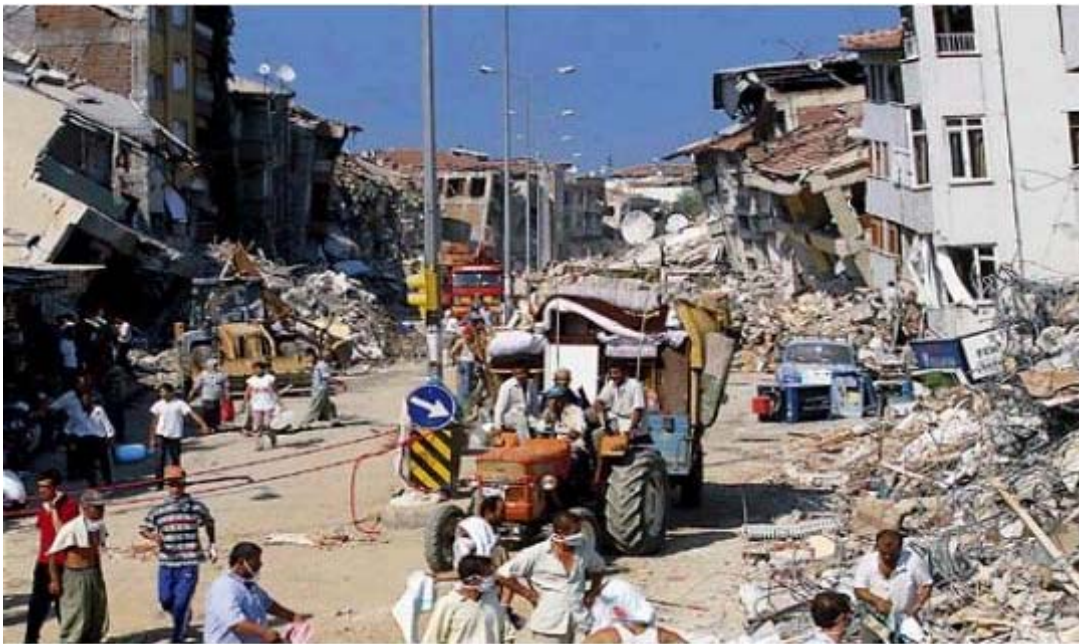
Figure 2: Another view of the main road, shown in Figure 1, after demolition work had started on the dangerously damaged buildings [iii].

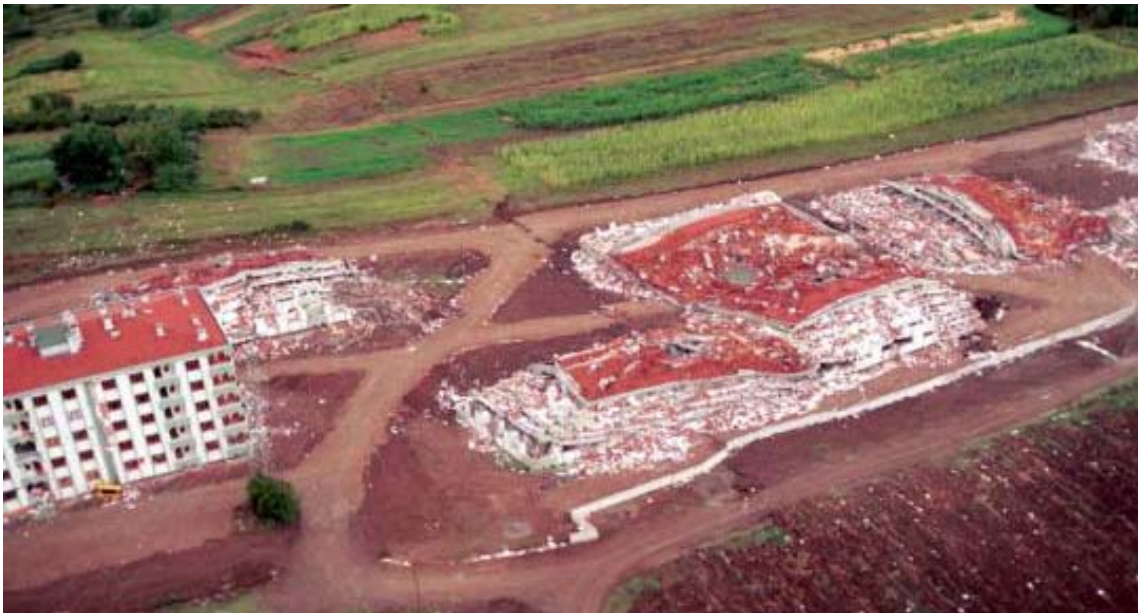
- a. *Totally collapsed structures*: buildings that were completely razed to the ground into huge mounds of rubble (Figure 3).

Figure 3: A moderately damaged building next to totally collapsed ones after the earthquake in the Marmara region [ii].

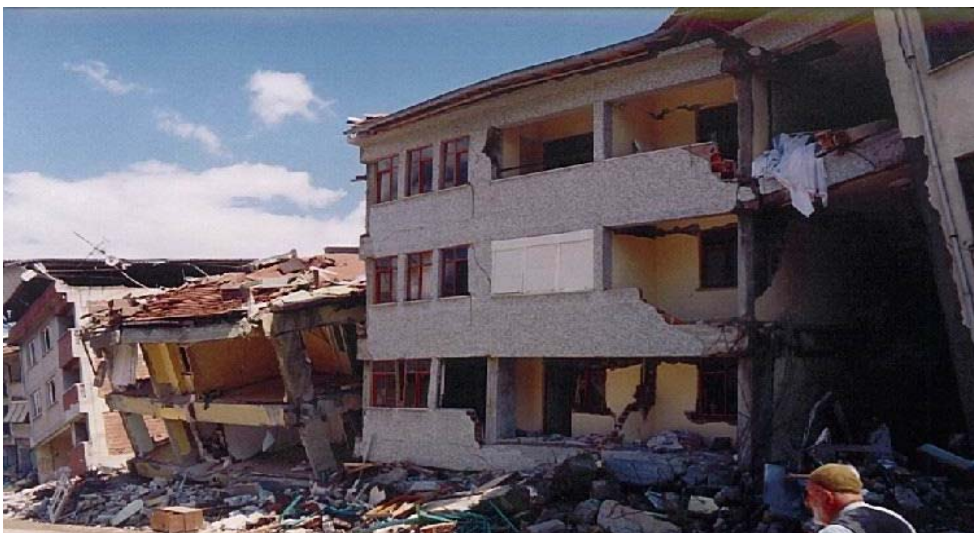
- b. *Partially collapsed structures*: buildings with some parts left still standing, but so precariously as to require immediate demolition (Figure 4).
- c. *Severely damaged structures*: buildings with irreparably damaged structural elements; Figures 8 and 14 show two such buildings.
- d. *Moderately damaged structures*: buildings with some structural and other damage rendering them unsafe, if not uninhabitable, in case of after-shocks (Figure 3).
- e. *Slightly-damaged structures*: buildings with damaged glazing and/ or superficial cracks that were repairable.

Figure 4: Semi-collapsed buildings in Adapazari, which were to be demolished soon [iii].

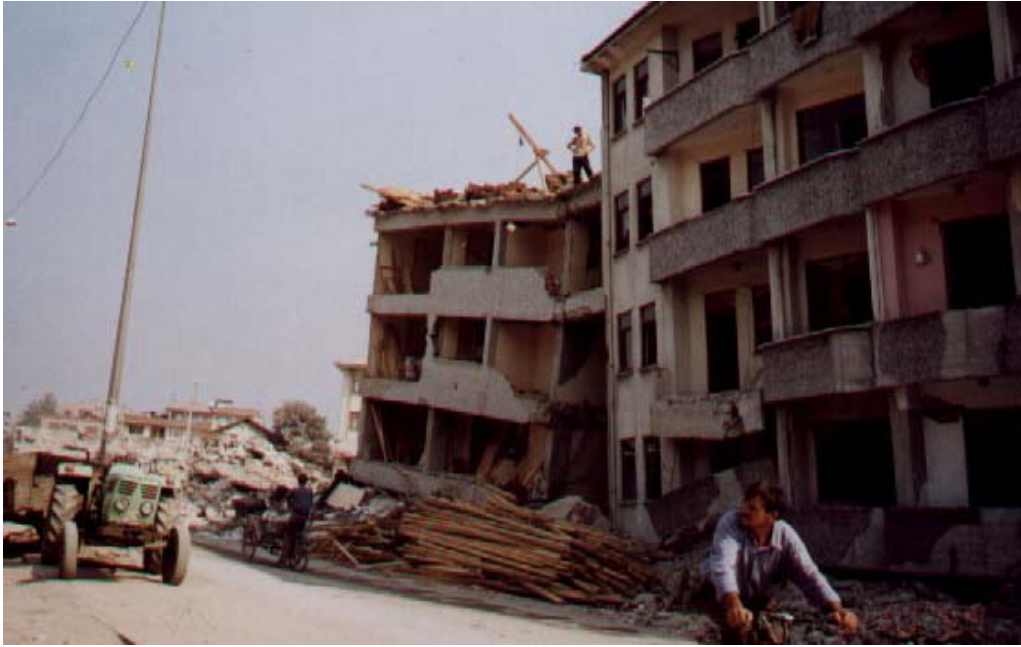
Figure 5: Recovery of building material from the severely damaged building in Figure 4; the structures beyond have been already been deconstructed and demolished [ij].

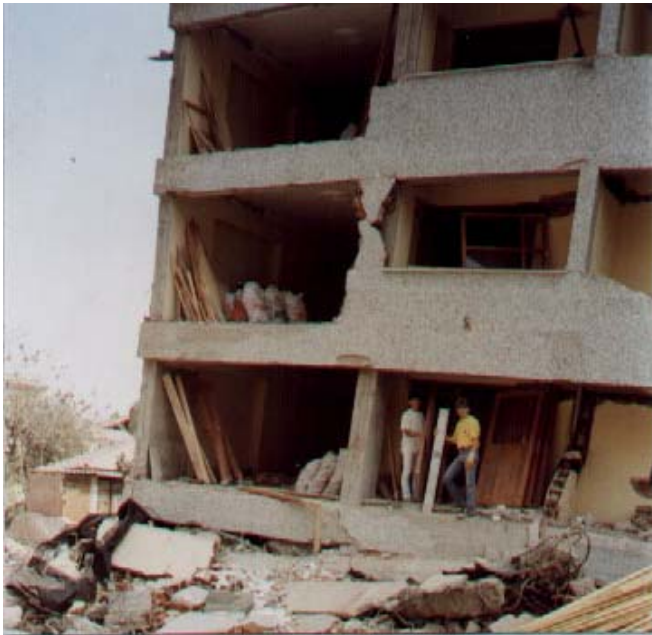
Figure 6: Deconstructing earthquake-damaged buildings: Selective demolition in progress on the building shown in Figures 4 & 5 [ij].

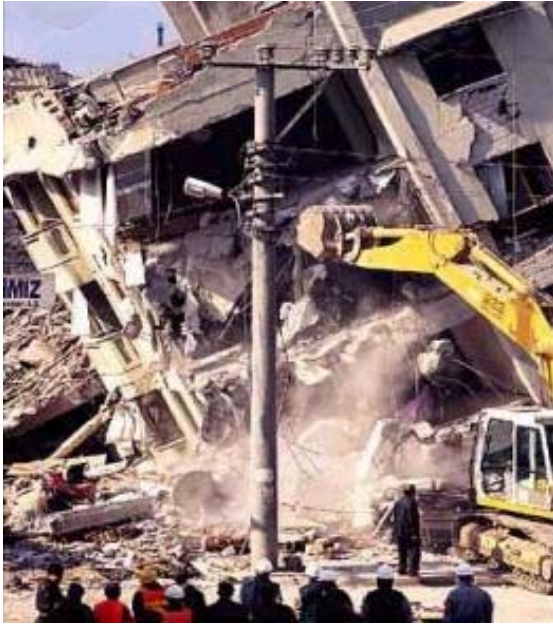
Most of the demolition work was being done by excavators, which worked their way in from the front to the rear of the structure. This approach not only caused immense pollution but also was also dangerous. Moreover, the debris created by such haphazard demolition made recovery of materials even more difficult. Figure 7 shows demolition work in progress on a severely damaged building.

Figure 7: A semi-collapsed structure being pulled down in Adapazari [iii].

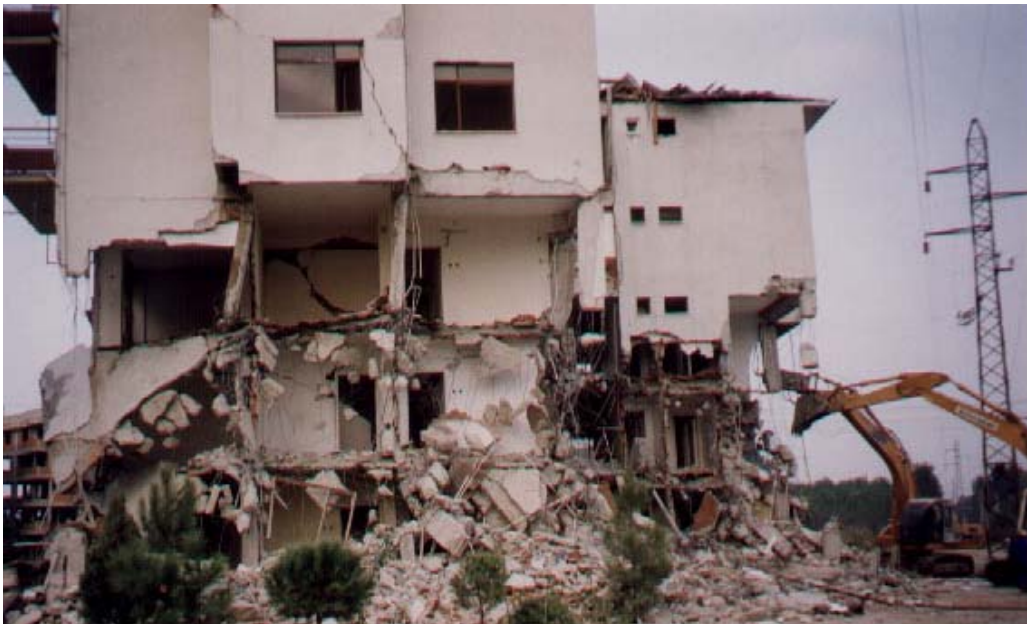
Some buildings were demolished by pulling out their columns one-by-one, starting from the ground floor and moving upwards (Figure 8). The movement of the excavators was limited by the high-tension cables passing overhead; at one point during the demolition work, the arm of one excavator got entangled in the power lines and was in danger of bringing them down too. Had a top-down technique been adopted to demolish the structure, much of the building material could have been recovered for re-use elsewhere.

Figure 8: Columns of a building being pulled out in Gölcük [iv].

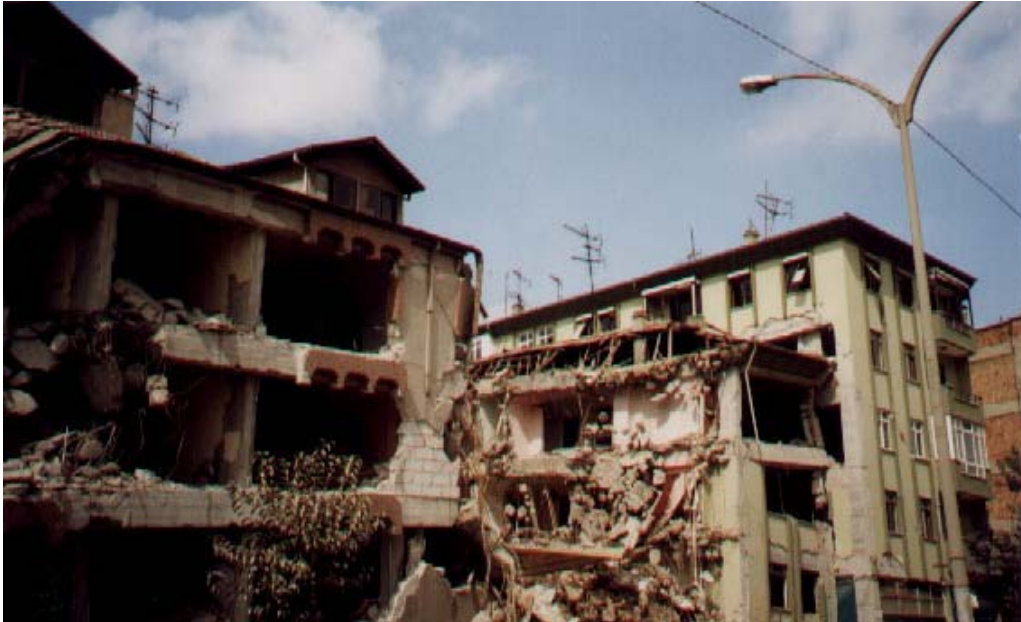
Damaged sections of buildings were being removed without taking into consideration the support of the upright portions. Figure 9 shows two such buildings in Adapazari with partially-collapsed sections; notably, there were two upstanding structures on the top floor of

Figure 9: Partially-collapsed buildings with penthouse on the structure to the left [v].

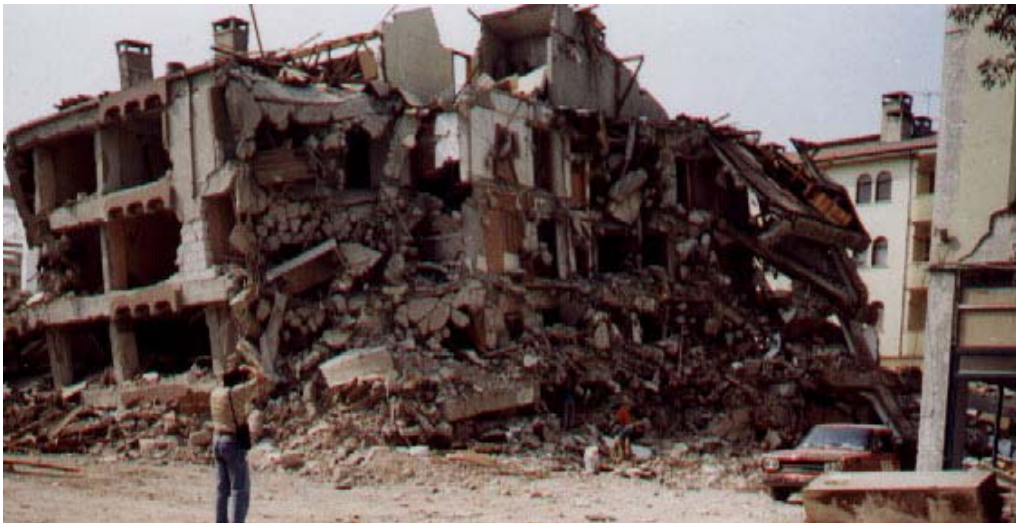
the building to the left. When the site was visited two weeks later, it was observed that, because the collapsed sections at the front had been removed in the accustomed manner, the rear had collapsed too, bringing down with it the structure on the roof (Figure 10).

Figure 10: Removal of collapsed sections of the building shown in Figure 9 led to the collapse of an upstanding one at the rear, bringing down the penthouse with it [ij].

The priority was to remove the dangerously damaged structures as fast as possible; hence, demolition work proceeded at a great speed, seemingly regardless of the safety of the demolition squad or passers-by. At times, debris from partially collapsed structures was removed prior to the demolition of the upstanding portions. This posed a danger to the surroundings, since the rubble might have been supporting some un-collapsed section(s) of the building. Contrary to the prevalent practice of demolishing a structure from its sides inwards with excavators, as observed in Adapazari and Gölcük, it would have been safer to adopt a top-down demolition technique.

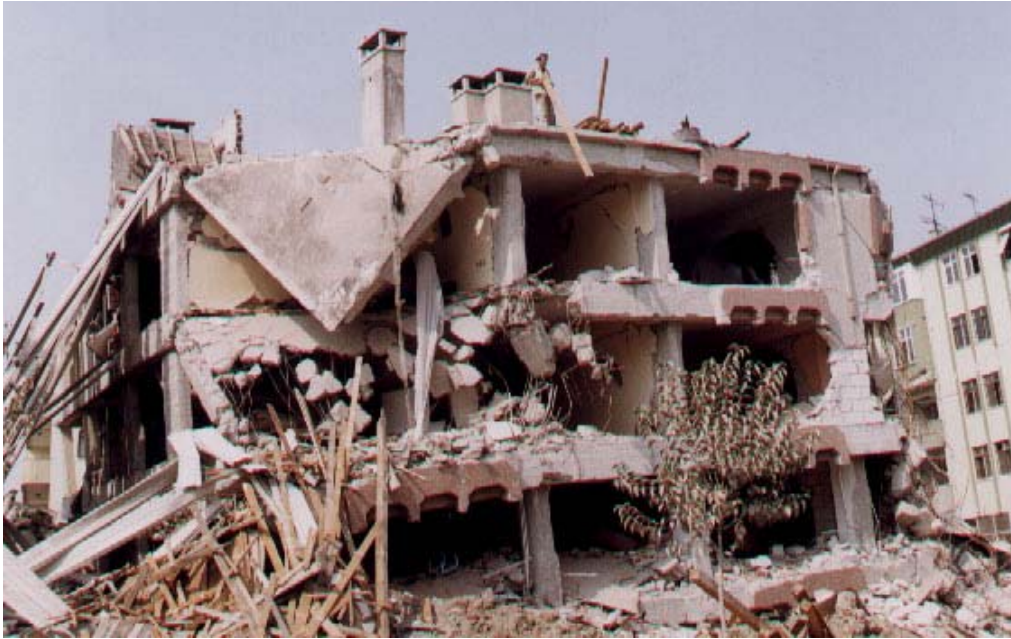
Salvage operations were carried out even in semi-demolished buildings tilted at precarious angles. Figure 11 shows recovery of building materials from one such building in Adapazari, while Figures 12 and 13 show recovery efforts in a similarly damaged building in Gölcük. The soft story of this building had buckled under, and the whole structure had tilted to one side. Construction workers were employed for selective dismantling of buildings that were severely damaged, with the aim of salvaging as much of the building materials and

Figure 11: Dismantling the roof of the building in Figures 9 & 10 above [i].

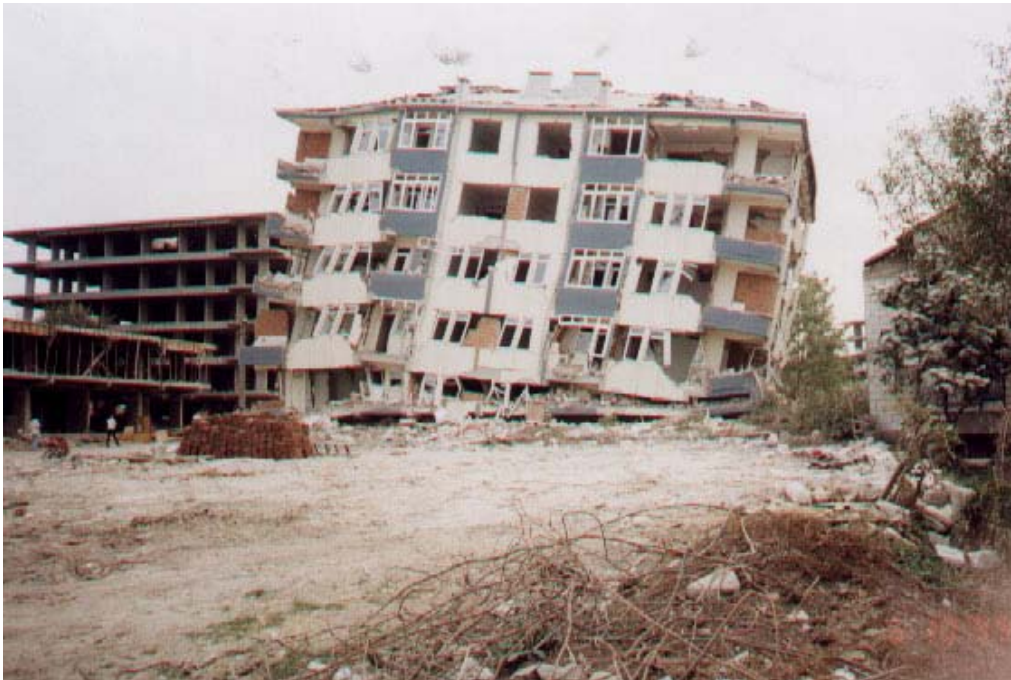
Figure 12: Building material being recovered from a dangerously damaged building: roof tiles stacked in the foreground (Gölcük) [i].

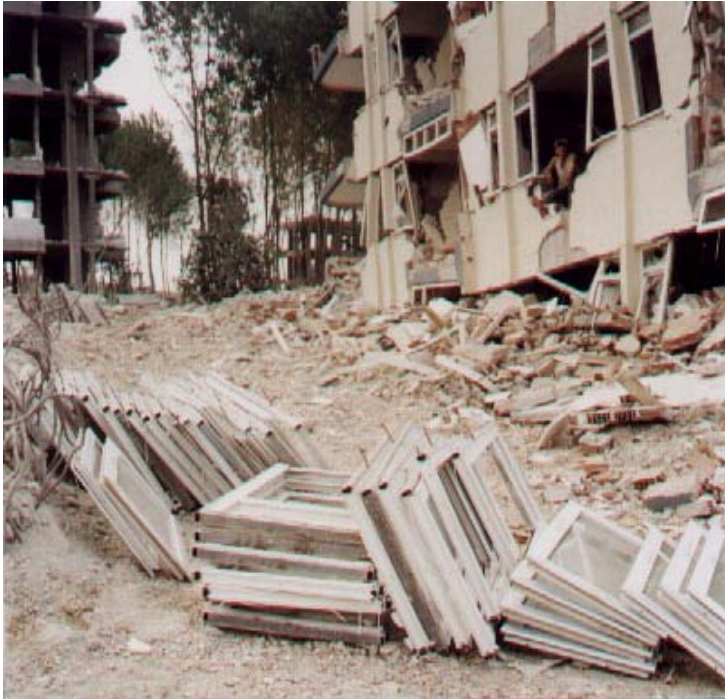
Figure 13: Rear view of the building in Figure 12 shows men working in this dangerously tilted structure to dismantle building components and fixtures; salvaged fenestration units are seen collected in the foreground [i].

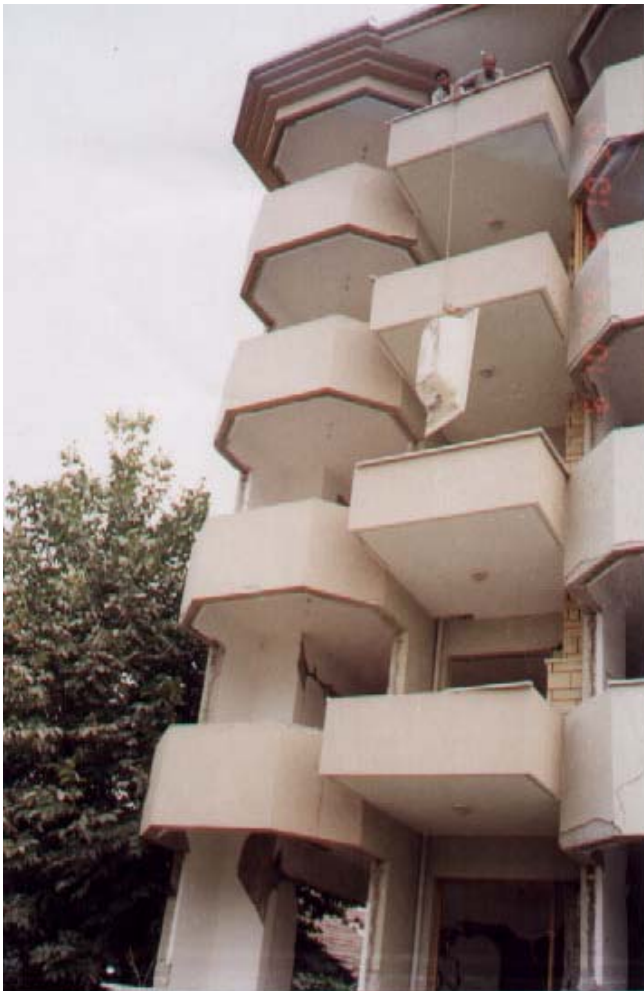
components as possible, before the municipality excavators and bulldozers moved in to demolish them. Figure 14 belongs to another earthquake-damaged building in Gölcük; selective recovery of fittings and fixtures was also witnessed here.

Figure 14: Deconstructing a severely damaged, newly constructed building in Golcuk: Bath tub being lowered from the 5th floor of the building whose ground floor had buckled under [i].

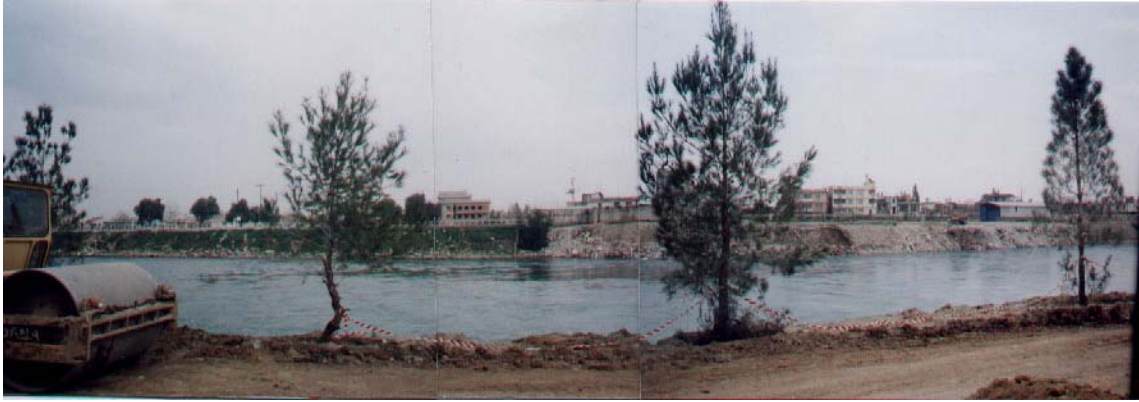
Figure 15: Rubble from the demolished earthquake-damaged structures was initially dumped along the banks of Seyhan River in Adana [i].

Furthermore, debris from thousands of demolished structures was disposed of without much forethought. Most of the rubble was dumped into a river in Adana, and into a lake in the Marmara region. Consequently, additional resources had to be wasted in order to retrieve this rubble and put it to a more environmentally friendly use.
