# Condition Assessment Of 40 Year Old Sewer Stacks In High Rise Buildings

PH Ferguson & DMF Nicholas  
Tyco Water Services and Hunter Water Australia Yennora NSW

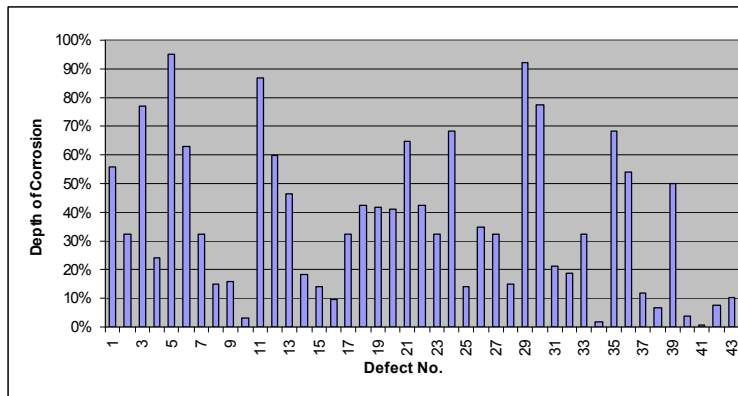
**Figure 5. Depth of Copper Stack Corrosion Defects**

Investigation of copper sewer stacks in 44 buildings revealed a total of 43 defects, all assumed to be attributable to corrosion, and none particularly severe and likely to impact on the life of the stacks in the short term. Figures 5 and 6 show graphical summaries of the results.

These results show small localised areas of pitting corrosion, with only defect number 21 exhibiting any appreciable loss of volume. However, in combination with only 40% depth of corrosion, does not represent a significant defect.

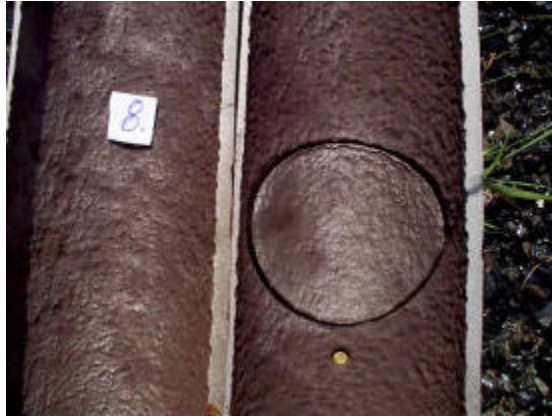
Samples 8, 15 and 44 exhibit considerable depth of pitting corrosion. However, in the case of samples 8 and 15, the pitting is confined to only a small area, resulting in minimal volume loss, and little reduction in structural strength. There is a greater loss of strength exhibited by sample 44. This can be appreciated by referring to Figs 7, 8 and 9.

**Figure 7. Close up of sample 8 from building 37 showing minor pitting corrosion. Note inspection plate on right hand section.**

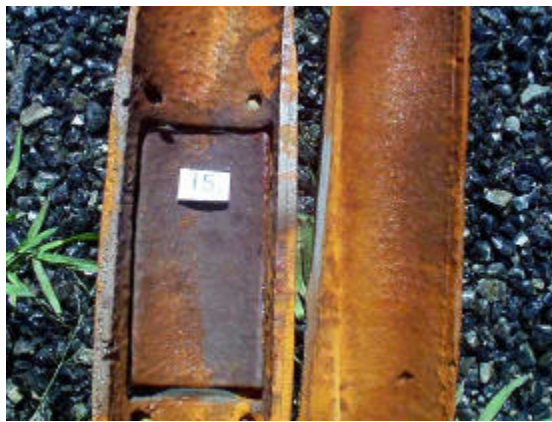
**Figure 8. Close up of sample 15 from building 16 showing inspection cover and small through-wall defect on bottom right hand photograph.**

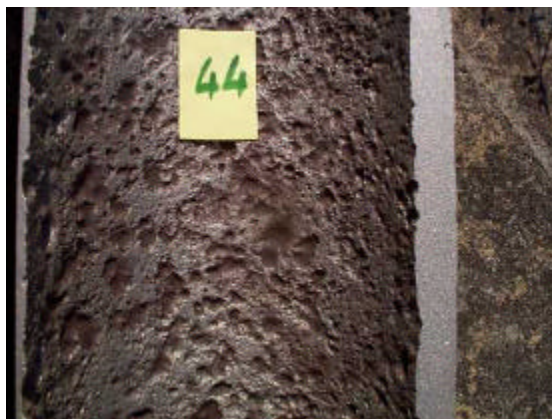
**Figure 9. Close up of sample 44 from building 11 showing pitting corrosion. Also note the eccentric wall thickness.**

Some cast iron stacks exhibit an eccentric bore which causes reduced wall thickness, a consequence of static casting process. When subjected to a corrosive environment and external loading this may lead to reduced life. It is not anticipated that pipes manufactured by centrifugal casting will exhibit eccentric bore.

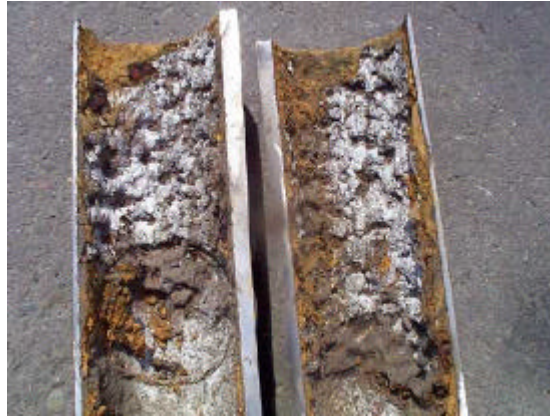
Further investigation of sample 44 from building 11 revealed that it is located in a horizontal position conveying water from a laundry. The photograph below (fig. 10) shows the build up of predominantly cellulose material on the wall of the pipe.

**Figure 10. Close up of sample 44 from building 11 showing build up of waste material.**

In general, both materials have exhibited good corrosion resistance when used to convey sewage into the water authorities reticulation system. Very minor pitting corrosion was detected in sparse and isolated locations for the copper tubes, with no evidence of substantial pitting or general corrosion. Only one sample exhibited significant corrosion for the cast iron system, and this appears to be attributable to the accumulation of waste material in a horizontal section of the sewer stack system.
