## **Case Analysis of Stainless Steel Corrosion in Hot Spring Waters and Using Titanium as a Measure against Corrosion**

### **Abstract**

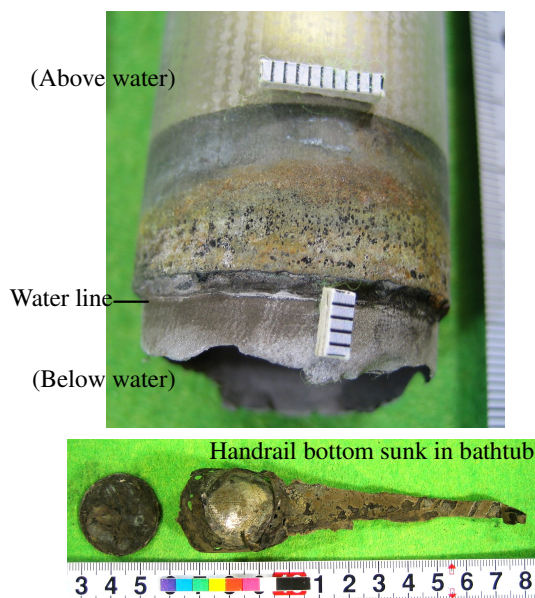
In bathtubs Nos. 1 through 3 which use acid sulfate-chloride spring water containing hydrogen sulfide (source A) for which corrosion was significant, the immersed parts of the handrails in bathtubs Nos. 1 and 2 were dissolved by corrosion after about 2 months and 8 months respectively, as stated above, and the lower parts of the handrails had sunk to the bottom of the bathtubs. The state of corrosion of handrails Nos. 1 and 2 is shown in Figs. 1 and 2. Below the waterline the thickness had been reduced and the metal disappeared, and the remaining lower part of the handrail (the bottom part) was significantly corroded so it was considered that there was uniform corrosion of the SUS304. In the handrail of bathtub No. 3 which was exposed to the same source A, after about 12 months, many microbubbles were generated from the immersed parts of the bathtub as shown in Fig. 3. Thin dark brown corrosion layer formed on immersed parts (See Fig. 4). On the other hand, in the handrail of bathtub No. 4 which is the only bathtub that uses acid sulfate-chloride spring water not containing hydrogen sulfide (source B), off-white scale adhered to the handrail directly above the water line, and below and around the scale pitting corrosion and discoloration with rust was seen. However, localized corrosion or discoloration with rust was not seen in the immersed parts or the parts exposed to air.

**Figure 1 - State of corrosion of handrail in bathtub No. 1, About 2 months use**

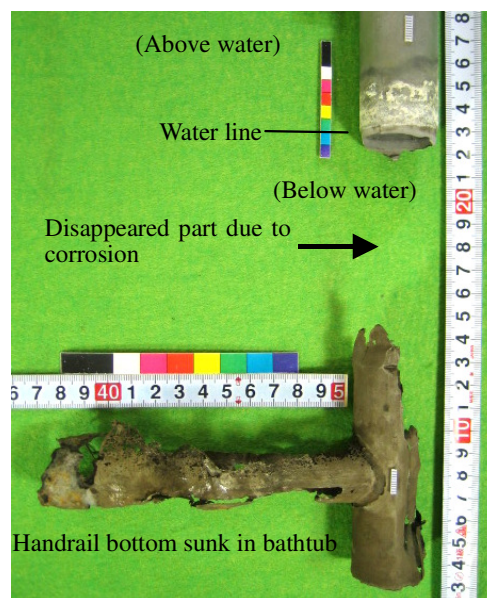
**Figure 2 - State of corrosion of handrail in bathtub No. 2, About 8 months use**

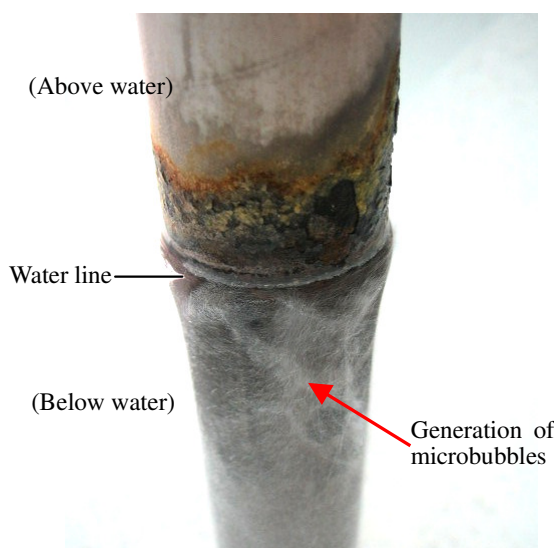
**Figure 3 - State of active dissolution of handrail in bathtub No. 3, About 12 months use**

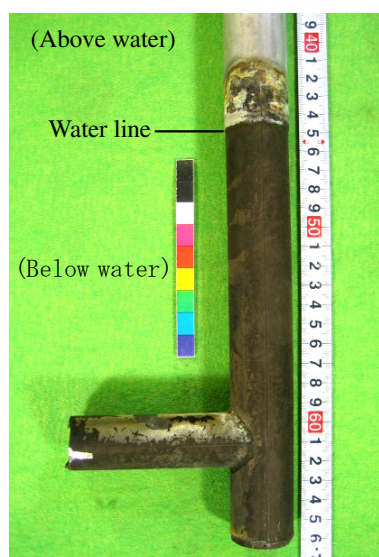
**Figure 4 - State of corrosion of handrail in bathtub No. 3, About 12 months use**

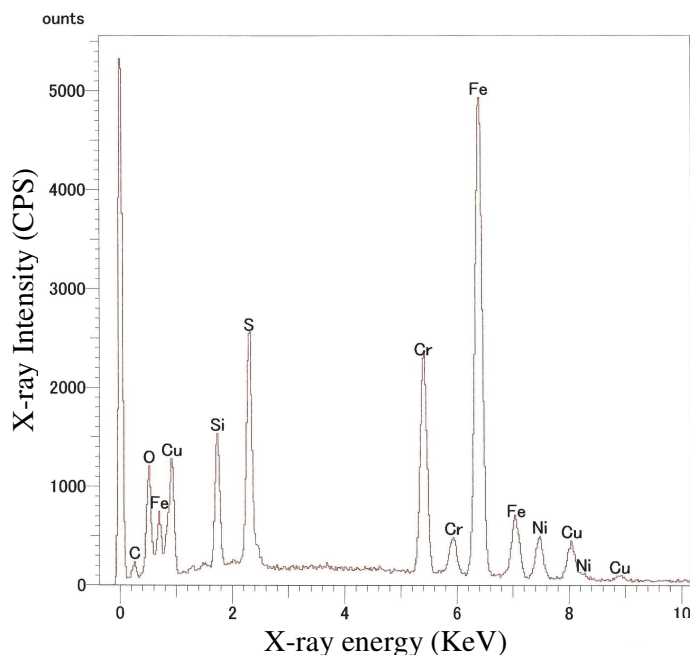
Rust from the waterline of the handrail of bathtub No. 1 was scraped off, and the results of analysis by EDX (JEOL Ltd., JSM-6300) are shown in Fig. 5. Apart from the

components of the material, S was strongly detected. Also, according to EPMA (JEOL Ltd., JXA-8100) analysis results for the cross-section of the rust layer shown in Fig. 6, S, O, Cr, Fe, and Ni are distributed throughout the whole layer. This infers that corrosion products of sulfide or sulfate of Fe, Cr, Ni were formed. From the analysis results of XRD (MAC Science MXP18 and Rigaku RU-2000) on rust samples from the handrails of the No. 1 and No. 3 bathtubs, only nickel sulfate was detected. In all cases the peak was broad, suggesting a compound with low crystallinity. In the case of non-crystalline rust, the state of the compound is estimated from the bonding energy, so state analysis was carried out by XPS (Shimadzu Corporation, ESCA-3200). The XPS analysis results for the rust from bathtub No. 3 are shown in Fig. 7. Figure 7 suggests the generation of sulfides FeS, FeS<sub>2</sub>, NiS, sulfates FeSO<sub>4</sub>, NiSO<sub>4</sub>, oxides Fe<sub>2</sub>O<sub>3</sub>, Cr<sub>2</sub>O<sub>3</sub>, CrO<sub>3</sub>, and hydroxides Cr(OH)<sub>3</sub>, etc. Also, as shown in Figs. 5 and 7, small quantities of copper and its compounds (Cu<sub>2</sub>S, CuSO<sub>4</sub>) were detected. According to the water quality analysis results for the two source waters shown in Table 2, the concentration of copper in source A was less than 0.01 mg/L, and the quantity of copper contained in the SUS304 of the handrails was 0.3% (mass%, x-ray fluorescence analysis, Shimadzu Corporation, MFX2400), so it is considered that the copper originated from the handrail material (an impurity). The quantity of copper in the SUS304 is minute, but there is a possibility that it was detected due to being concentrated in the rust.

**Figure 5 - Analysis result by EDX of corrosion products of SUS304 handrail in water line part**

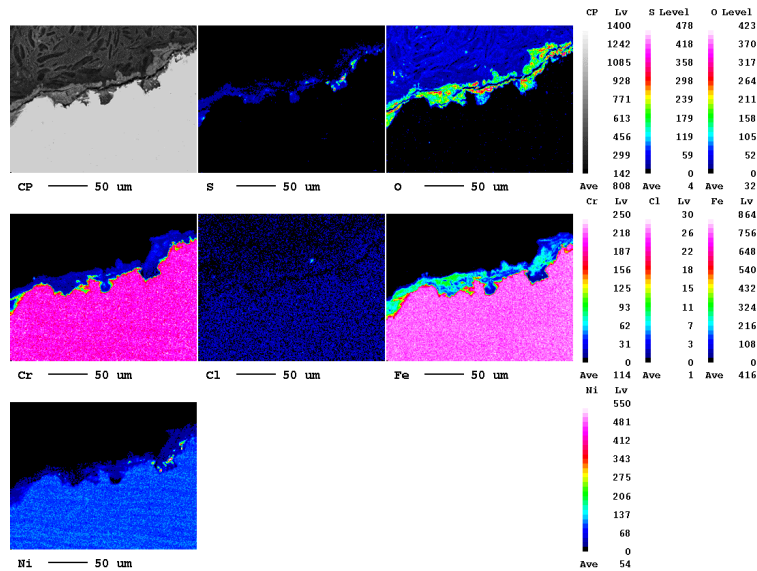
Figure 6 - Analysis result by EPMA of corrosion products of SUS304 handrail in water line part(bathtub No. 1)

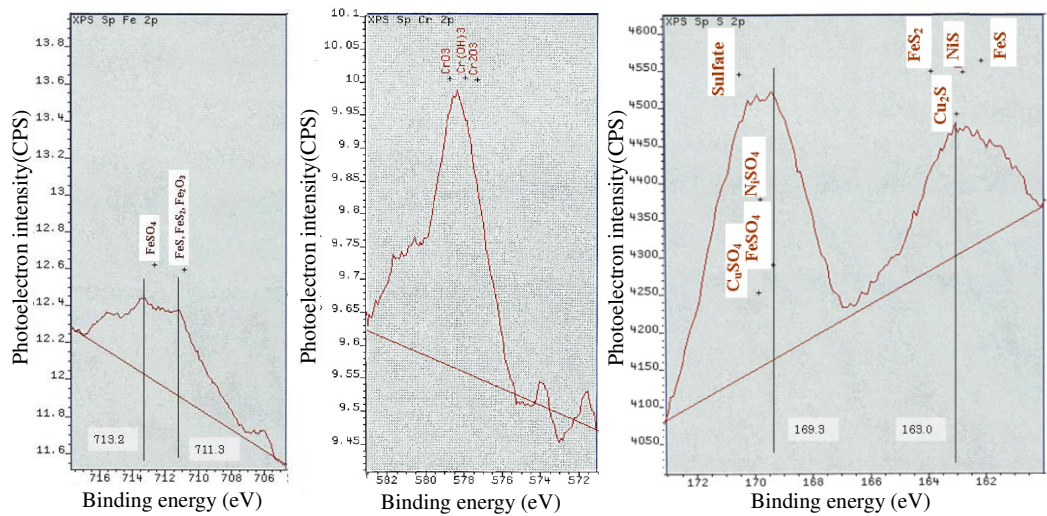
Figure 7 - Analysis result of corrosion products of SUS304 handrail by XPS in bathtub No.3

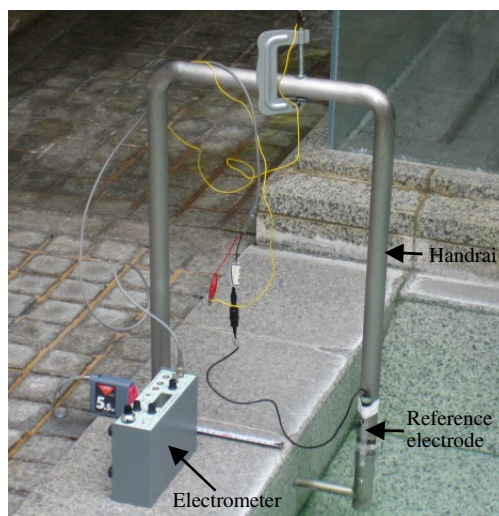
**Figure 8 - Corrosion potential measurement of handrail**

The measurement results for the corrosion potential of the handrails of bathtubs No. 3 and No. 4 are shown in Table 3. The corrosion potential of the SUS304 from the handrail of bathtub No. 3 with source A was -0.494 V (vs. SCE), which is significantly less noble potential so it is considered that it was de-passivated. On the other hand the corrosion potential of the handrail in bathtub No. 4 with source B was -0.023 V (vs. SCE), which was in the passivity state. The corrosion potential measurement results for each test specimen are shown in Fig. 9. The corrosion potential of the SUS304 test specimens in source A varied at a level that was close to that of carbon steel from the start of immersion. The SUS316 exhibited a similar less noble potential as that of SUS304 at the beginning, and thereafter became high potential to close to 0 V. However after 41.5 hours it became unstable becoming less noble again to -0.157 V. The corrosion potential of both SUS304 and SUS316 in source B varied close to 0 V, and the

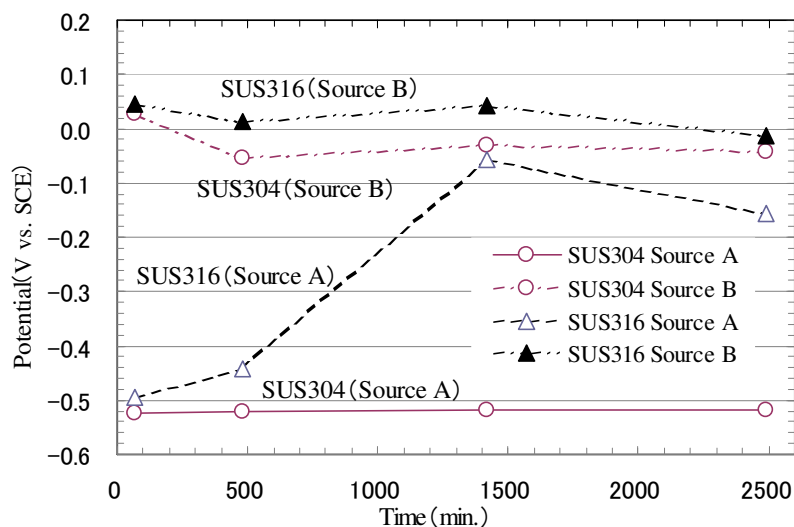
results showed that the SUS316 was several tens of mV more noble compared with SUS304. The surface condition of the SUS316 and SUS 304 test specimens after soaking in source A initially became black soon after immersion, and after completion of the test the color changed to a blackish brown color on all surfaces as shown in Fig. 10, but the color of the SUS316 was relatively lighter. In source B, no signs of corrosion were seen in both SUS304 and SUS316, and they retained their metallic luster.

**Figure 9 - Change over time on corrosion potential of SUS304 and SUS316 test pieces in hot spring source**

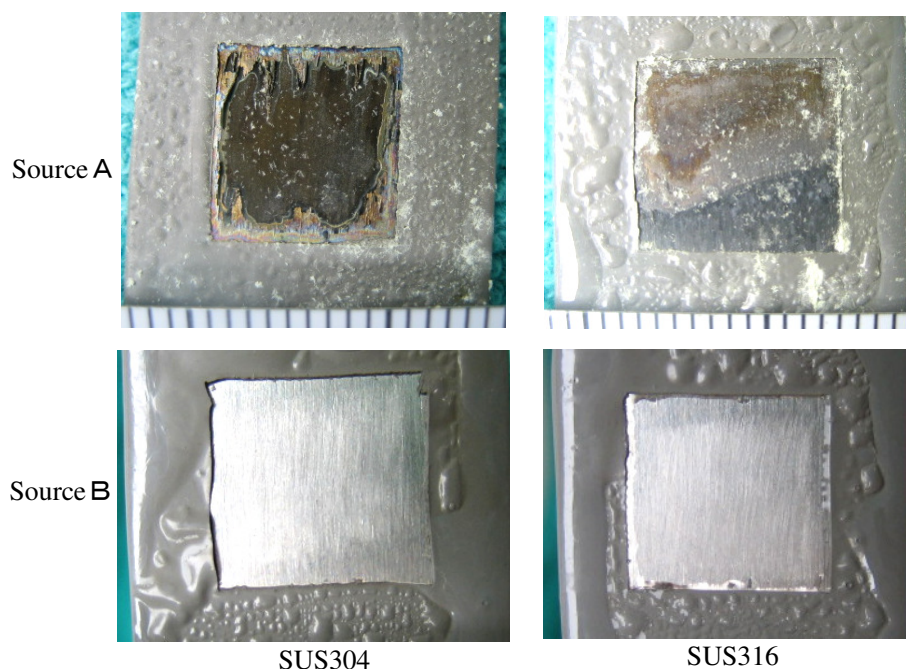
**Figure 10 - Appearances of stainless steel test pieces in the hot spring source after 41.5 hours dipping**

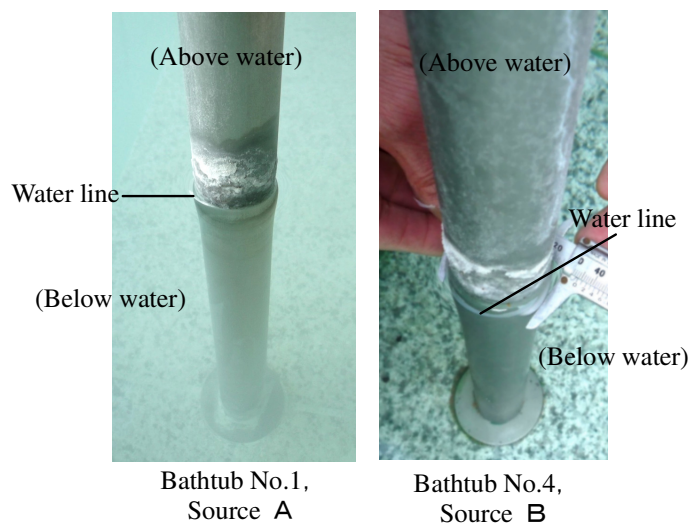
Figure 11 shows the external appearance of the titanium handrails at No. 1 bathtub (source A) and No. 4 bathtub (source B) after about 18 months. As shown in Fig. 11, after about 18 months a white scale can be seen directly above the waterline in the handrails of both the source A and source B bathtubs, but discoloration with rust or local corrosion has not been generated either in the immersed portion or in the portion exposed to air.

**Figure 11 - Appearances of titanium handrail after about 18 months use**

The use of SUS316 and SUS329J4L or other materials were investigated as alternative materials to SUS304. However, in corrosion test results by Iino and others<sup>2)</sup> on welded members in an acidic sulfur – sulfate spring water that was similar to source A, uniform corrosion occurred in SUS316 and localized corrosion occurred near the waterline in SUS329J4L, so titanium was selected for its technical safety from the point of view of corrosion resistance to spring water and strength.

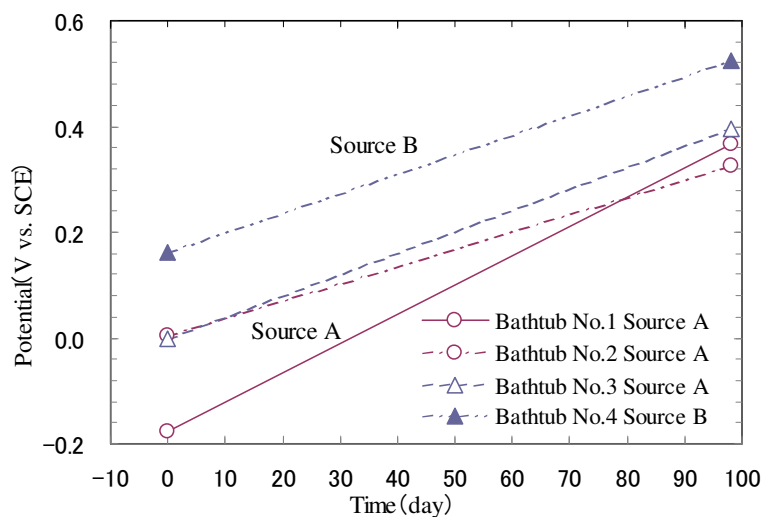
Figure 12 shows the corrosion potential of each bathtub immediately after installation and after about three months. It is considered that in all cases the potential is within the passive region of titanium. About three months of immersion, the potential in each

bathtub became 0.3 to 0.5 V more noble compared with immediately after immersion. This infers that the oxide film of titanium surface increased with passage of time. Each of the potentials measured in source A are less noble compared with source B, so it is considered that the water quality of source A is affecting the surface oxide film of titanium.

Figure 12 - Change over time on corrosion potential of titanium handrail
