## TECHNOLOGICAL POSSIBILITIES OF REPAIRING CORROSION DAMAGED REINFORCED CONCRETE STRUCTURES

**J. Kampioni, G. Slowek**

*Poznan University of Technology, Poland*

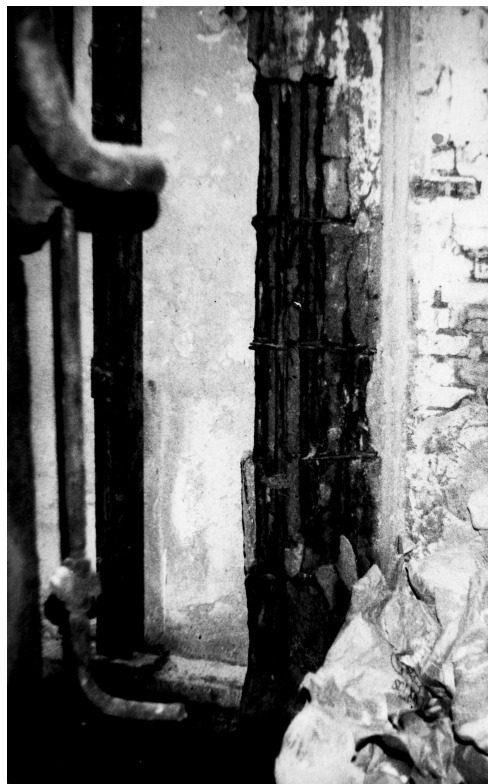
High moisture content, aggressive environment due to usage of NaCl for water softening caused significant damage, especially of RC columns. RC foot was less damaged thanks tight to surface concrete layer and properly profiled inclinations and outlet channels.

Near walls, in regions hard to access due to location of machines the moisturising and NaCl contamination was more intense. Thus significant damage was done to RC columns of load carrying structural frame.

Structural RC columns that were in direct contact with salt experienced the biggest weakening.

Reinforcing bars in the columns were very corroded, sometimes discontinued. Concrete was cracked, concrete cover missing, steel-to concrete bond non-existent. Columns were in emergency condition - Fig.1.

Fig.1. One of columns in emergency condition

Columns were strengthened by cross-section magnification. Additional strengthening reinforcement and 10 cm layer of B25 concrete was applied. Concrete was placed in stages 1,20 m long in specially designed moveable steel formwork. Afterwards surface protection layer was applied manually on all members.

An important feature of repair, influencing its efficiency was erecting RC pedestals along walls at the level of floor. It was covered with additional moisture-tight isolation to eliminate migration of salt water that would penetrate RC columns.
