## **FIRE IN HIGH-RISE BUILDING UNDER CONSTRUCTION INVOLVING NON COMBUSTIBLE ACP (ALUMINUM COMPOSITE PANELS)**

Michele M. La Veglia<sup>1</sup>

### **ABSTRACT**

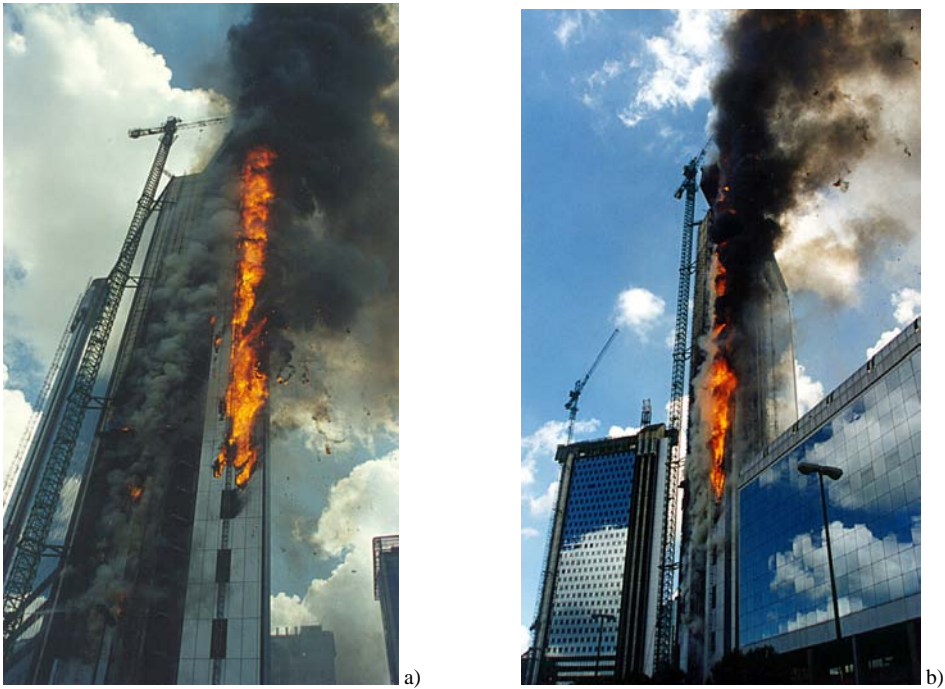
Fig. 1. a) The fire in high-rise building construction. b) The fire involved ACP panels

The burning of the "ENEL Tower" had origin of around 10.30 of 2nd June 1995. In that time the facades cladding assembly works (between the 10th and 12th floor) on the wall in reinforced concrete were in progress. The height is more than 45.00 meters below ground level. The fire was spreading at speeds towards the polyurethane panels already mounted, both in the overlying portion, due to the high flames and the ascending hot gases in the area below, for effect of the the 'drip' and the fall of the hot combustion residues (see Fig. 1).

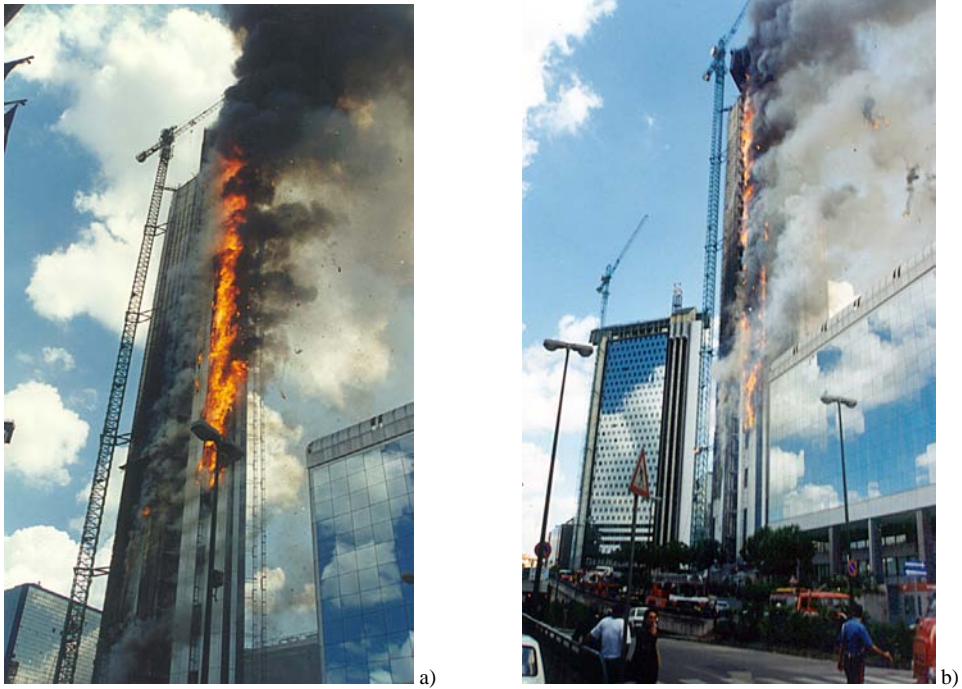
At the end of the intervention, the entire facade of the nucleus on the right wall appeared devastated, with extensive damage caused also the adjacent building (see *Fig. 2*). About 20 m of the facade were affected by the fire, to varying heights from 30 m (for the first part) to 90 m (for the other two neighboring facades to those in which the fire has developed).

Fig. 2. a) The fire in high-rise building construction. b) In the fire there were no victims
