# Zukunft Bau

## Short Report

### ERBE

Survey and evaluation of safety-relevant delamination processes at plaster and façade elements using non-destructive measurement and testing methods

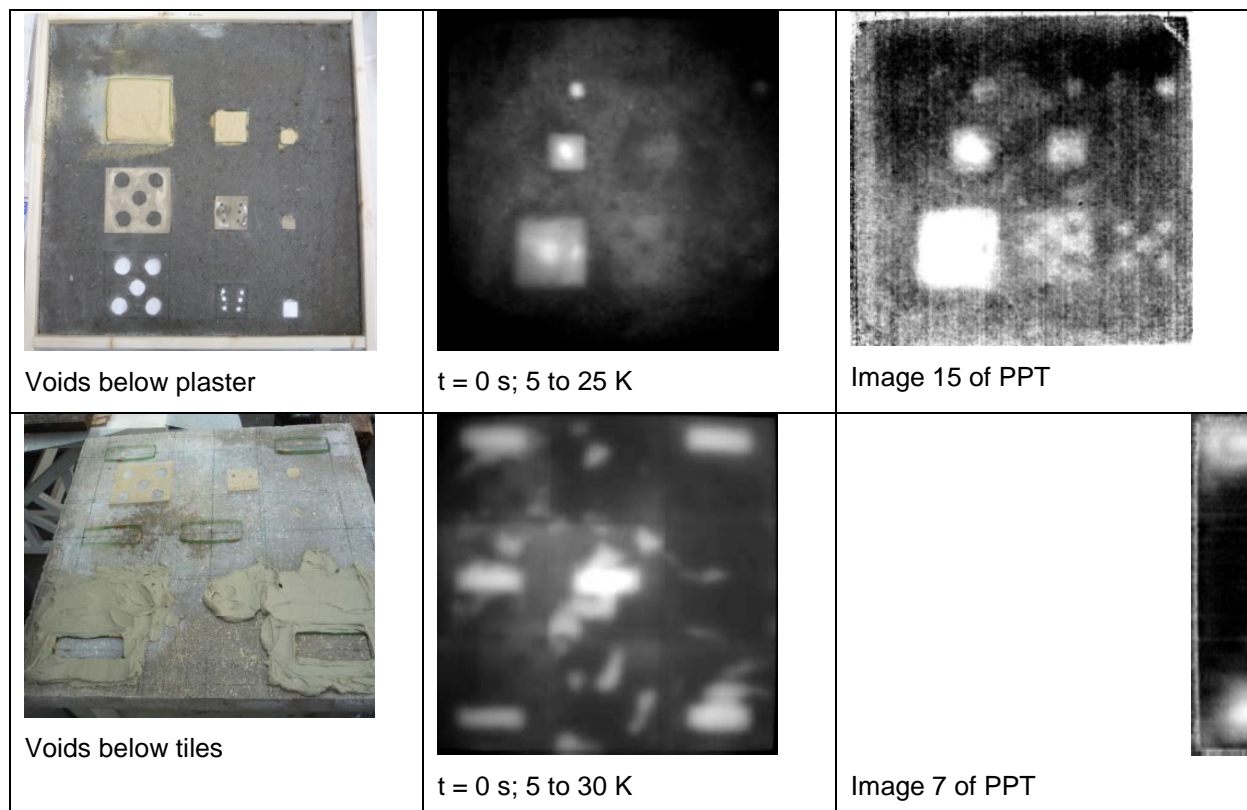
Figure 1: Visualisation of the results of active thermography of two different test specimens with plaster (top) and with tiles (bottom), where the heat was introduced with an IR radiator. The middle column shows the thermograms directly after heating, the right column displays phase images of the sequences calculated by pulse phase thermography (PPT). The phase images show more voids than the thermograms.

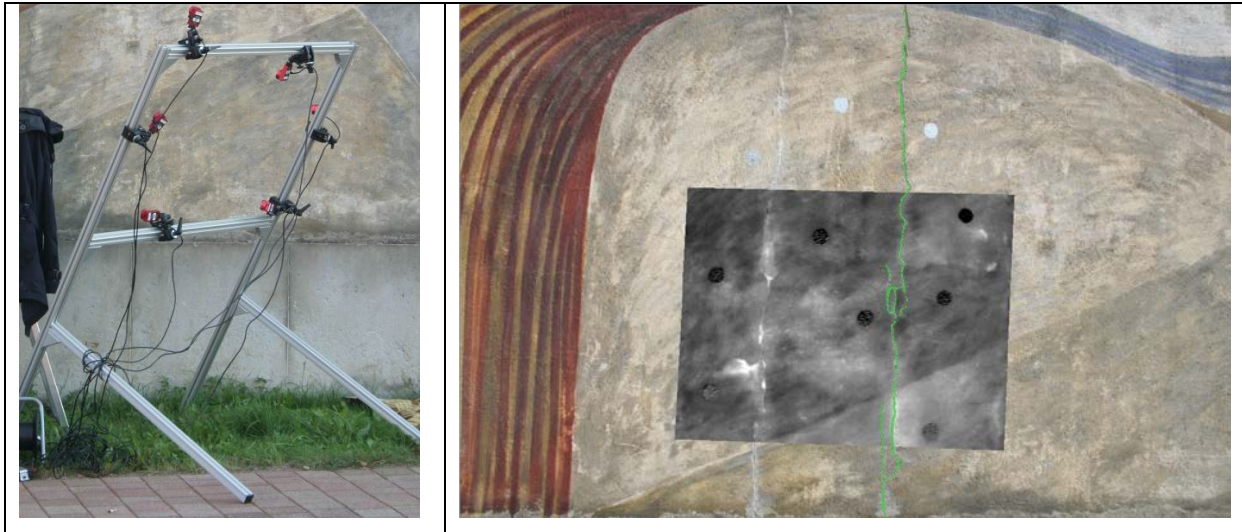
Figure 2: Left: Frame with flexible fastening possibilities for the tracking cameras and adjustable tilt. Right: Fusion of a thermogram (grey, middle of the image) with a photo and with a tracked crack (green) as an example of an area of a façade with reference markers at the rural painting in Cobbelsdorf.

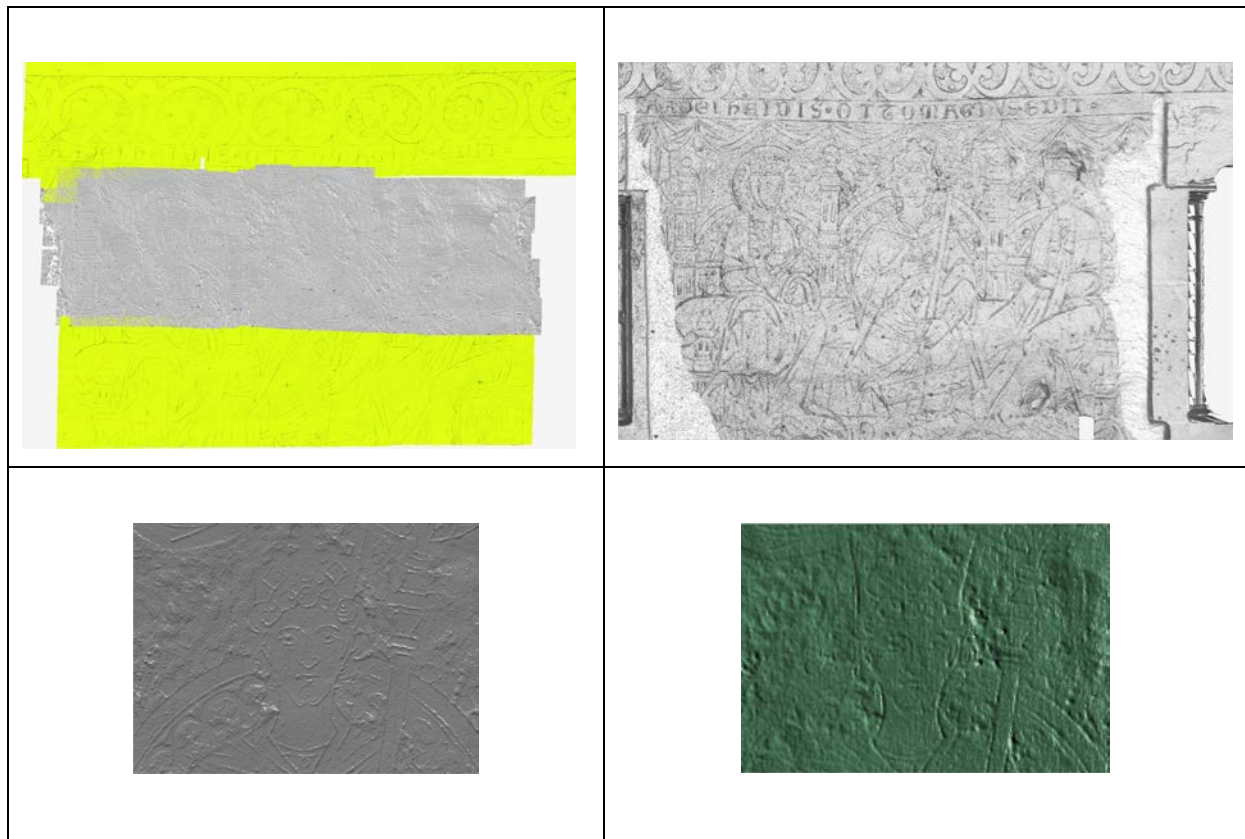
Figure 3: Comparison of the results of 3D recording of the plaster scratches at the Magdeburg Cathedral with the stereo sensor (left) and a commercial laser scanner (right). On the top, the complete central image is displayed, the bottom shows partial sections. These partial sections provide a distinct better resolution in the data of the stereo sensor (left).

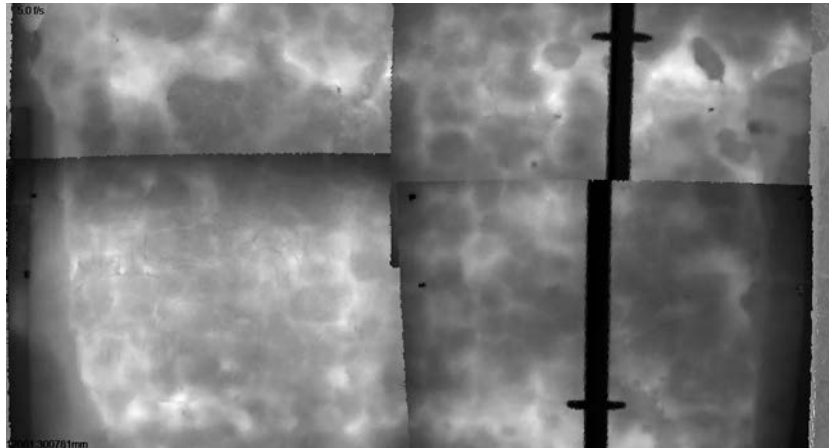
Figure 4: Fusion of four single thermograms of the central image of the plaster scratches at the Magdeburg Cathedral with a 3D data set. The thermograms were recorded directly after a heating period of 5 min using an IR radiator. The overlapping areas were not corrected concerning the temperature values. Warmer (lighter) areas are denoting to voids.

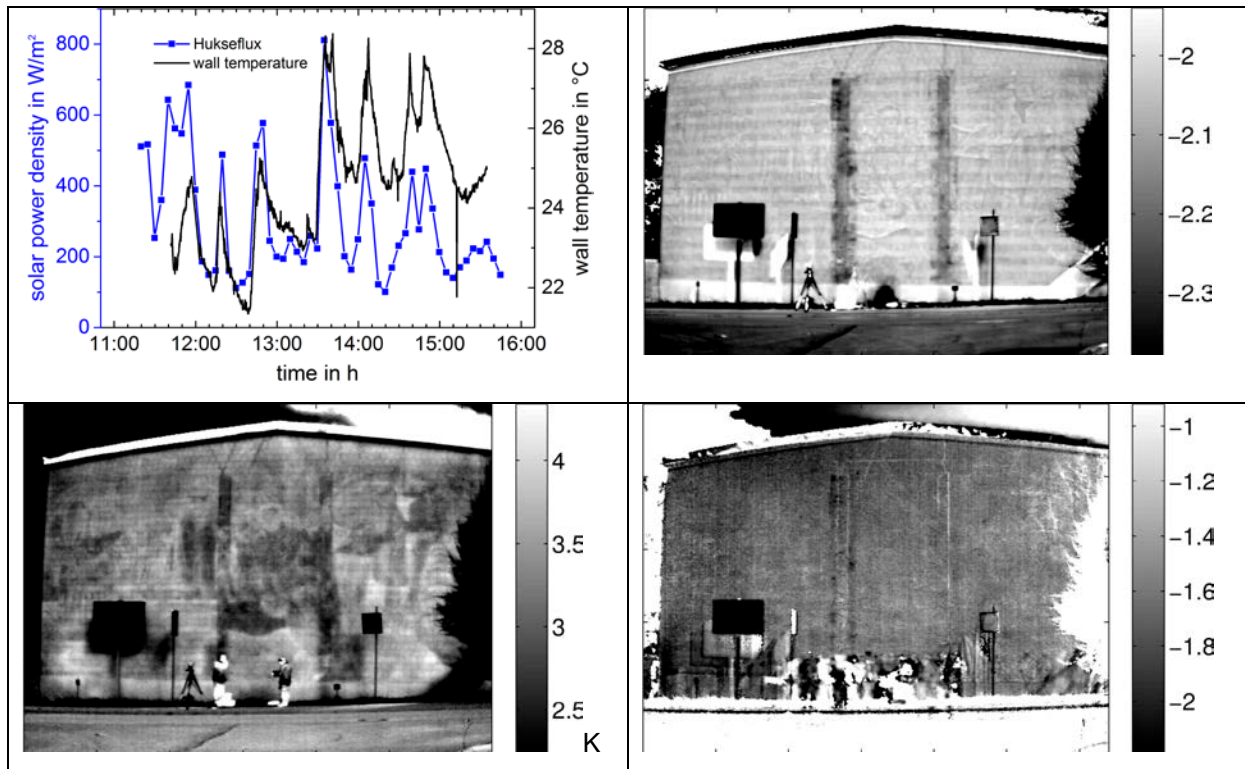
Figure 5: Results of investigations at the rural painting in Cobbelsdorf using active thermography with solar heating during a day with alterations of sun and clouds. Top left: Radiant flux density of the sun and mean wall temperature as a function of measurement time. Bottom left: Difference thermogram at 1:56 p. m. related to a thermogram at 11:40 a. m.; both metal bars in the middle of the thermogram can be recognised as cooler (darker) areas. Top right: 2<sup>nd</sup> phase image of the sequence, the metal bars can be recognized even better as in the thermogram. Bottom right: 10<sup>th</sup> phase image of the sequence, the cracks below the roof and near the metal bars can be detected.
