Durability of Concrete and Brick Facades of Apartment Buildings Built Between 1960-90 in Estonia

ABSTRACT

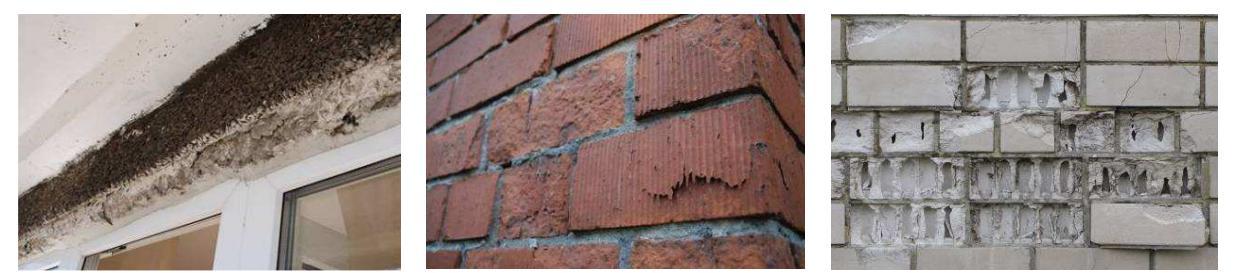
Both visual inspection of buildings (Figure 1) and laboratory tests (Figure 2) indicated to problems with the residual frost resistance of concrete and brick facades. Only half of the specimens fulfilled the criteria for the frost resistance of concrete in the XF1 environmental class: loss of mass $\leq 0.5 \text{ kg/m}^2$. Frost resistance of older buildings were in the worst condition. To compare concrete and brick according to the same conditions, brick specimens were tested according to the standard for the frost resistance of concrete [EVS 814] (Figure 2 right). It was found that brick showed much worse performance than concrete, independent of the building age. Nevertheless, frost resistance tests of two buildings based on calcium silicate brick [EVS-EN 772-18] showed no loss of compressive strength after freeze-thaw cycles. Frost resistance tests of ceramic bricks (three buildings) according to the old GOST 7025 test method did not show large mass loss in most of the specimens. Furthermore, the mass of some test specimens grew due to filling cracks of brick with water.

In addition to differences in test procedures, also the place where the test specimens were taken influences the results. South and southwest facades were found to be in the worst conditions in terms of frost resistance. In the building with brick facade the residual frost resistance was satisfactory up to three storeys. Bricks from higher storeys, below windows, around the balcony and loggia, and around the downpipe were in a worse condition.

Figure 1. Frost damages of concrete (left), ceramic (centre) and calcium silicate brick (right) facades.

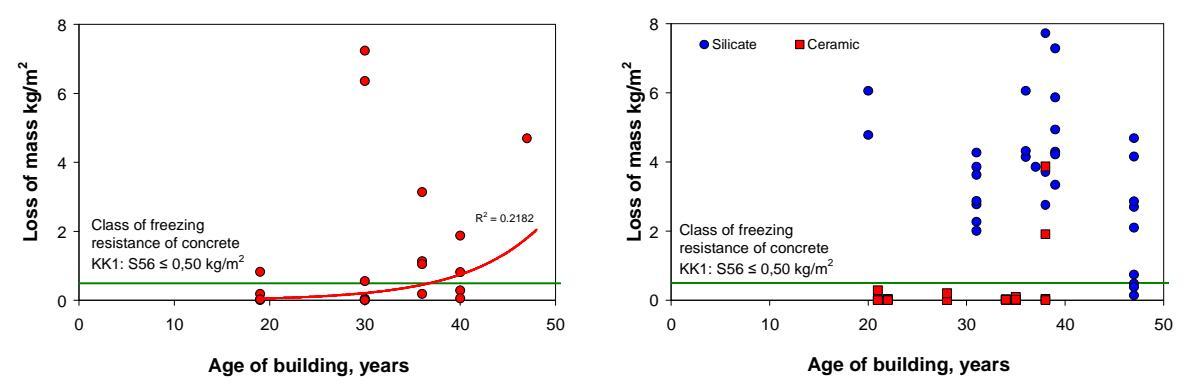
Figure 2. Mass loss of concrete (left) and brick (right). Green line refers to maximum allowed mass loss for a concrete facade 0.5 kg/m².

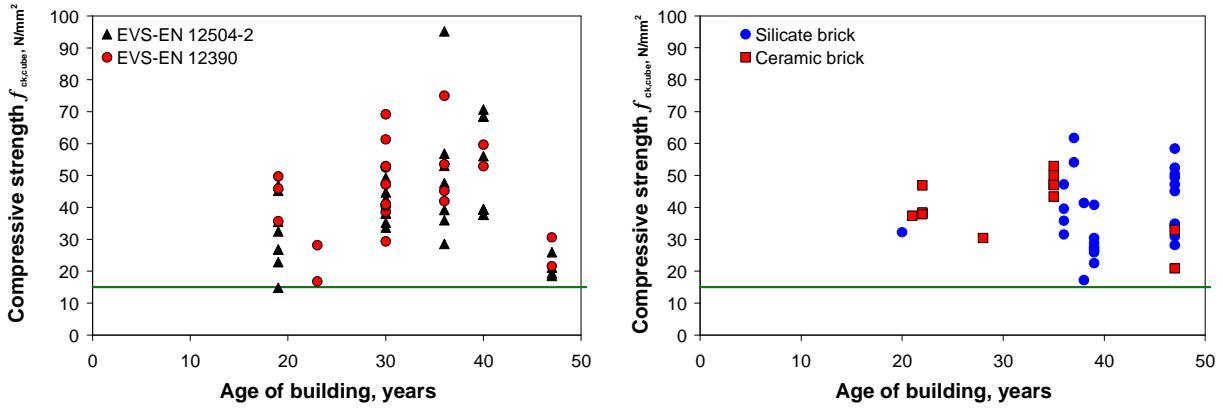
As a result of the comparison of compressive strength of all concrete and brick test specimens (Figure 3) for the reference designed value 15 N/mm², it is possible to conclude that the compressive strength of concrete or brick is not the limiting factor for loadbearing capacity or stability that were set to it at the time of erection. In all the specimens, compressive strength exceeded the value, $f_{c,cube}>15$ N/mm² that characterizes the compressive strength of the concrete mark 150 (corresponds to 15 N/mm²). Strength of mortar between bricks was variable: in some cases mortar was removed quite simply by handtools and striking drill had to be used in other cases.

Figure 3. Compressive strength of concrete (left), calcium silicate and bricks ceramic bricks (right).

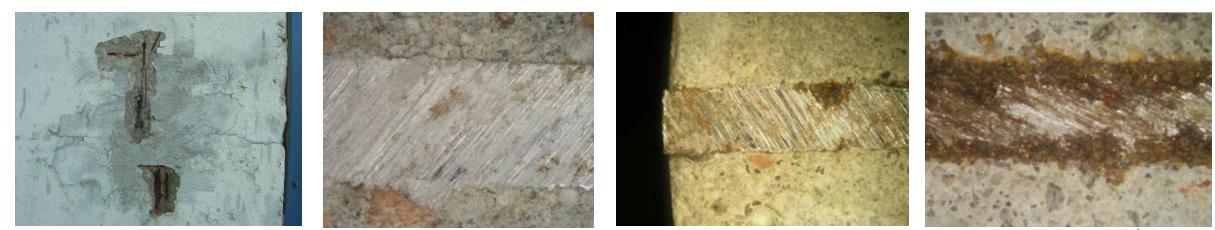
Corrosion of concrete large-panels and brick walls was studied via visual survey and with a light microscope (Figure 4). Corrosion of reinforcements of external wall layers of panel concrete in apartment buildings was generally minor. Reinforcement was corroded only when it was very close (\approx <2 cm) to the external surface (Figure 4 left). Serious corrosion of reinforcement existed at awning panels and balconies and also in places of concrete wall panels. These structural elements have more severe water loads, therefore small frost resistance has made cracks into concrete and corrosion may develop more easily.

Figure 4. Corrosion of reinforcement via visual survey (left) and microscope: non-corroded (2nd from left), partly corroded (2nd from right) and fully corroded (right) reinforcement.

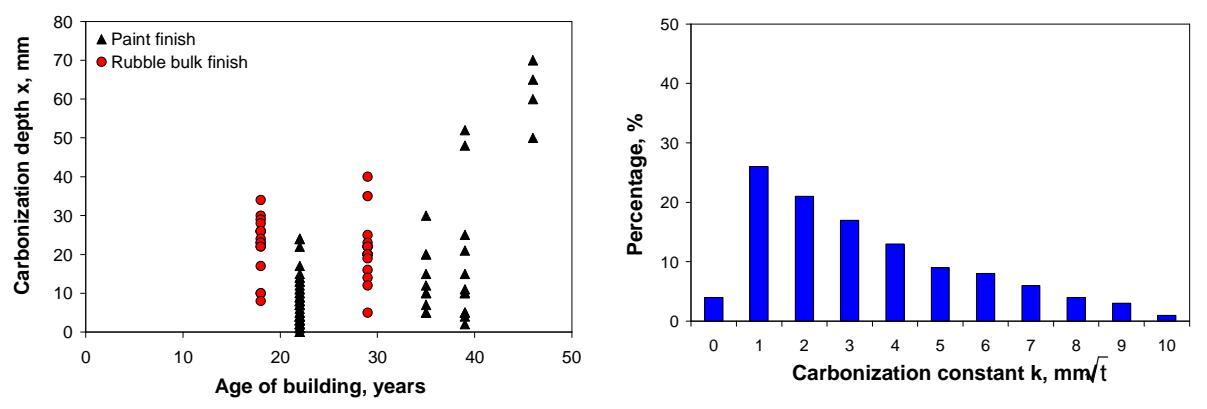
Carbonation depth of concrete facades was between 0-70 mm, typically 10-40 mm, see Figure 5. left. Comparison of paint finish and rubble bulk finish showed that facades with paint layer had

where x is carbonation depth, mm; k is carbonation constant (normally 1.5...3.5 mm/ $\sqrt{\text{year}}$; t is the age of concrete in years. The distribution of the carbonation constant is presented in Figure 5. right.

Figure 5. Carbonation depth of concrete of the apartment buildings composed with concrete large panels (left). Carbonation constant to calculate the theoretical carbonation depth (right).
