Deutsches Fachwerkzentrum Quedlinburg e.V.

Dipl.-Ing. Bettina Stöckicht

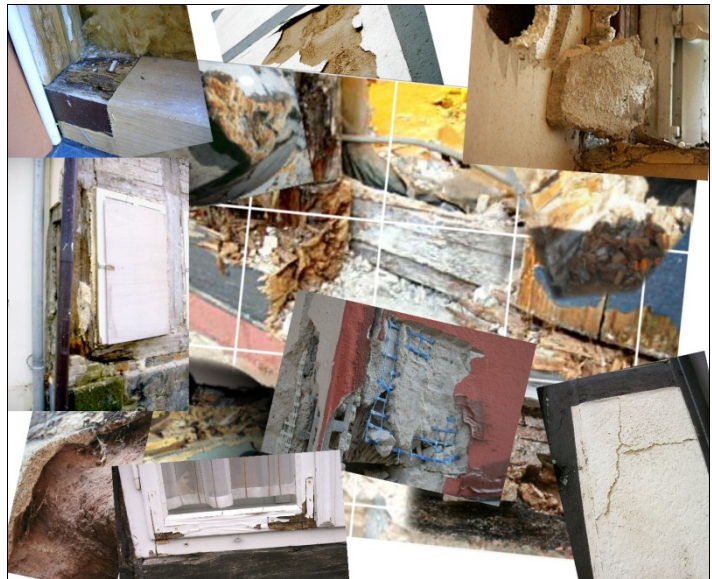
Consequential damages after redevelopment measures at selected buildings

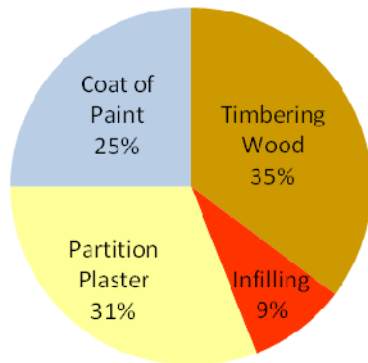
Diagram 1 Percental apportionment of the documented damages at timber framed construction - without architrave blocks, windows, roofs and outbuildings (B. Stöckicht, DFWZ)

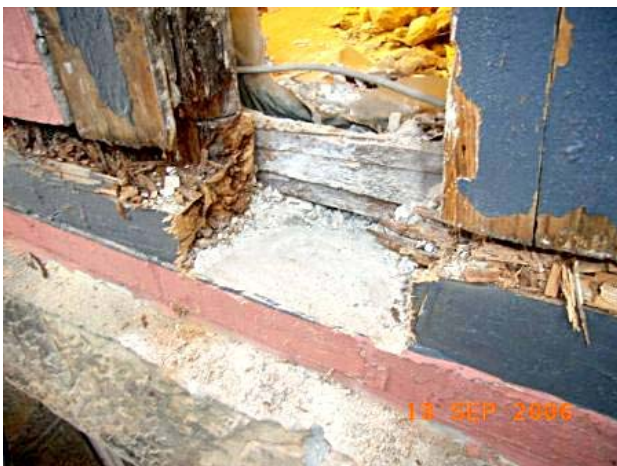
Pic. 1 Excavated wall construction, clearly visible is the extremely damage of the sill plates and the rising upright caused by brown and white pocket rot. The glass fibre-glass-insulation layer is viewable in the background. (private, wood preservation expert)

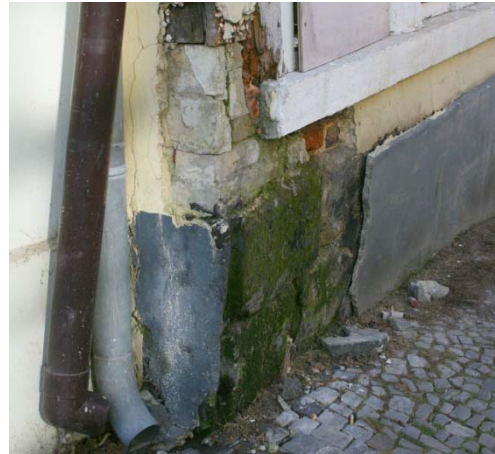
Fig. 2 The cement plaster discoidal scales off from the sandstone. Additionally, the moisture load was forced by defective roof drainage, so that in the sill plates and in vertical pillars timber-destroying fungi could spread. The sandstones are grown over by algae and moss. (DFWZ)

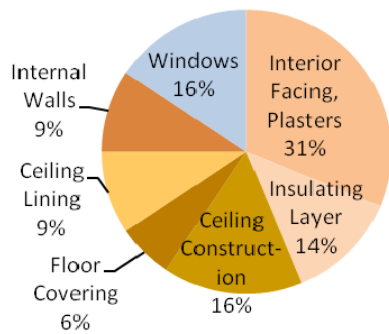
Diagram 2 Percental allocation of the damages in the inside of the building (B. Stöckicht, DFWZ)

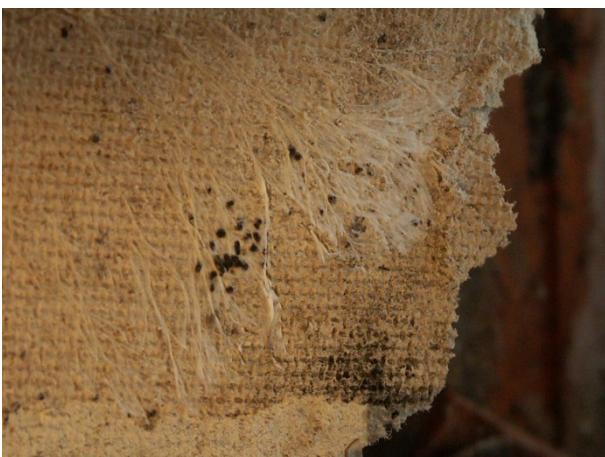
Pic. 3 Distinctive fungus mycelium at the back side of a gypsum board layer of a sandwich insulation board of polystyrene and gypsum board (DFWZ QLB)

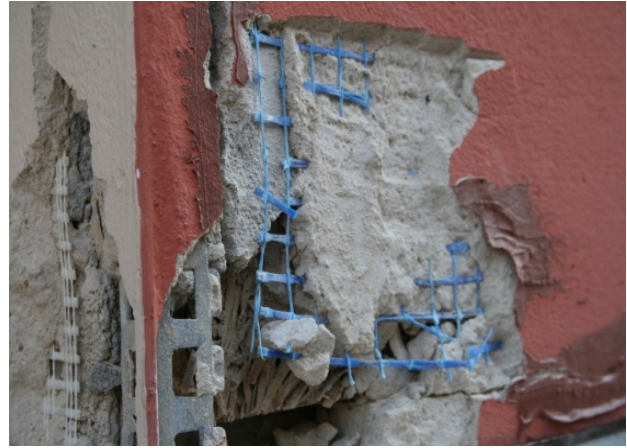
Pic. 4 Performance deficiency: The fabric insert in the plaster coating ends approximately 2 cm before the external corner and is not fixed around it. The corner profile is not conform to the system and has been fixed insufficiently on the subsurface. (DFWZ QLB)
