## **Wall Cladding System Durability Lessons Learned from the Premature Deterioration of Wood-Framed Construction Clad with Exterior Insulation and Finish Systems (EIFS) in the U.S.**

### **M.B. Bronski**

Simpson Gumpertz & Heger Inc. Consulting Engineers  
41 Seyon Street, Bldg. 1, Suite 500, Waltham, MA 02453, USA  
[mbronski@sgh.com](mailto:mbronski@sgh.com)

TT2-153

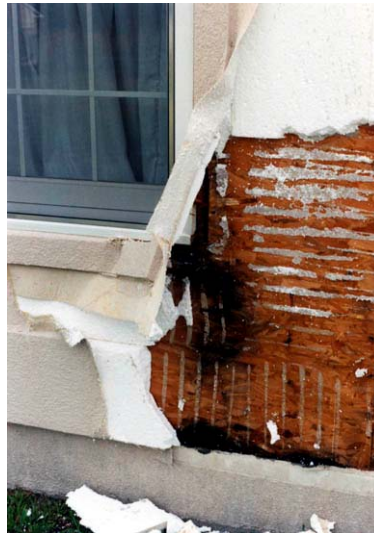
**Figure 1. Rapid durability failure of wood-framed wall clad with barrier EIFS in the southeastern U.S. EIFS cladding is removed at lower right to reveal deterioration of wood-based oriented strand board (OSB) sheathing. The house is fewer than five years old at the time of the photo. Note the localized deterioration of the wood-based sheathing (black areas) beneath locations of leakage at window-frame corners and window-perimeter sealant joints.**

From the late 1980s to the early 1990s, use of barrier-EIFS cladding became common on wood-framed residential construction in the U.S. In the mid-1990s, despite laboratory testing of the EIFS cladding, unanticipated and spectacularly rapid deterioration problems occurred on many wood-framed walls beneath the barrier-EIFS cladding, particularly in regions with significant rainfall and humidity, such as the southeastern U.S. In many cases, significant localized deterioration (rot) of the wood sheathing and, less often, the wood framing occurred within the first five years after the house was constructed. In such cases, the EIFS cladding was typically intact and undamaged; however, the undamaged, intact cladding concealed significant wood deterioration.
