## **DETERIORATION EVALUATION OF COOLING TOWER UNIT 28 IN MOBAREKEH STEEL COMPLEX AND PROVIDING ITS REPAIR PROCEDURES**

F. Moodi<sup>1</sup>, A.A. Ramezaniapour<sup>1</sup>, M. Peydayesh<sup>1</sup>, A. Nadimi<sup>2</sup>, M. Pajouhesh<sup>2</sup>, M. Rasouli<sup>2</sup>  
<sup>1</sup>Concrete Technology and Durability Research Centre, Amirkabir University of Technology  
<sup>2</sup>Mobarekeh Steel Complex

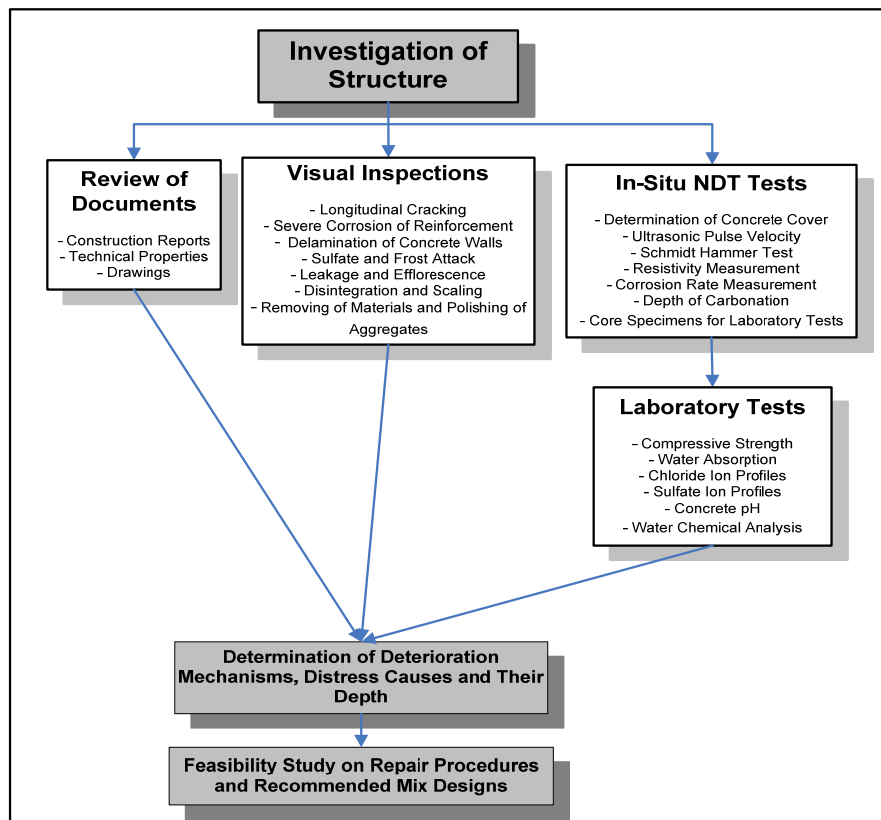
Figure 1. Flowchart of various stages of diagnosing distresses in cooling tower unit 28.

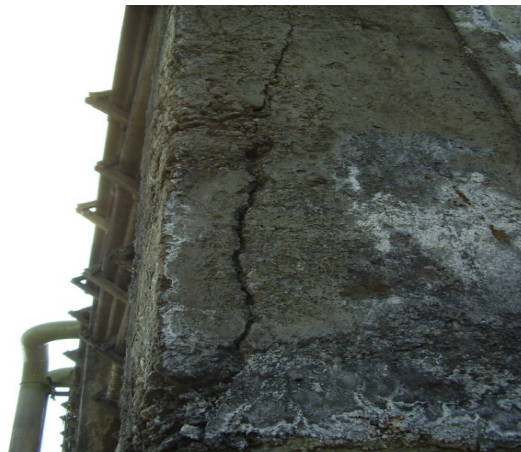
The most important deteriorations which were obviously seen in the exposed concrete in cooling tower unit 28 are longitudinal cracking due to corrosion of reinforcement in beams and columns and also severe sulfate and frost attacks (see Figure 3). Nevertheless, the essential distresses which are manifested in this

Figure 3. Longitudinal cracking and sulfate attack

- a) Formwork and pouring of concrete in beams and columns.
- b) Patch repair of minor deteriorations.
- c) Shot Crete for concrete walls.
- d) Repair of cracks by injection.
- e) In the result of water penetration from inside to outside, the interior surface of concrete walls must be cleaned and coated with impermeable materials.

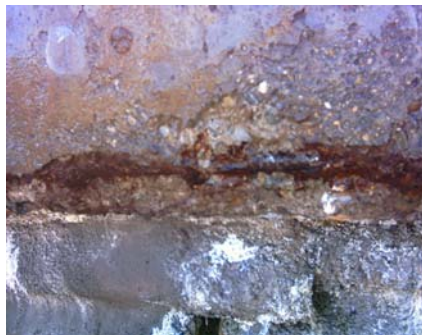
Figure 4. Severe corrosion of reinforcement

- d) High leakage and penetration of water from inside to the outside of concrete walls of the structure caused an intensive corrosion of reinforcement and sulfatation of concrete. Low cover of concrete in some locations in concrete walls also caused corrosion and concrete delaminations.

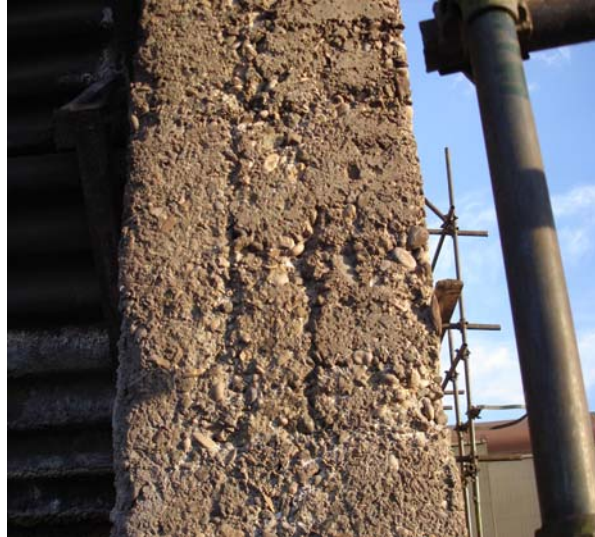
**Figure 5. Removing of cement paste and exposed aggregates**

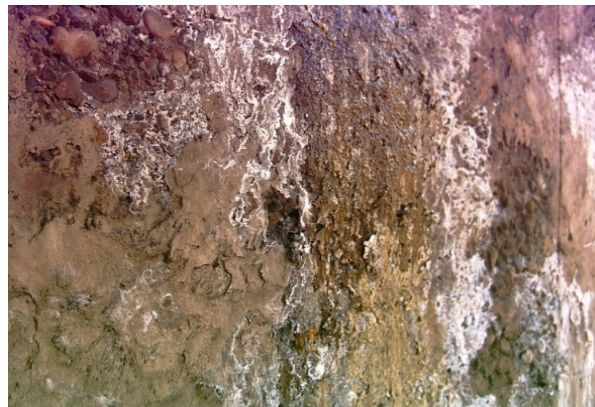
**Figure 6. Leakage and efflorescence**

- h) Also due to the penetration of water from the interior to the exterior, the interior surface of concrete walls must be cleaned and coated with impermeable materials. In addition, the existing joints which have caused leakage of water to the outside must be filled with appropriate resin.

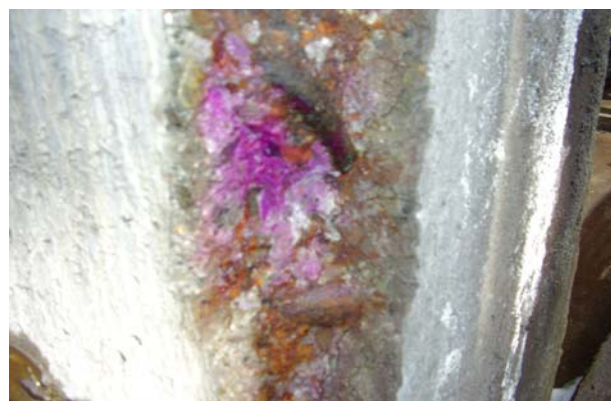
**Figure 7. Determination of carbonation depth**
