Acceptable Designs for Timber Framed Parapet Walls

Abstract

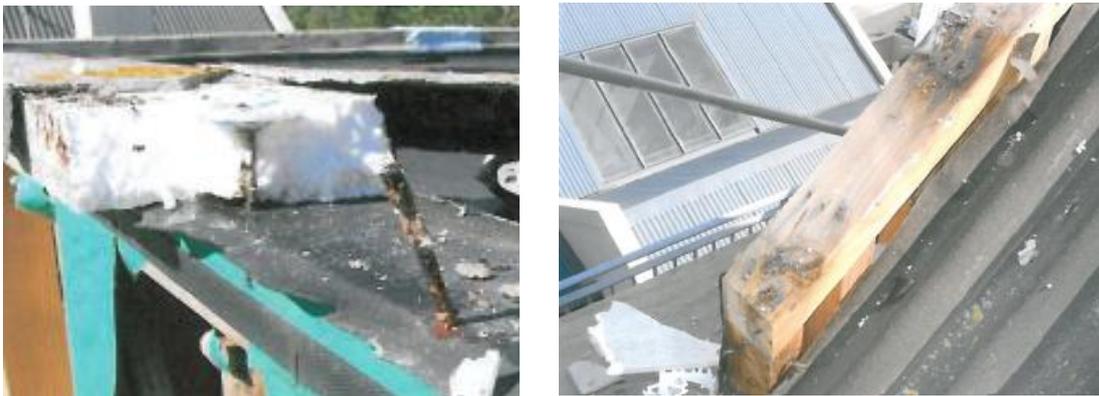
Figure 1: Examples of decay at head of parapet walls – notice lichen growth on left-hand photo

A particularly weak point of these designs was parapet walls. Parapets are an inherently vulnerable point of any building because they are exposed to the elements on three sides and are somewhat isolated from the main structure (Oliver, 1997). Numerous building surveyors witnessed widespread decay of walls that seemed to originate from the head of the parapet (Figure 1). Many failures were likely to be from relatively simple gravity leaks facilitated by poor design. Cappings were not inherently waterproof (worsened by any cracks due to movement) and were often not sloped to encourage run-off. This allowed water to penetrate, track along to fixing points and eventually reach timber.

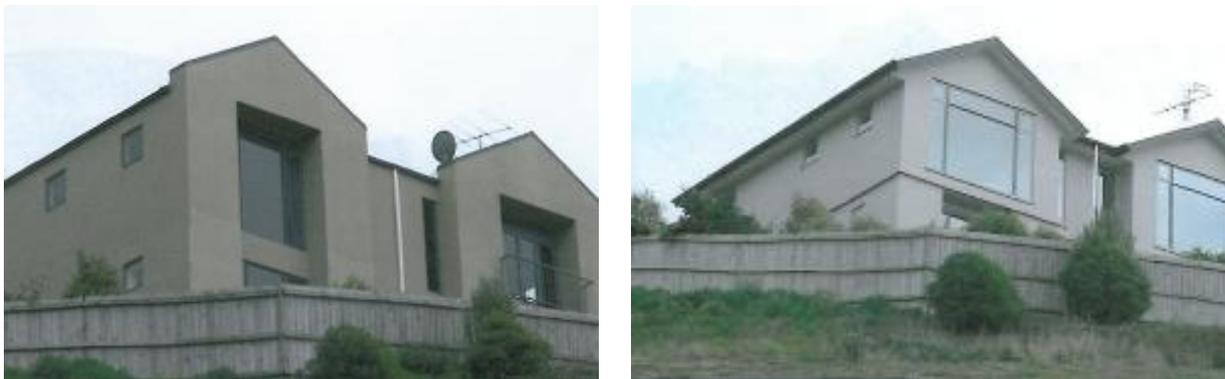
Figure 2: Example of 'removal' of parapets to completely change the appearance of a building

An interesting phenomenon observed by remediation specialists is that even if a parapet can be successfully remediated, the owners can still be left with an 'unsellable' house because potential buyers now associate parapets with leaky homes and will avoid them. Some remediation specialists now prefer to replace the roof with a more traditional design that includes eaves (Figure 2). This can solve the moisture problems and positively alter the appearance of a house such that it is free from the leaky home stigma, and can often be achieved for a relatively small extra cost that is easily recuperated in the onward value of the home.
