The Performance of Wall Drainage Media in New Zealand

Overton, G.
BRANZ, NZ
(email: greg.overton@branz.co.nz)
Bassett, M.
BRANZ, NZ
(email: mark.bassett@branz.co.nz)
McNeil, S.
BRANZ, NZ
(email: stephen.mcneil@branz.co.nz)

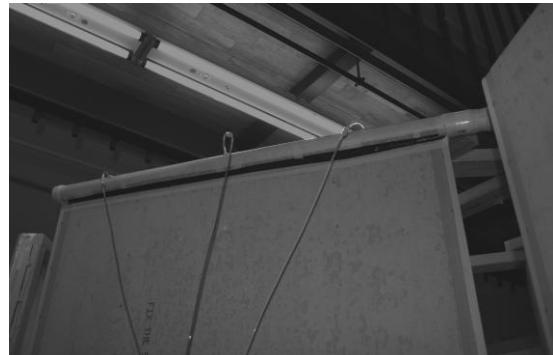
The air resistance measurements were performed by attaching a manifold to the top edge of the wall and then sucking air through the cavity using an axial flow fan. Flow rates corresponding to a series of driving pressures were then measured. This arrangement measured the resistance of the whole cavity. This meant that any pressure difference calculated (wind and stack) could simply be applied to the flow resistance equations to give the ventilation rate. To calculate the pressure difference across the height of the walls, the pressure coefficients from Bowen (1976) and re-presented by Liddament (1986) were used.

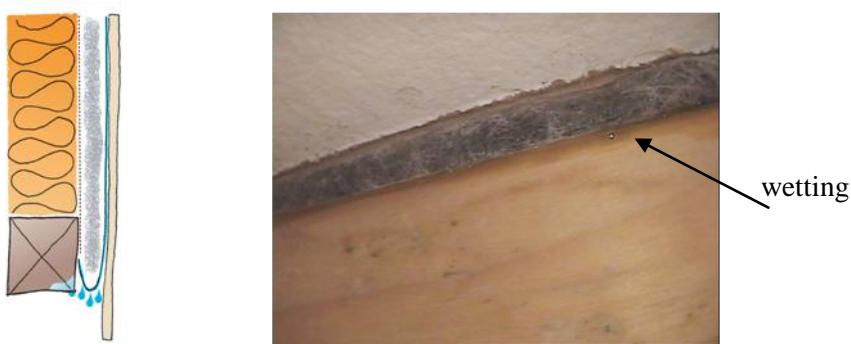
Figure 6. Frame wetting – water tracked along from bug screen

Frame wetting was observed in several walls. However, no moisture was seen to pass through the building wrap(s) and wet the framing. Instead, water was seen to track along to the bottom plate and up into the framing as illustrated in Figure 6. These frames drained out relatively quickly. However, subsequent tests will utilise a flashing in an attempt to prevent the initial wetting. Indeed at least one manufacturer now supplies such a flashing. Alternatively the product could be terminated below the level of the bottom plate to form a drip-edge.

None of the specimen walls appeared to allow water to track through to the framing, although there were three instances where water reached the bottom plate because the drainage mat and building wrap had not extended low enough to prevent capillary tracking across to the frame. This defect can be easily corrected by terminating the building wrap and drainage media well below the bottom plate or by fitting an appropriate flashing. The more important question of how exposed these drainage solutions are to a defect in the building wrap has yet to be explored. The walls in this study were carefully built to minimise penetrations and tears in the building wrap.
