E1) Assessment of water supply and drainage systems for an historical hammam by using non-destructive methods

Hot and cold water supply system; rainwater drainage system; waste water collection and discharge system; non-destructive evaluation ; Sengul Hammam

Such a study was conducted on a 15th century Ottoman bath building, the Sengul Hammam^[1], located in the province of Ankara, Turkey. This study was focused on the investigation of hot and cold water supply systems, waste water collection and discharge system of the interiors and rainwater drainage systems consisting of roof and surface water drainage of this building. The study consisted of the mapping of decay forms, levelling survey, infrared thermography (IRT), water supply capacity and waste water and rainwater drainage calculations. The contemporary calculations were adapted to the calculations used in this study by taking into account the characteristics of Sengul Hammam.

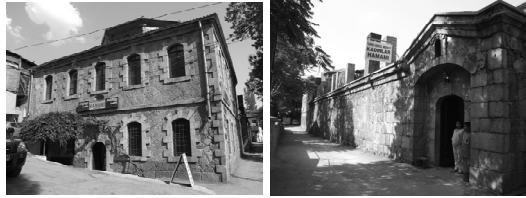
The Sengul Hammam is a typical Ottoman double bath consisting of two separate parts for men and women (Figure 1). It was constructed with stone masonry walls with brick transitions and brick upper structure^[1]. The floors of the hammam were covered with marble tiles at interiors.

Figure 1- Views of the Sengul Hammam: the north façade – (a) entrance to the men's part (at the left); (b) the west façade - entrance to the women's part (at the right).

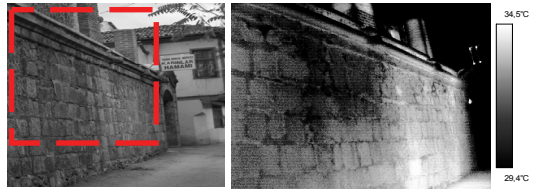
Figure 17 - Darker areas indicate the water penetration problem between the spouts WS6 and WS7 due to the overflowing from the roof eaves level. Severe material loss together with salt deposits and biological growth overlap with the colder areas.

Figure 18 – (a)The detached areas close to the rainwater downpipes were detected as colder areas; (b)The lower parts of the wall corresponding to the axis of the downpipe and the waterspout were found to be cold and damp.

Ponding on roof surfaces and/or overflowing from the eaves level, therefore, were concluded to be inevitable due to these faults summarized above. Such accumulations and overflows have potential for absorbing and retaining rainwater in the structure, as detected in infrared images (Figures 16-18), where it should otherwise be rapidly discharged.
