Long-term Performance Evaluation Of External Renderings On Autoclaved Aerated Concrete Wall

H Kus¹ & G Kalmar²

¹KTH Research School University of Gävle Sweden

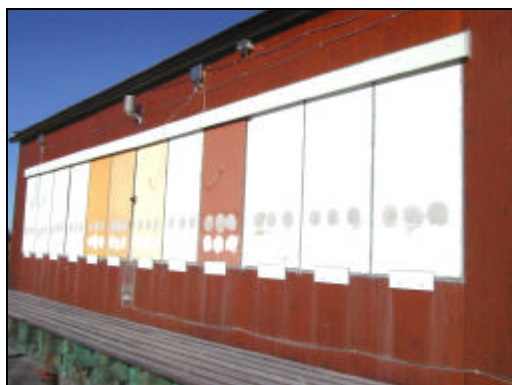
Figure 1. Test panels

curing period of approximately three months, rendered test panels (Fig. 1 and 2) were installed to the long sides of the test cabin facing north-east and south-west, respectively. There are 12 test panels on each of the two facades including uncoated and un-rendered AAC as control sample panels, System 1. The joints between the test panels themselves and the wall were insulated and sealed. The systems tested involve inorganic and organic renderings as well as their modifications with water repellants. The compositions of the six rendering systems, which are studied in this paper, are summarised in Table 1 below.

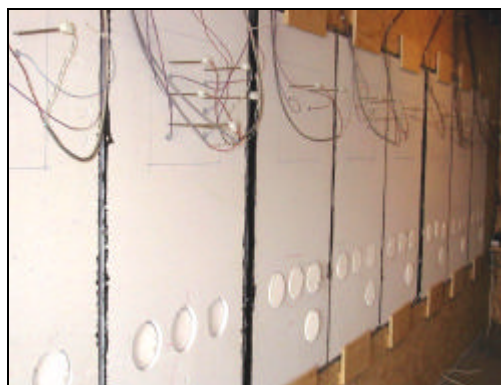
Figure 2. Test panels from the inside
