# Linseed Oil Paint As An Alternative To Wood Preservatives

E Brandt<sup>1</sup> & T Lading<sup>2</sup>

**Summary:** For reasons of sustainability great efforts have been made to find environment-friendly alternatives to paints and wood preservatives. This paper presents results from a project where efforts focused on the use of linseed oil paint, which is well known from old buildings.

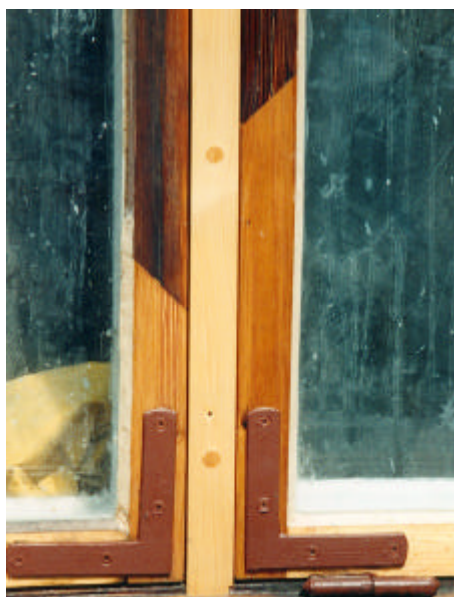
**Figure 1. Mending of sashes in old wooden windows in order to preserve as much as possible of the original sashes.**

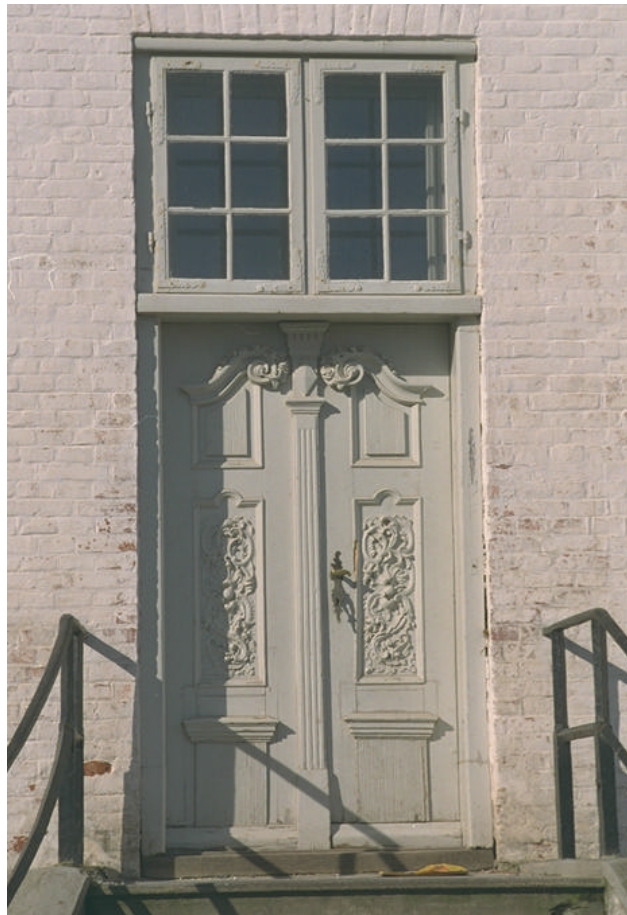
**Figure 2. Linseed oil painted door with good performance after 8+ years. The wood quality is good and the workmanship of high quality.**

- The painting was in excellent condition (after 8+ years) probably due to a combination of high quality of the wood, protection by design, careful workmanship, long drying time between applications.

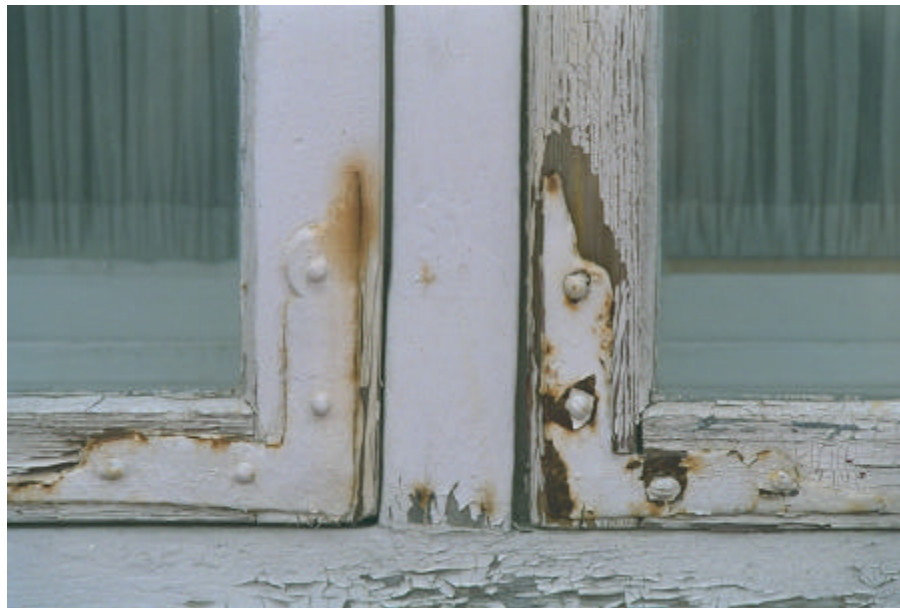
**Figure 3. Bad performing linseed oil paint after about two years of exposure. Probably the problems encountered are due to insufficient cleaning of the window before application combined with poor workmanship and unfavourable weather conditions at application. The photo also demonstrates that linseed oil does not provide sufficient protection to sash-angles and other metal parts.**

- The fittings were the most vulnerable parts of the objects as they were not sufficiently protected by the linseed oil products. This is a remark generally valid for most of the surveyed buildings.

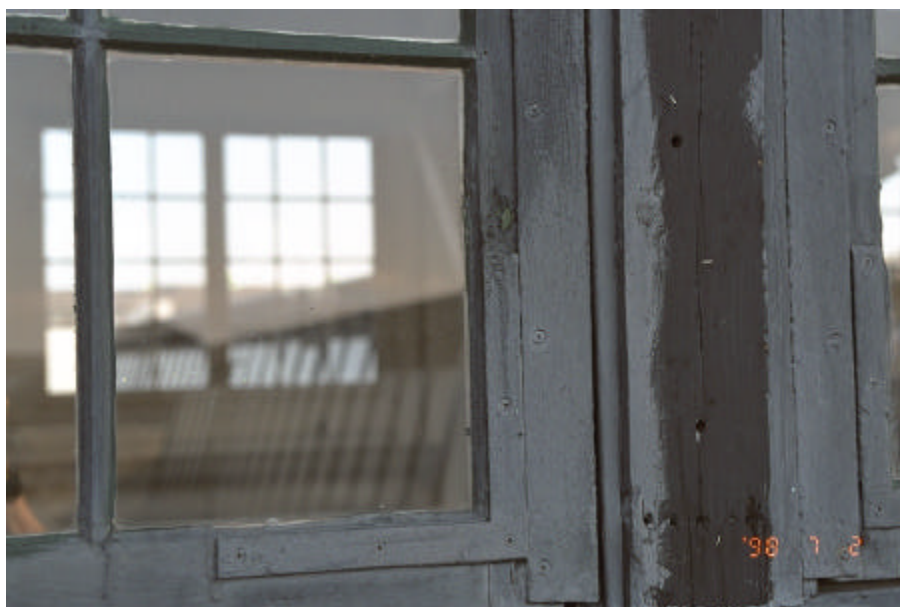
**Figure 4. Repair of linseed oil painted window where the paint used for the repair differs significantly from the original due to a larger content of chalk filler.**

- Too much or wrong filler
- filler was added partly to make the paint fuller (which means that the viscosity is enhanced to make the application easier), partly to make it cheaper. Too much or wrong filler will result in chalking, wrong viscosity etc. There were examples of thinner being needed because too much filler had been used in the first place!

- chalk is often used as a filler, but along with the subversion of the linseed oil it might become visible as chalking; the surface becomes lustreless and gradually gets a white, foggy surface; at the same time it becomes more susceptible to humidity – this was especially distinct upon dark surfaces.

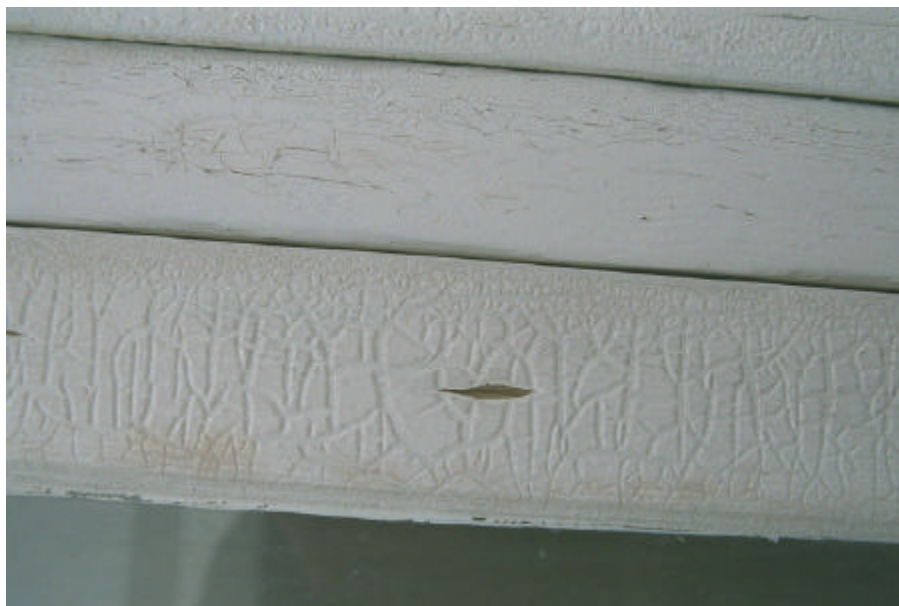
**Figure 5. Paint looking like crocodile skin due to application in too thick layers.**

The linseed oil paint should be applied in thin layers and one layer must be thoroughly dry before the next one is applied. If paint is applied in thick layers, it wrinkles and gives the surface the look of crocodile skin. Also the paint is not solid until it has dried up and consequently it is more susceptible to destruction until it has dried completely. In cold weather, i.e. below 5-10° C, it is difficult to apply thin layers and drying becomes slower. The same occurs in damp weather. Therefore, generally

skilled users are required to obtain a satisfying result, as it e.g. is a matter of experience to apply a coat of paint in a thin layer and to assess when the previous layer is sufficiently dry to proceed.
