CEMENTITIOUS ADHESIVES PERFORMANCE DURING SERVICE LIFE

V. P. de Freitas, A. Vaz Sá
Laboratório de Física das Construções (LFC) –
Faculdade de Engenharia da Universidade do Porto
(FEUP)
Rua Dr. Roberto Frias, 4200-465 Porto, Portugal
vpfreita@fe.up.pt vaz.sa@fe.up.pt

TT1-163

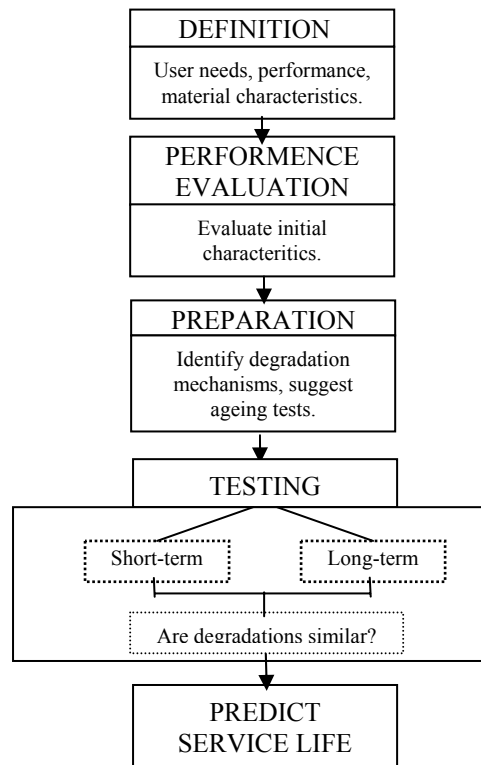
Figure 2. Systematic methodology for predicting the service life of ceramic tile coatings.

Guidance Document 003 of the European Organization for Technical Approvals – GD003, EOTA, December 1999 – proposes a systematic methodology for assessing and/or predicting the working life of products. Based on that proposed methodology, we established the followed steps to evaluate the durability of ceramic tile coating:

1. Definition – User needs, building context, performance requirements and criteria and product characterisation are established.
2. Performance evaluation – After knowing the product characteristics we evaluate its initial performance by laboratory experimental tests.

3. Preparation – Possible degradation mechanisms, degradation factors, degradation indicators and suggest ageing tests.
4. Testing – Ageing tests both in short term and for longer periods are proposed.

5. Performance evaluation – Determine the performance of the aged product on the same characteristics evaluated before (3).
6. Predict service life – Verify that the degradation achieved is similar in both short term and for longer periods testing. If the behaviour under the effects of short term testing is similar to that observed in the longer term the results of the short term testing may be used to predict the service life.

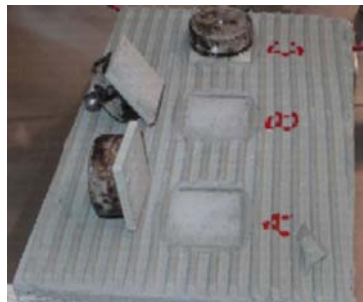
The tensile adhesion strength tests performed for type PE0 samples determined an adhesive failure in the interface between the ceramic tile and the cementitious adhesive [Fig. 4].

Figure 4 – Adhesive failure in the interface between the ceramic tile and the cementitious adhesive Sample PE0.

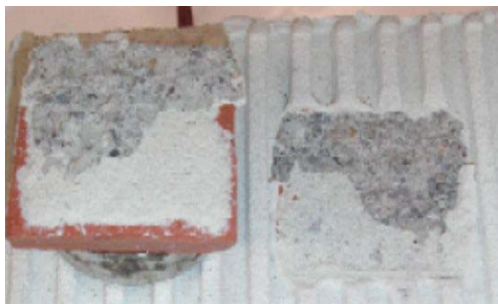
Cohesive failure was detected in the other tests, especially within the cementitious adhesive. However, in the tests of samples with cementitious adhesive type C2S and after 1 aging cycle, a cohesive failure was detected within the substrate [Fig.5 - PE4.1], and there was only one case where cohesive failure took place in the ceramic tile [Fig.5 - PE4.2].

Figure 5 – Picture showing two different cohesive failure. Sample PE4.1 - Cohesive failure within the substrate; Sample PE4.2 - Cohesive failure within the ceramic tile.

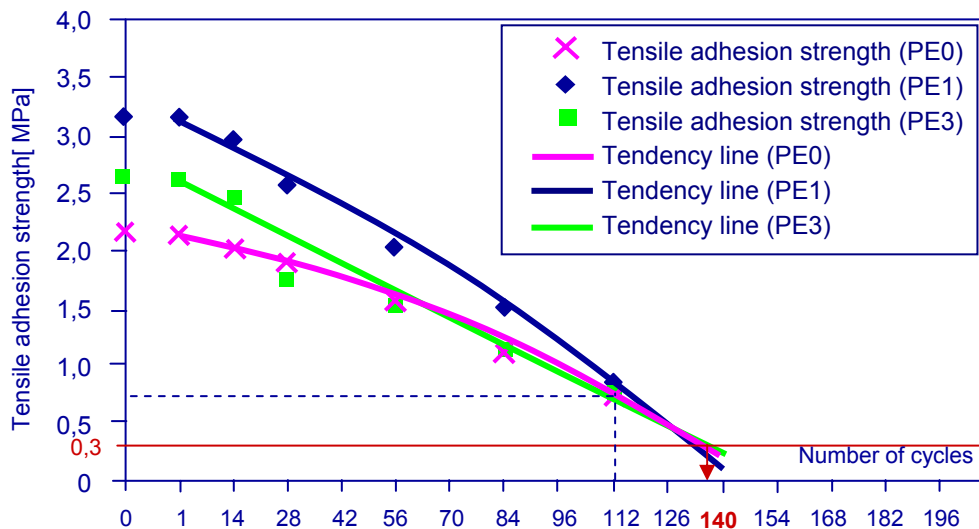
The graphic in Figure 6 shows the tensile adhesion strength variation under the aging tests according to the number of cycles on specimen types PE0, PE1 and PE3. The tests results from these samples reveal three essential aspects:

1. Regardless of the cementitious adhesive type, about 140 cycles will lead to the end of ceramic tile coating's service life.

- The failure type was greatly influenced by the type of ceramic tile used. Thus, the failure in the PE0 sample, consisting of ceramic tile with a low absorption coefficient (0.02%), belonged to the adhesive type. Consequently, the indicated values represent the cementitious adhesive adhesion. Nevertheless, the failure in the PE1 and PE3 samples (absorption coefficient > 0.5%) belonged to the cohesive type within the cementitious adhesive, and thus the attained values represent their tensile adhesion strength.
- After 112 aging cycles we measured about 30% of the tensile adhesion strength's initial value.

Figure 6 – Change in tensile adhesion strength during aging cycles – Samples PE0, PE1 and PE3 – Cementitious adhesive C2.

The graphics in the next two figures show tensile adhesion strength according to the number of aging cycles. The results obtained so far show significant deterioration in tensile adhesion strength, although the critical level of tensile adhesion strength indicated as 0.3 MPa was not reached. Based on the average results, we can compute a tendency indicating the critical value under which the service life can be considered to have terminated.

1. The results show a substantial loss in tensile adhesion strength.
2. For the established critical value of 0.3 MPa, cementitious adhesives types C2 and C2S terminated their service life at 140 and 210 aging cycles, respectively.

3. The type of failure observed is strongly influenced by the type of ceramic tile used.
4. After 112 aging cycles, measurements indicated about 30% and 50% of the initial tensile adhesion strength for cementitious adhesive types C2 and C2S, respectively.
