New Trends on Building Pathology

CIB W086 - Building Pathology

**EDITED BY
Jorge de Brito
Inês Flores-Colen**

October 2021

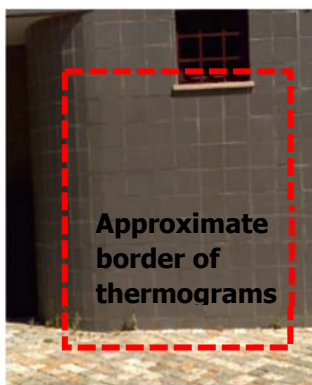
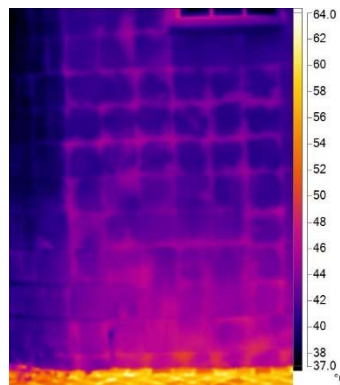
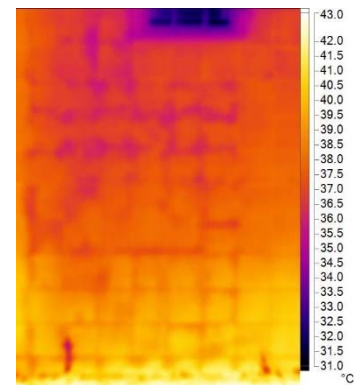
Picture of an adhered ceramic cladding with delamination

Its thermogram during solar heat gain (12:00h) - *delamination shows up with increased temperature*

Its thermogram during heat loss (19:00h) - *delamination shows up with decreased temperature*

Figure 3.2.3 - Thermal behaviour of areas with delamination at different times of a day.

In detection of a delamination within a building element or a void within a building component, insulating performance of the entrapped air allows generating surface temperature variations at the deficient area. Once there is heat flow within the object inspected, warmer or colder areas on the surface, depending on the direction of heat flow within the object and on the position of the observer, are induced by entrapped air (Figure 3.2.3), and it allows making a qualitative evaluation, such as the one explained in ASTM D4788 [13].

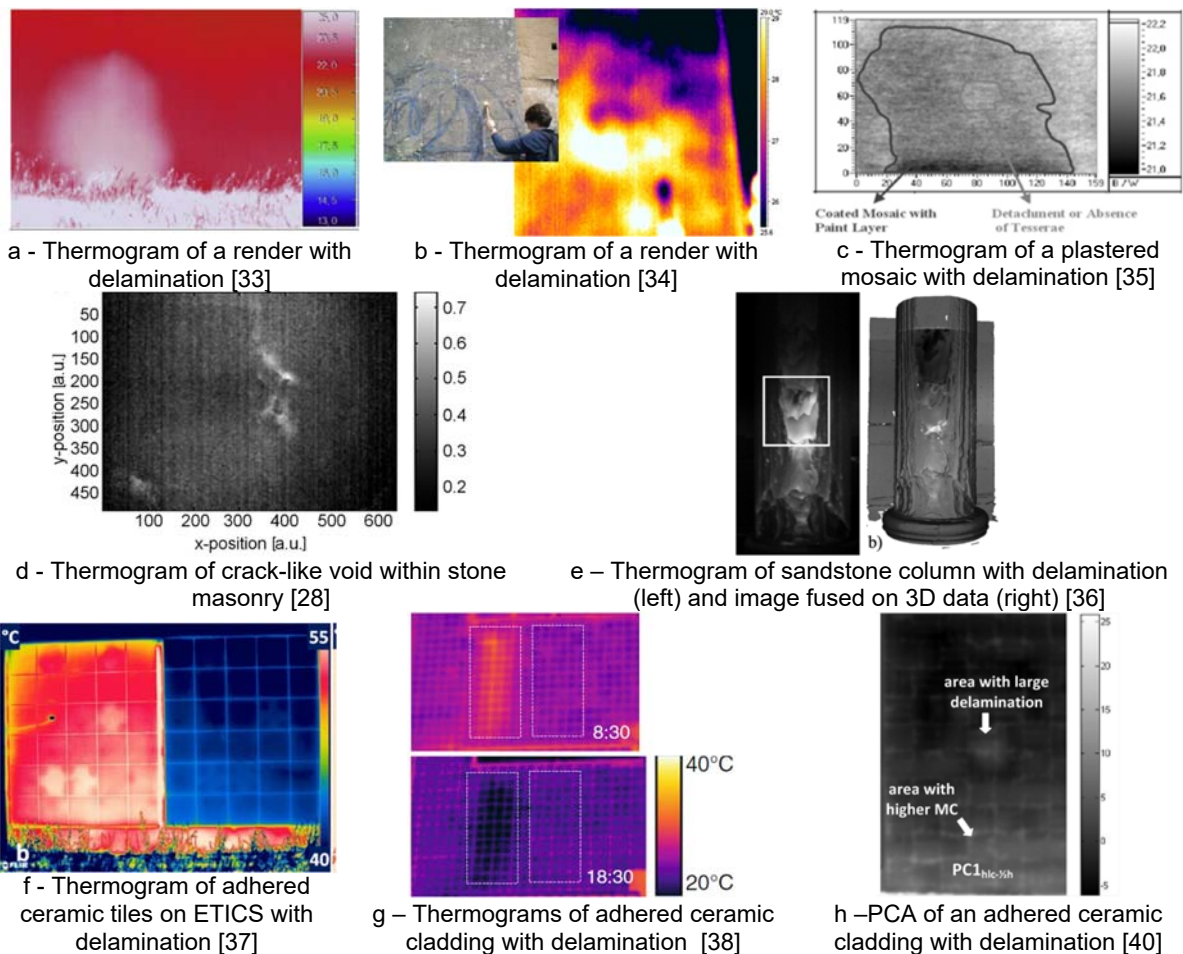
Figure 3.2.4 - Thermograms/images from in-situ delamination detection examples.

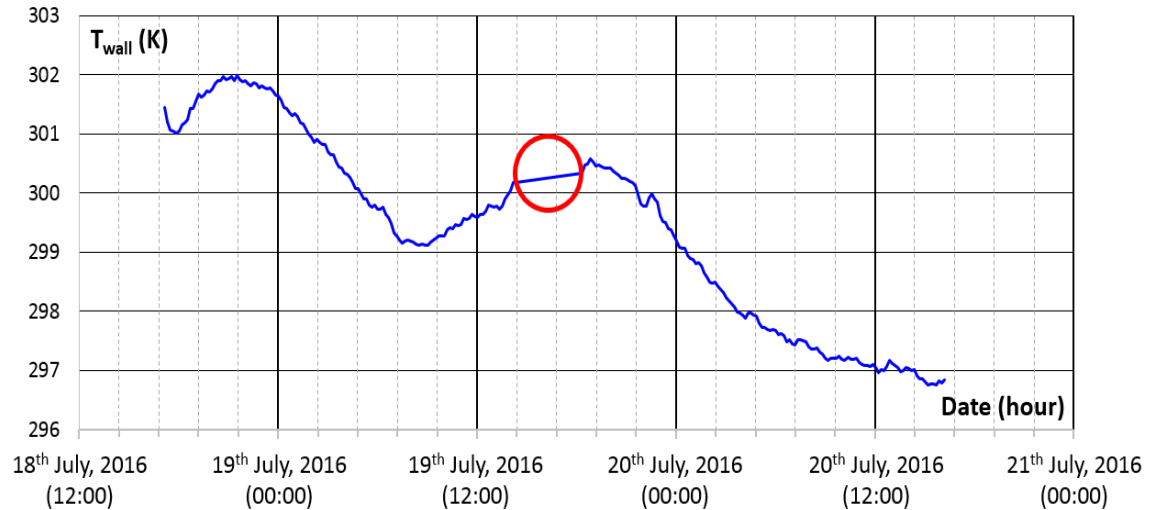
Figure 3.3.4 - Evolution of the wall temperature during the experiment from 18th July at 16:30 to 20th July at 15:30. On 19th July the measurements suffered a cut between 14:30 and 18:15 (red circle).

the hours of the day, allowing the cycle of heating, heat maintenance and cooling it undergoes to be observed.

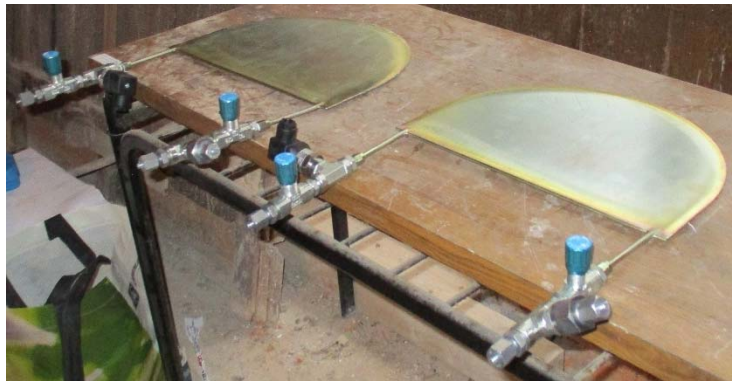
Figure 3.3.10. Device for continuously monitoring stress level variation.

The device developed enables the determination of the existing stress state, and its continuous monitoring over time. Moreover, in combination with other devices, it is possible to monitor the loading of a structural strengthening applied to a construction. It is composed of a pressure pad (flat jack), a pressure transducer and a system of hydraulic connections designed to monitor the pressure of the fluid inside the pressure pad (Figure 3.3.10).

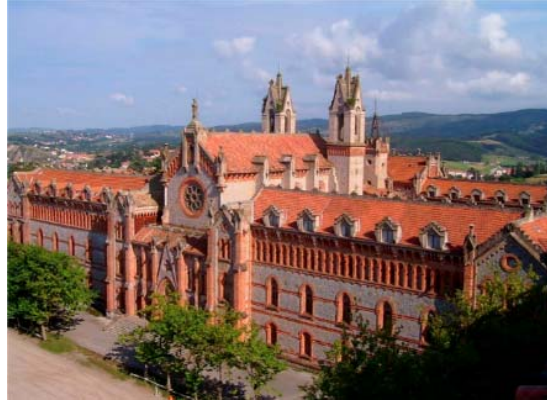
Figure 3.3.12 - The building monitored: Church of the “Seminario Mayor de Comillas”, Spain.

presence of several rows of bricks with low-strength lime mortar at the lower part of the buttresses and walls of the building was also detected.

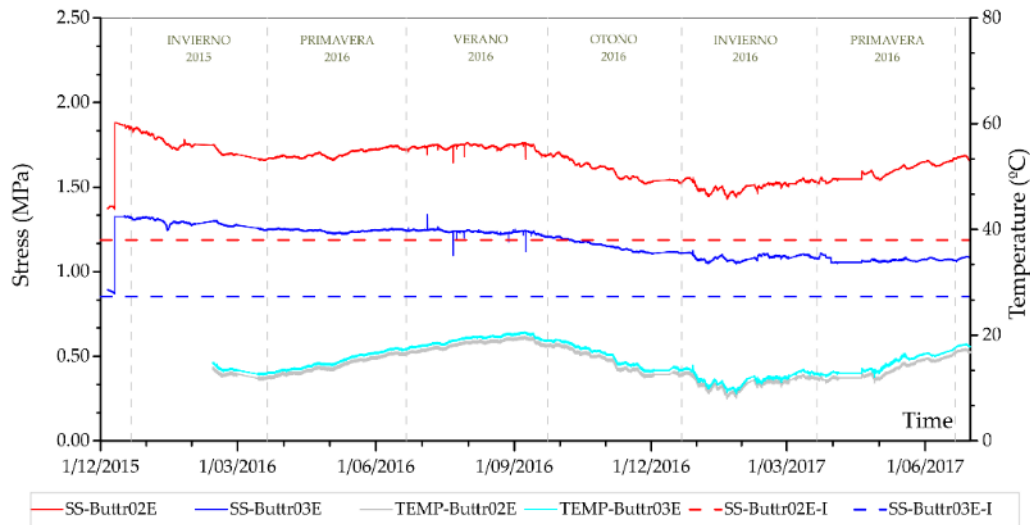
Figure 3.3.14 - Stress evolution in the monitored areas of the building's east buttresses (SS-Buttr02E and SS-Buttr03E). In addition, the temperature was recorded with the aim of assessing the influence of temperature variations on the measurements.

As an example, Figure 3.3.14 shows the evolution of stresses in the east buttresses of the building during 19 months of monitoring (SS-Buttr02E and SS-Buttr03E). During this period, passive strengthening interventions took place in the east load-bearing wall and the monitoring of this area before, during, and after these. In addition, by means of a discontinuous constant reference, the stress value determined in the masonry (SS-Buttr02E-I and SS-Buttr03E-I) is included.

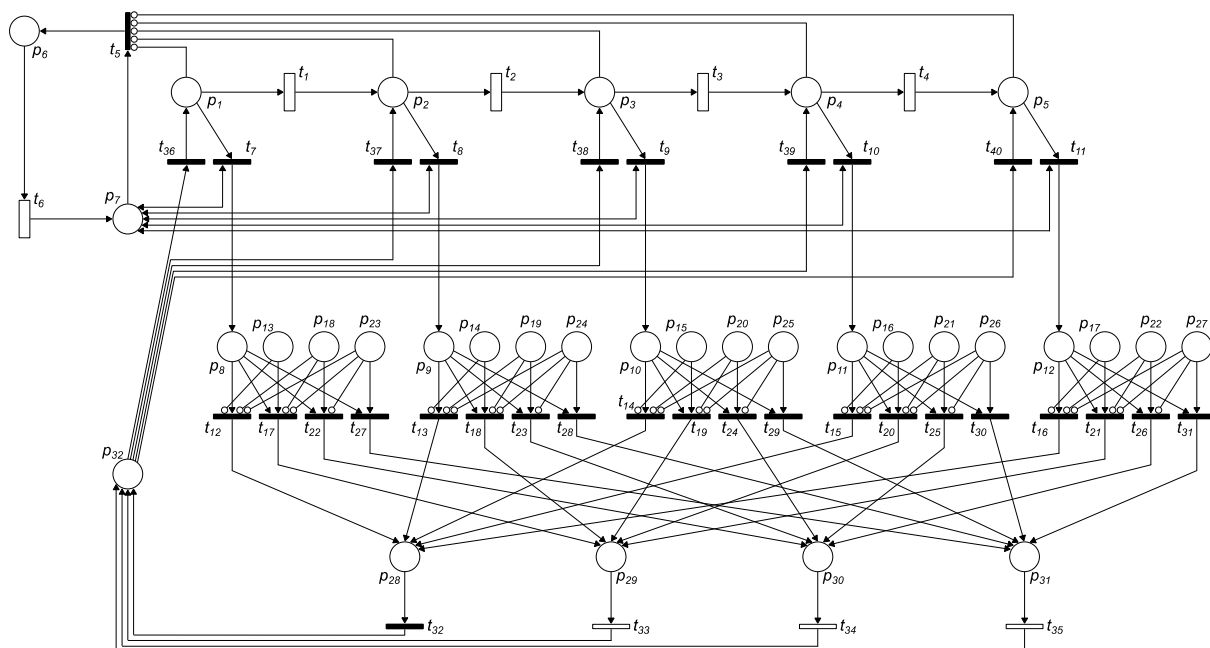
Figure 4.2.2 - Petri net scheme of the maintenance model

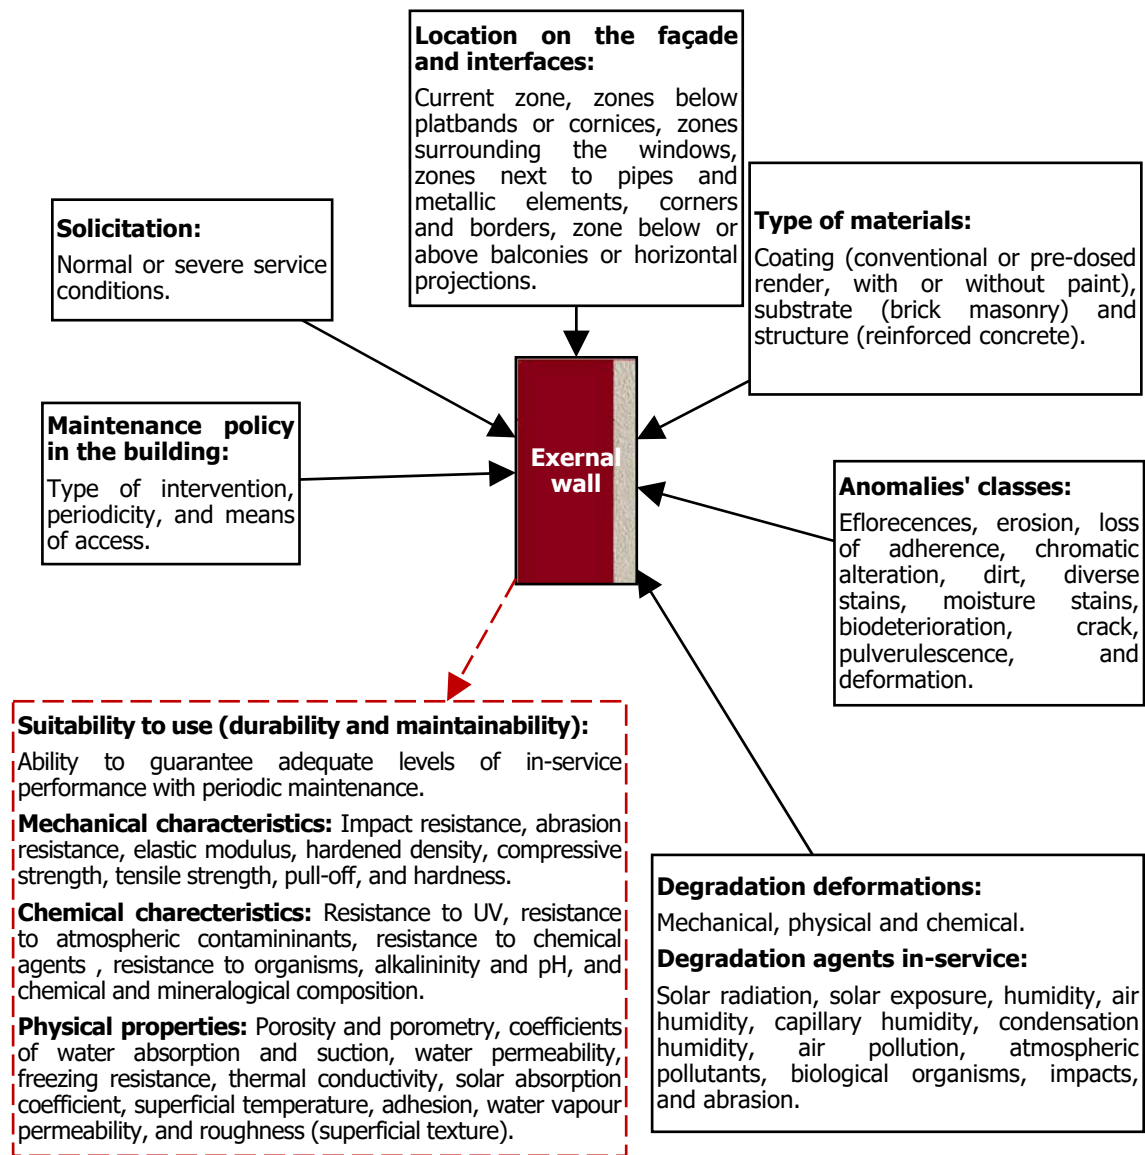
Figure 5.1 - Factors that influence in-service performance of rendered façades

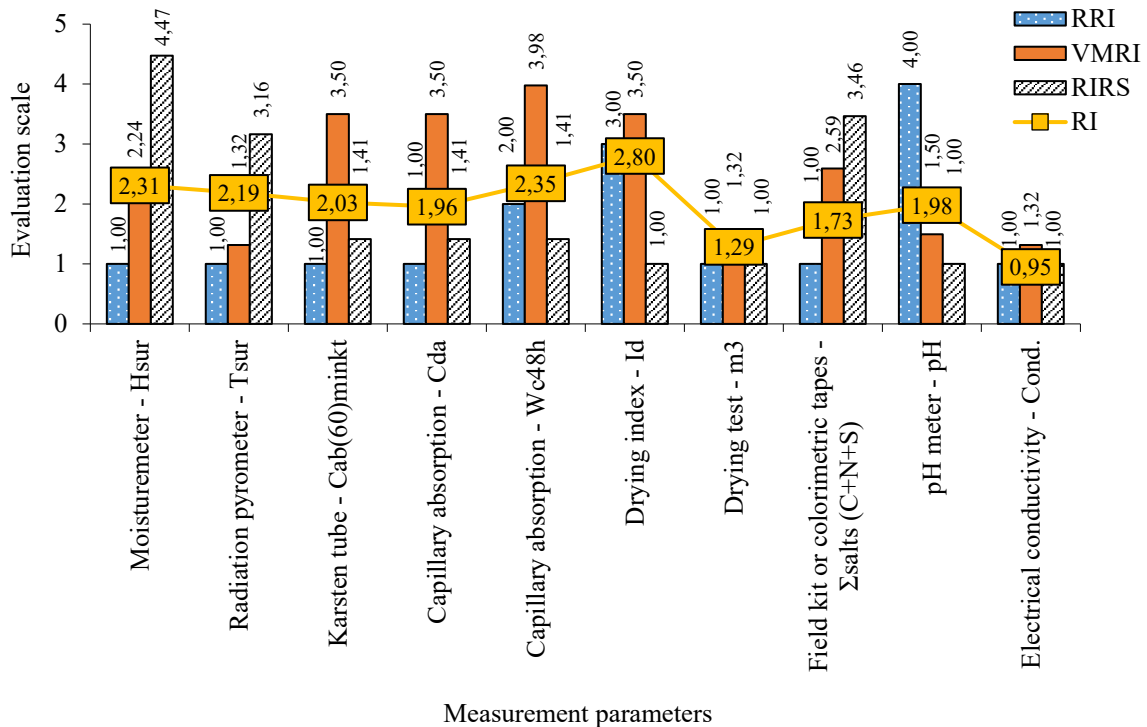
Figure 5.2 - Partial reliability indicators (RRI - reference reliability indicator, VMRI - verification method reliability indicator, RIRS - reliability indicator of in-service results) for each physical-chemical in-service measurement
