7th WTA Colloquium – Maintenance of Concrete Buildings – June 10th, 2022, Delft (NL)

Strategies for the Conservation of Historic Concrete Structures

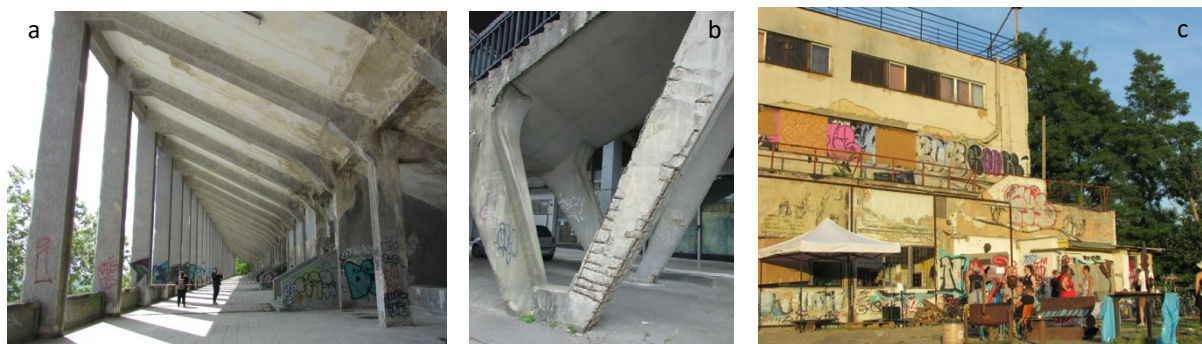
Examples of case studies in the Czech Republic: a) Abandoned structure: view of the Strahov stadium in Prague during an opening day for visitors; b) Detail of the Strahov stadium showing corrosion of the reinforcement due to inadequate concrete cover and lack of maintenance; c) Building in need of conservation: view of the Fuchs restaurant in Prague during a local community party.

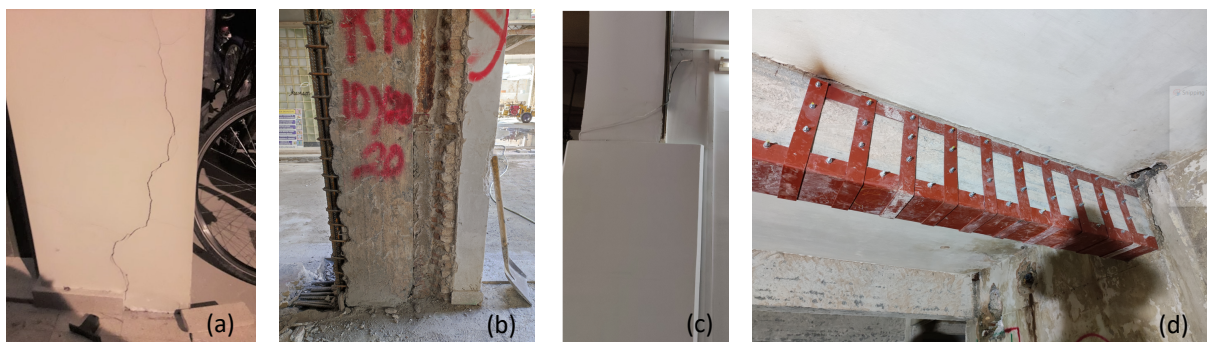
Figure 1: (a) Crack expansion in restored column due to expansion of corroded steel reinforcement, (b) Strengthening of column only on one side, (c) jacketing of column only up to a certain height, (d) externally bonded reinforcement of beam

This presentation focuses on good and poor intervention practices adopted during the restoration of listed and non-listed historic concrete structures in Cyprus (Fig. 1), where the various repair and retrofit scenarios must include design for seismic events; this was not taken into consideration during the original design of historic concrete structures on the island, despite the fact that it is located in a seismic prone area. The interventions hereby presented (i.e., jacketing, complete replacement of reinforced concrete elements, confinement with metal parts, replacement of reinforcement cover with high performance grout material, addition of shear walls) have a construction age history span of ca. 20 years, thus allowing us to assess their performance in time and decide upon their efficiency and suitability for use in relevant restoration projects.

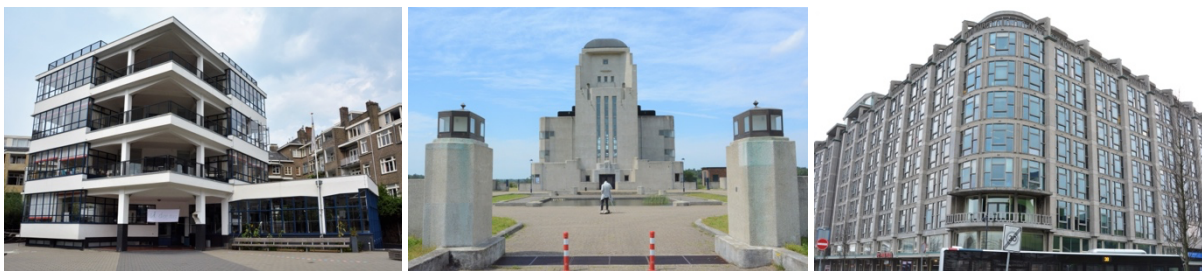
Figure 1: From left to right: Open-air School (1930), Radio Kootwijk (1918) and Groot Handlesgebouw (1953).

In the CONSECH20 research project 15 buildings located in the Netherlands (fig. 1) were assessed and compared with 33 buildings in three different countries (Italy, Czech Republic and Cyprus). The results indicate that the Dutch buildings have in general a better state of conservation than those examined in the other countries and that the most common damage process across countries is corrosion. The research showed that state of conservation is dependent on different factors like maintenance, continuous building use, use of sacrificial plasters. These factors are further analysed and discussed to shed light on how historic concrete buildings can be better preserved.
