Non-Destructive Testing of Elastomeric Joint Sealants in Construction

Huff, Daniel N.¹

T 14

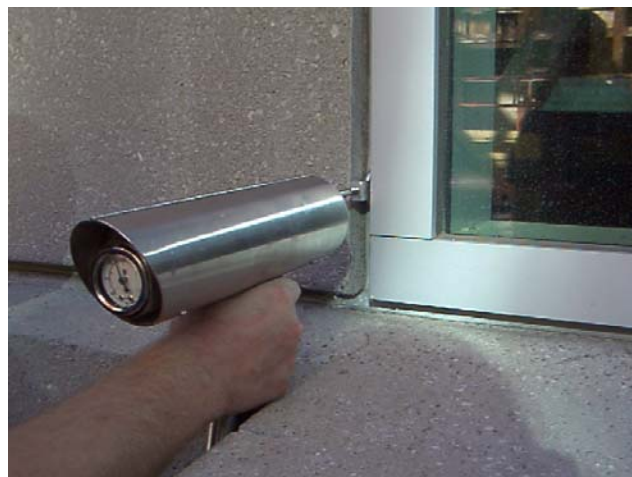
Figure 2. The picture is a depiction of the pressure-controlled as discussed in this paper.

The device is a hand held instrument able to exert pressure in a controlled manner to the sealant joint. Extending from the housing at the front of the device is an armature with a roller at the tip. Behind the armature is a piston charged with compressed gas delivered from a pressurized tank. The amount of pressure behind the piston translates directly into the amount of force that is applied to a surface to which the roller probe is engaged. The amount of gas pressure delivered from the pressurized tank is adjusted with a regulator. Pressure within the device and behind the piston is monitored from a gauge visible on the control box. Within the pressure control box the gas is manipulated in such a way that the pressure is constant within the entire stroke of the piston in the hand held portion of the device. Pressure in the apparatus as derived from the gas source resulting in strain at the probe contact point is maintained if the armature is somewhere within the stroke of the piston. The operator pushing in or pulling away from the joint with the device during operation cannot alter the pressure at the probe contact point. This means that the pressure that the test probe exerts on the sealant remains constant. To maintain constant pressure, the piston must simply be kept within its' 3-inch [7.6cm] stroke range.

Using this device, accurately applied pressure to the joint is not dependant on adjacent surfaces (as in the case of a backer rod placement style device) or the judgment of the user (as in the case of a screen roller or similar device) when testing. The result is a reproducible and objective evaluation system. The user simply dials up the predetermined pressure for the device to operate on and then lets the device do the rest. A predetermined pressure is set for the specific sealant through calibration of the device.

Calibration of the device is aimed at a 50% elongation of the sealant based on the sealant movement capability, following the guideline for the non-destructive procedure found in ASTM C1521. The calibration numbers used in the field are an average based on the particular sealant and the average joint width on the building. If the test practitioner wishes to, adjustments for joint width changes can

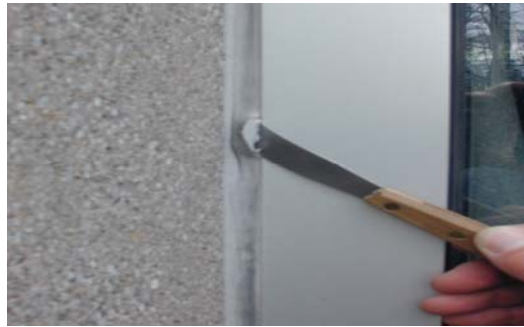
Figure 3. This is an example of the type of “invisible” seal failure uncovered by using the non-destructive method and device described elsewhere in the paper. Prior to finding this seal breach, the entire sealant bead depicted looked exactly like the area above and below the breach.
