## COST CENTRES FOR RESTORATION WORK OF HISTORICAL BUILDING: A CASE STUDY IN GEORGE TOWN

**Tan Lee Kean**

**Lim Yoke Mui**

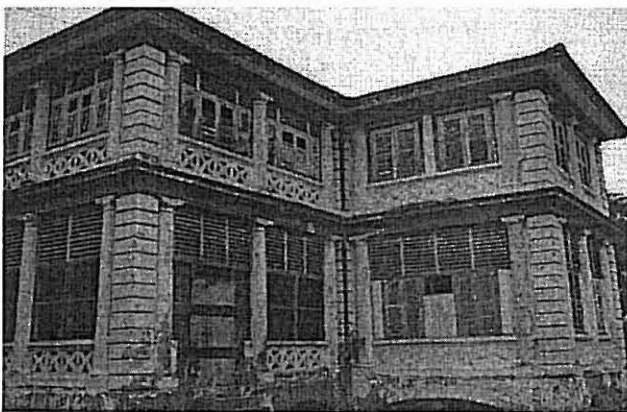
Figure 1: Case study – Before restoration  
(Source: [www.hbp.usm.my/conservation/biodata.htm](http://www.hbp.usm.my/conservation/biodata.htm))

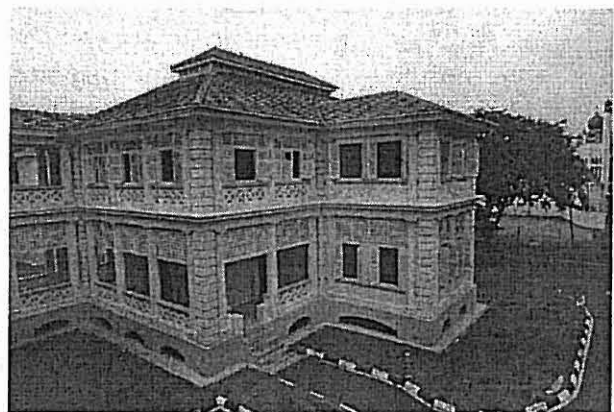
Figure 2: Case study – After restoration  
(Source: [www.pht.org.my/57-macalister-road.htm](http://www.pht.org.my/57-macalister-road.htm))
