Rubblizing Concrete Pavements Using Resonant Vibration Technology

G. Thenoux and M. González

Abstract

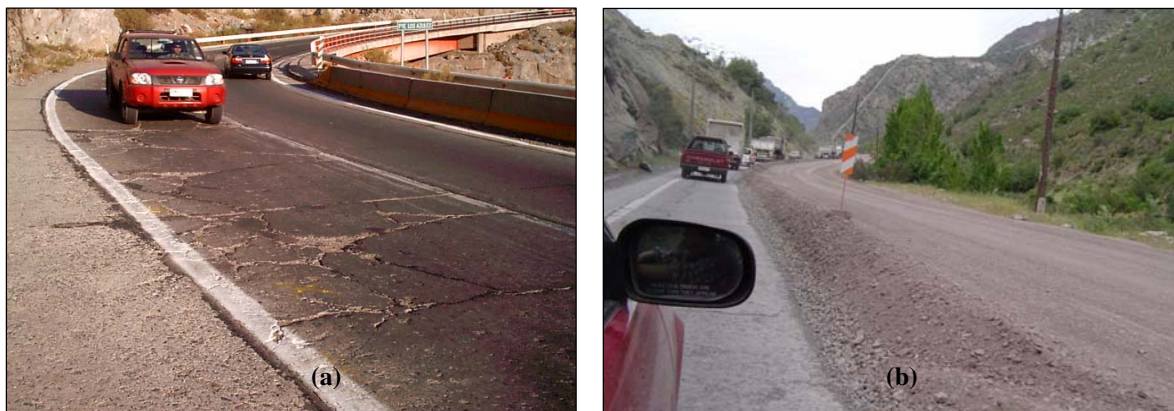
Figure 3-(a), shows typical original conditions of the concrete existing concrete pavement. The test section was located between a relative large construction project (aprox. 50 km) where part of the project was reconstructed and an important part was being rehabilitated using a granular base overlay plus asphalt overlay (Figure 3-(b)). This technique is widely used in for highway concrete pavement rehabilitation in Chile. Although, direct asphalt overlay was also considered this is not included in the analysis, since due to the actual pavement conditions and traffic there is a high potential for reflecting cracking.

Figure 3: typical pavement original conditions (a) and overlay with granular base (b)

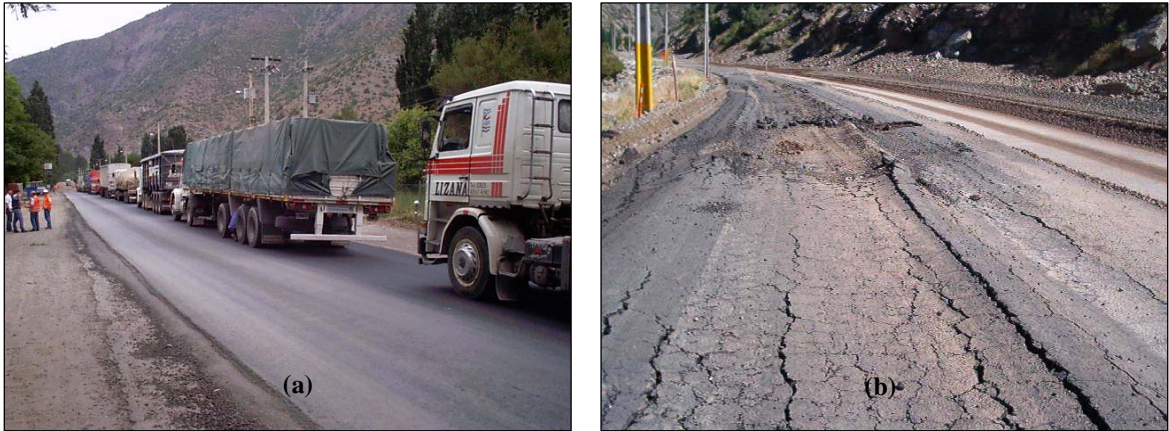
Figure 5-(a) and Figure 5-(b), shows how the road looks after the rain. Although was not possible to do traffic performance analysis it was possible to prove drainage performance of the rubblized layer is excellent.

The road was damage almost in all its extension. Since drainage was very poor water did not drain out from the granular overlay. It could not drain laterally fast enough due to the lack of lateral drainage and it could not drain downwards due to the existing concrete pavement. The section that was Rubblized being located under the same conditions performed very well. The rubblized layer is not water susceptible and it drains laterally very easy, thus going good performance of the asphalt overlay layer.

Figure 5: Rubblized section (a) end overlay section (b) after the rain

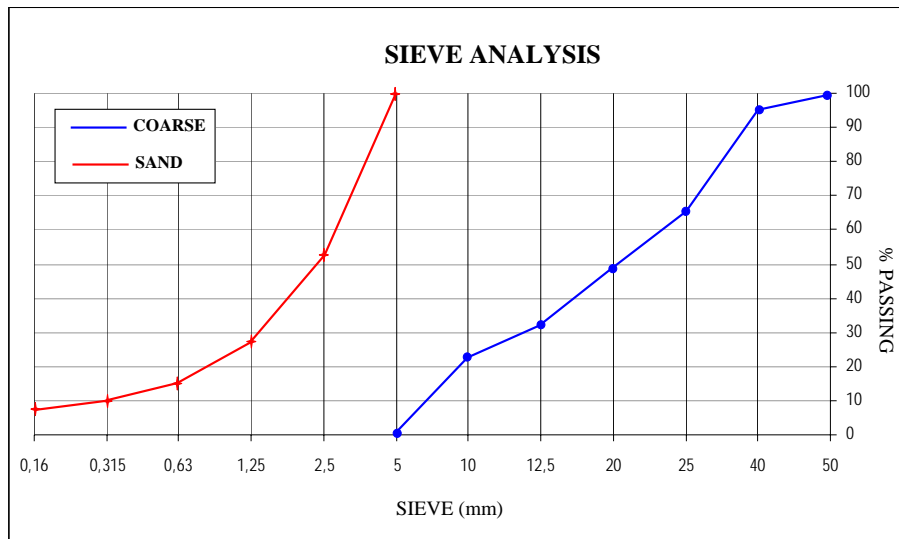
The last analysis that was done was a sieve analysis of the upper part of the rubblized material. This is composed approximately with 15 % sand and 85% medium coarse size. The sieve analysis for each size is shown in Figure 6. Based on this results this material may be used directly in other applications without further crushing.

Figure 6: Sieve analysis of rubblized material
