WATERLESS URINAL TECHNOLOGY: CASE STUDY

W. Schmidt (1), O. M. Gonçalves (2)

Escola Politécnica da Universidade de São Paulo, Departamento de Construção Civil,
São Paulo, Brasil

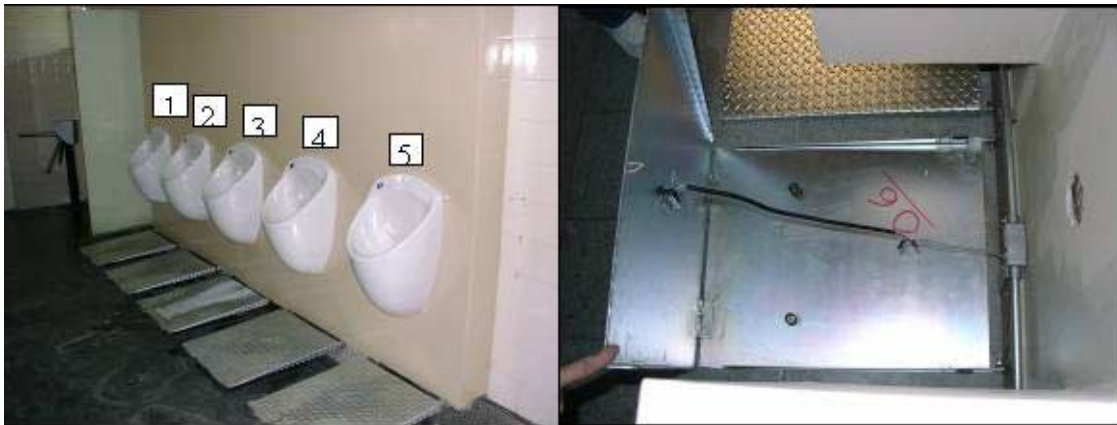
A measurement system of urinal's uses was created in both restrooms. Metallic platforms with contact sensors were installed on the restrooms floor, in front of each urinal, according to Figure 4. The sensors were connected to a panel which registered each use.

Figure 4 – Measurement system - platforms with sensors

By means of the measurement system, it was possible to quantify the lifetime of each cartridge in each individual urinal. In other words, it was possible to verify the cartridge's durability and performance.
