Long-Term Expectations and Experiences of ETFE-Membrane Constructions

ABSTRACT

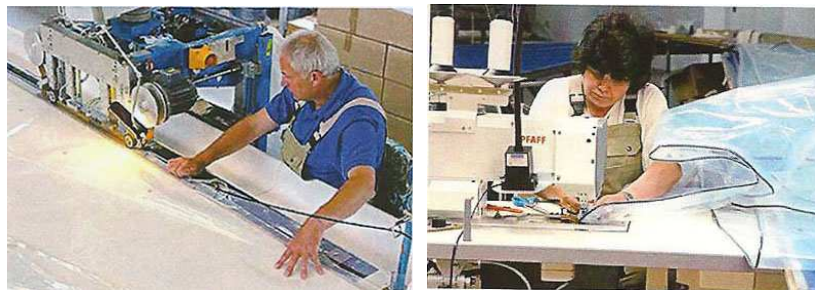
Figure 1 and 2. Jointing of ETFE-foils by hot fusion and inlay of keder in foil boundary loop.

ETFE-foils 1.5 to 2.0 m of width and 50 to 250 microns of thickness can be fused together by a thermo-fusion process to any size of cushion. In the jointed zone, the overlapped surfaces fully melt. With the help of pressure rolls, a solid jointing is created. This zone of 25 mm width is visible because of doubled thickness and surface imprints. CNC-controlled machinery is needed for precise cutting and jointing.

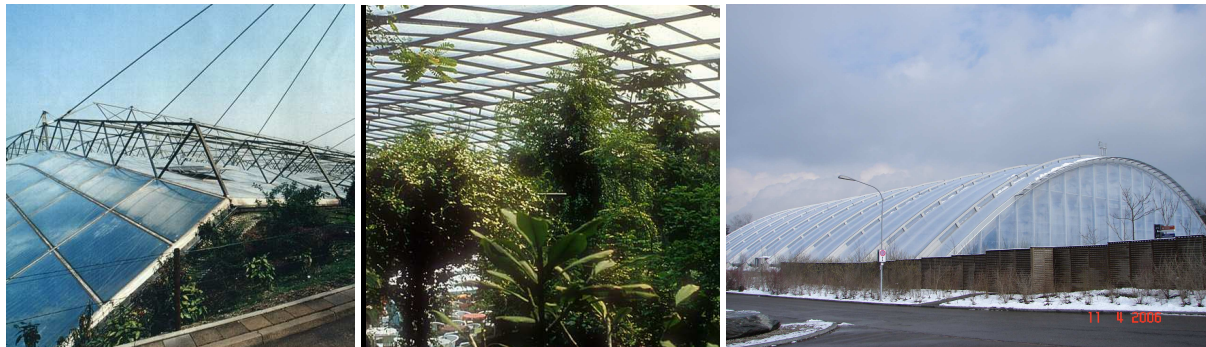
Figure 4, 5 and 6. The roof of bush hall of Burger’s Zoo Arnhem NL (left), inside view (centre) and the Masoala Rain Forest building at Zoo of Zurich (right).

ETFE-foils from three buildings in the Netherlands, in Germany and in Switzerland were available for this investigation. The longest exposure time was 22 years at the Bush Hall of Burger's Zoo in Arnhem (BZA) [Fig. 4 and 5]. Whereas, the pyramid spa-hall (PSH) in western Germany was installed 13 years ago and the roof of the Masoala Rain Forest building (MAS) of Zoo Zurich 7 years ago [Fig. 6]. In table 1 the relevant building data are listed. From the MAS and PSH building, new membranes were also available where the results of the installation were taken from as reference data.

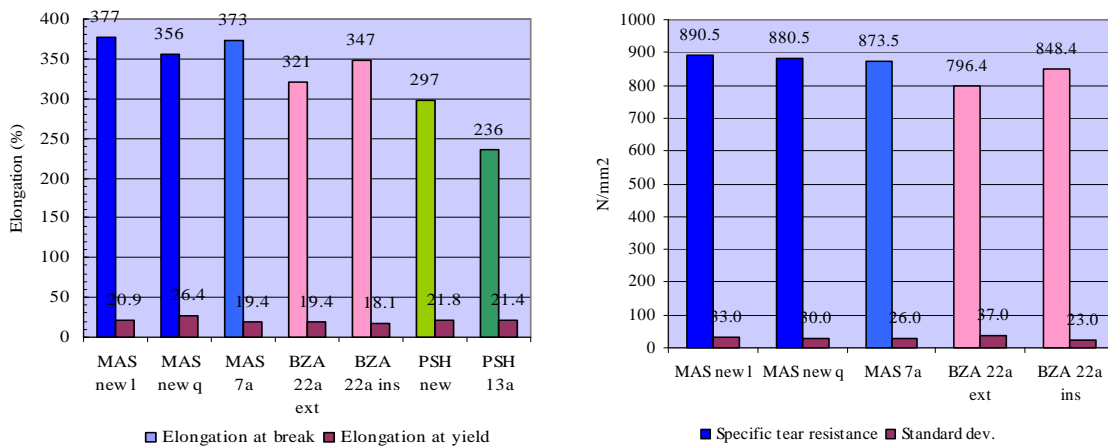
Figure 8 and 9. Elongation at break and at yield from tension tests (left) of all three buildings. Specific tear resistance in N/mm^2 of MAS and BZA buildings.

All membranes were subjected to tension, impact tension and tear resistance. The tests revealed the values were nearly unchanged compared to new membranes. A higher scatter of the standard deviation was observed at the BZA-membrane due to little mechanical defects which were neglected during the test sample extraction. The tension test results of the PSH building showed a certain difference compared to the MAS and BZA building membranes [Figure 8 and 9].

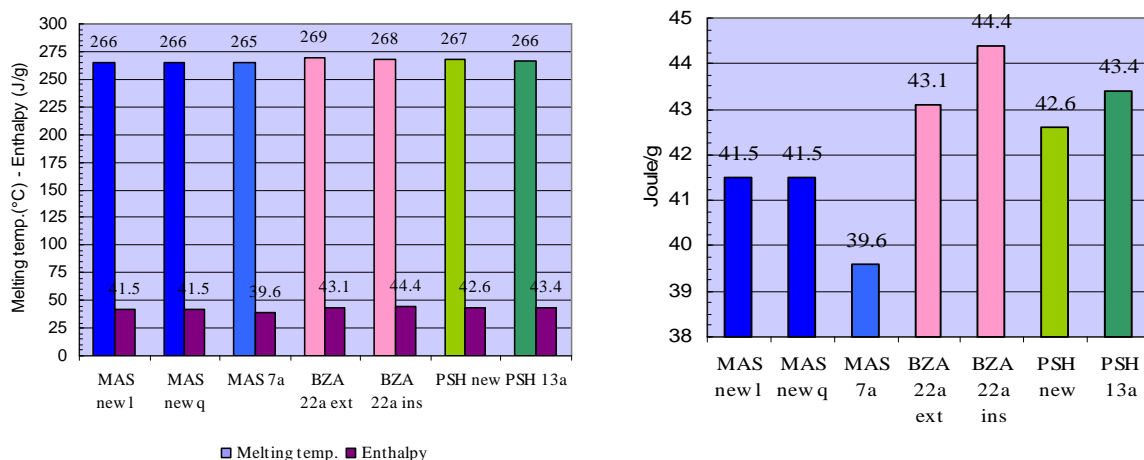
Figure 10 and 11. Melting temperature (° C) and enthalpy (J/g) for new and aged ETFE membranes (left). Enthalpy peaks blown up for better discrimination (right).

DSC investigations pointed to the possibility that changes may have been influenced by the stored heat due to longer sun exposure of the BZA-building. However, these changes were minimal but detectable (Fig. 10 and 11).
