Durability of Reinforced Concrete Structures in a Petrochemical Complex: a Case Study

ABSTRACT

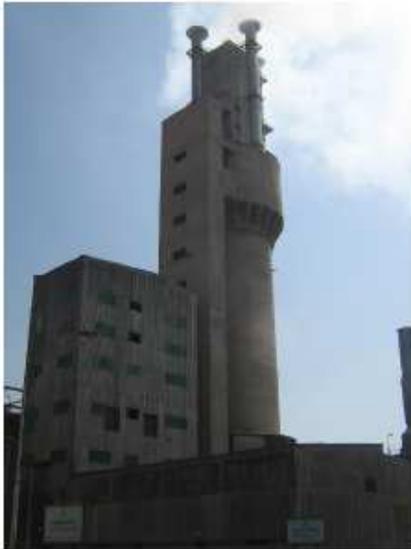
Although a protective epoxy coating was applied to concrete surfaces, the prill tower nonetheless showed severe deterioration due to the long time exposure to ammonium nitrate. Damages were mainly softening of concrete (to the extent that even extracting cores from the tower's foundation was not possible) and removal of concrete cover (Figure 2). Therefore a thorough investigation was performed to assess the causes of these damages and also the level of deterioration.

One of the products of a petrochemical complex is chemical fertilizer which is often sold as small particles known as prills. These small particles are produced by converting liquid ammonium nitrate into solid granules. This conversion process is implemented in a tall tower called a prill tower (Figure 1).

Figure 1. The ammonium nitrate prill tower.

- 1) For the ammonium nitrate unit in which the concrete was decalcified to a depth of 30 mm from its surface but for which reinforcement corrosion was not observed, the best repair scheme would be to remove concrete up to 30 mm depth and replacing with a high quality and compatible repair material [Vaysburd et al. 2004; Moragn 1996]. This should be followed by placing a protective and breathable coating on the exposed surfaces.

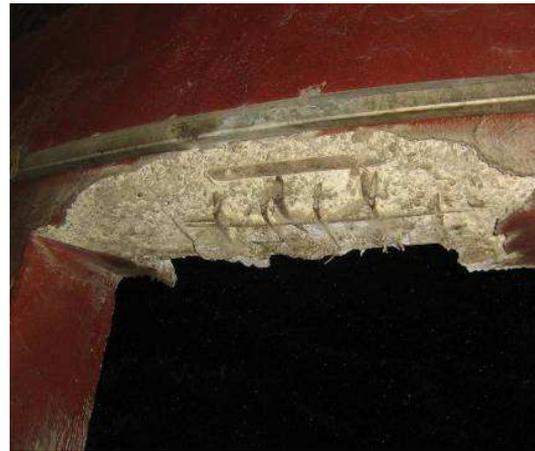
Figure2. Destruction of concrete cover.

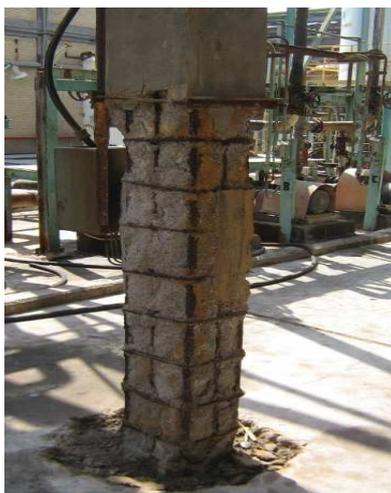
The chloride unit is located at the northern part of the petrochemical complex. Most columns of this unit's structures are constructed by reinforced concrete. High concentration of chloride ions in the atmosphere of this unit was the most important finding obtained from the visual inspections; these results served to confirm the high degree of deterioration that was evident on the different concrete elements. Figure 3 presents a column of this unit. It is obvious that the concrete cover has been totally removed and reinforcement corrosion is observed.

Figure 3. A view of supporting columns of the structure of chlorine unit.

Furthermore, according to different measurements, the concrete cover of the columns in this unit was about 4 cm which is clearly not sufficient from a durability point of view given the extremely harsh environment to which the structure has been subjected.

- 3) Most parts of the concrete structure of the chloride unit are contaminated by chloride ions far beyond the threshold value and up to 8 cm depth from its surface; reinforcement corrosion was observed to be well developed. Therefore it would be more cost-effective to build a new chloride unit than perform repair operations; in any case, durability parameters should be taken in to account.

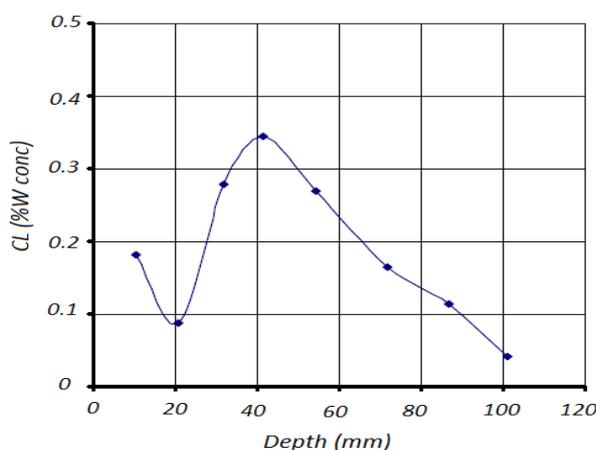
Results of different laboratory experiments on the extracted cores with in-situ measurements of carbonation depths are summarized in Table 2. Results confirm the poor condition of the concrete. The depth of carbonation is rather high and according to Figure 4, carbonation phenomenon has pushed the maximum peak of diffused chloride ion from surface of concrete to its depth. Moreover, the concentration of chloride ion at the location of the reinforcement bars (40 mm depth) is far beyond the chloride threshold value ([Pargar et al. [2007]). Therefore, reinforcement corrosion is highly probable. This was in complete agreement with the results of visual inspection and half-cell potential map (changing of absolute potentials along a short distance is an obvious indication of steel corrosion).

Figure 4. Chloride diffusion profile of a selected column.

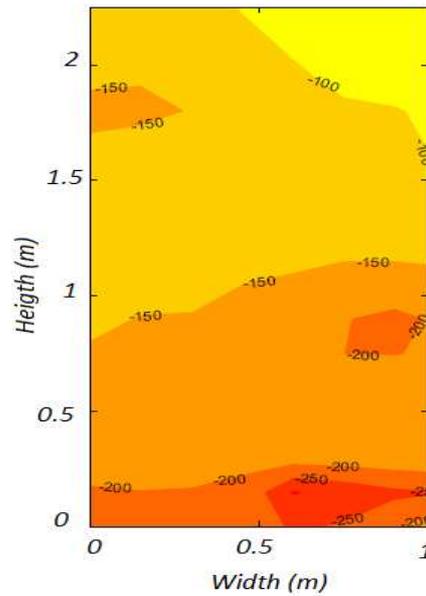
Figure 5. Half cell potential map of a selected column.

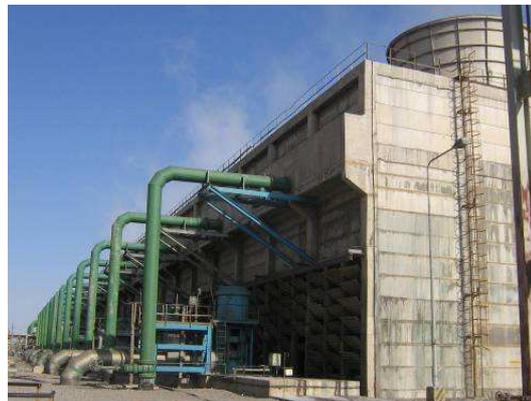
This unit is located at the north western part of the petrochemical complex and next to the Chloride unit. The function of this unit is to reduce the temperature of water gathering from cooling systems of different units by spraying it from the top to the bottom of the cooling tower. As the drops of hot water fall, they evidently lose temperature. Therefore, high humidity conditions exist where water is sprayed and the concrete is thus almost near the saturation limit for large areas of this structure. Concrete elements of this unit consisting of peripheral frames such as columns, beams and walls are pre-fabricated and the columns rest on pedestals that are almost two meters in height (Figure 6).

Figure 6. A view of the cooling tower unit.

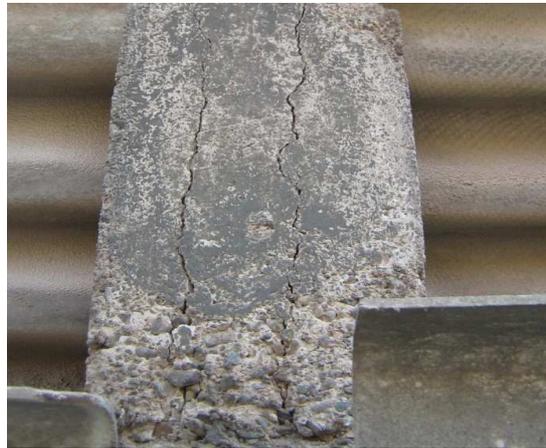
In some of the columns and walls of this unit, longitudinal cracks with almost 2 mm size were observed (Figure 7).

Figure 7. Longitudinal vertical cracks of almost 2 mm size in a selected column.

- 2) As was the case for the ammonium nitrate unit, for the cooling tower units the best repair method would be local patch repairs. But in some locations of these units, reinforcement corrosion was observed and in some regions the chloride content in proximity to the reinforcement was around the threshold value. Therefore, not only must the contaminated concrete be substituted by high quality and compatible concrete, but the corroded reinforcements must also be replaced by new rebars.

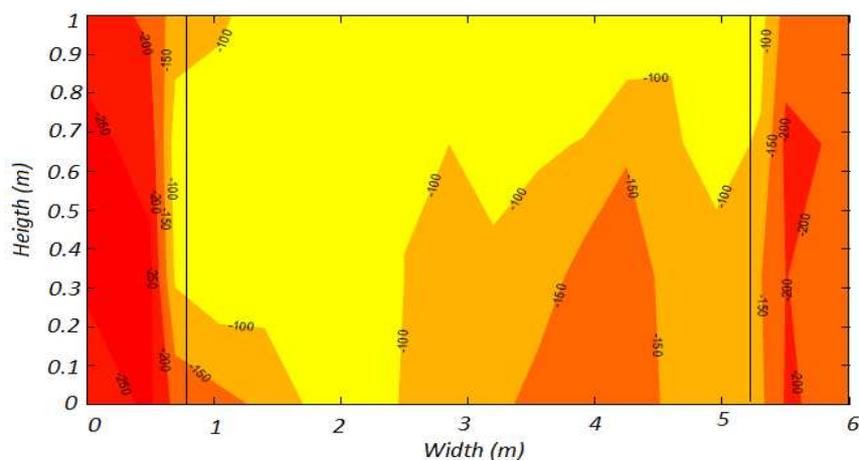
Various studies have suggested that different half-cell potential ranges should be considered instead of absolute potential values in order to determine the locations of “high-probability” corrosion activity within a reinforced concrete structure [RILEM TC 154-EMC 2003]. Figure 8 displays half-cell potential contours of a wall which exhibited many longitudinal cracks that likely originated from reinforcement corrosion. In this figure, high fluctuations of potential values in both ends of the wall were observed which is indicative of a high likelihood of the presence of steel corrosion.

Figure 8. Half cell potential map of a the western wall of the cooling tower unit.

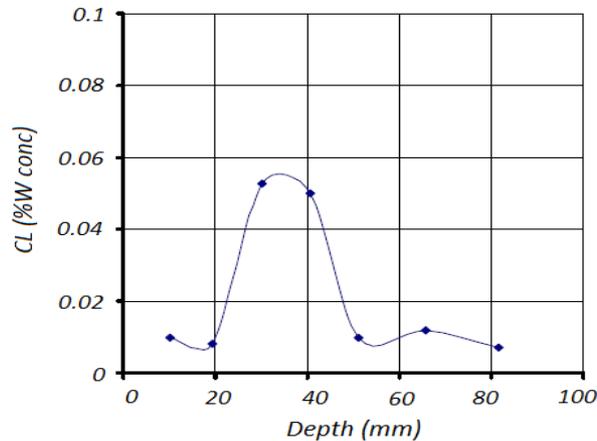
As it was mentioned earlier, this unit is located beside the chloride unit and because of the high concentration of chloride ions in the atmosphere of the latter unit; the chloride-induced corrosion also threatens the durability of concrete in the cooling towers unit. Figure 9 provides an overview about the penetrating chloride ion to the concrete on a western wall of the cooling tower unit. As was the case in Figure 4, the existence of carbonation phenomenon is apparent since the maximum peak of the curve is transferred from surface of the concrete to its depth. Chloride content is somehow high. At the location of bars (40 mm depth) chloride content of approximately 0.06% by weight of concrete which is very close to chloride threshold value is observed. Meanwhile, results of chloride profile of the farther units from the chloride unit showed a little amount of diffused Chloride. Therefore, the hypothesis of occurring interactions between adjacent units is highly presumable and should be considered in designing or at least allocating sufficient distances between different units.

**Figure 9.** Chloride diffusion profile of a selected wall.
