Investigation On The Corrosion Of Zinc Sheeting Of The Highly Insulated Cold Zinc Roofs In A Moderate Humid Region

Summary: During the last decades, with increasing concerns on energy efficiency and global warming, the U-factor of building elements has been pushed towards low threshold values. The trend to lower U-factor may greatly change the hygrothermal situation of traditional cold zinc roofs. Expectedly, that change could affect the corrosion of zinc sheeting in traditional cold zinc roofs.

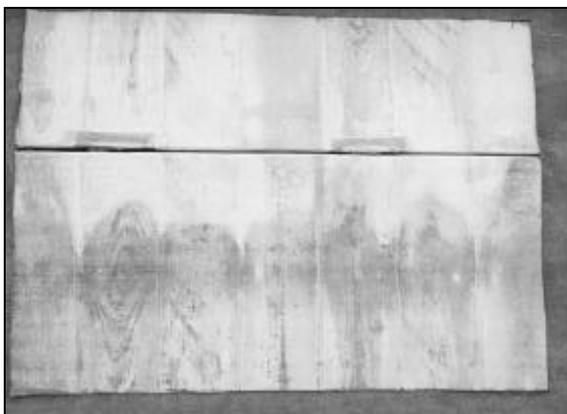
Roof NE1c

As shown in Fig. 3, the distribution of white corrosion products was not uniform at the underside of the zinc sheeting. It is also noted that there was no much apparent difference in corrosion between the air-open cold zinc roofs (SW1c and NE1c) and the air-tight cold zinc roofs (SW2c and NE2c). Generally, in light of the distribution of the corrosion products, there existed two typical regions on the underside of the large specimens. One region was heavily covered with white corrosion products (here labeled type I), the other was covered by a thin white film of corrosion products (here labeled type II). The directional characteristic of rolled zinc sheeting can clearly be seen on the areas with a thin white film of corrosion products.

Figure 3 Large zinc specimens taken from the cold zinc roofs (50 ~ 70 cm)

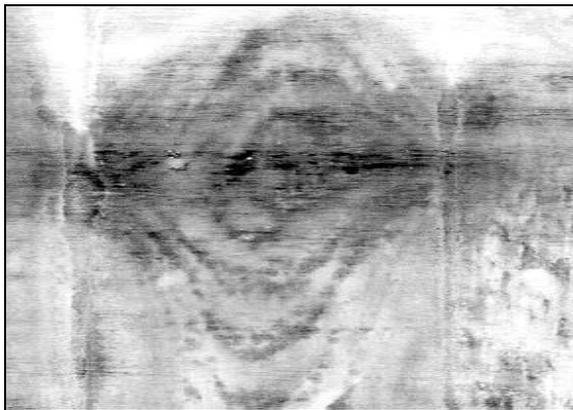
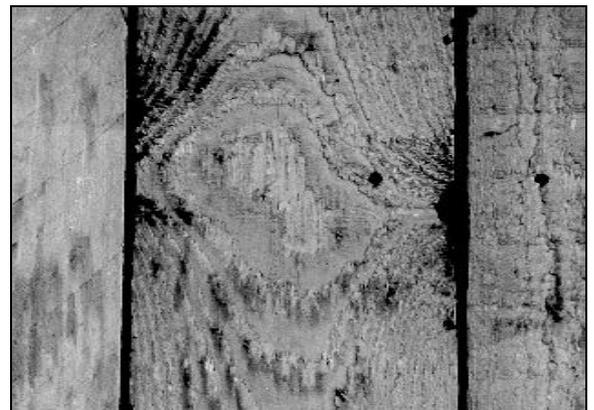
Figure 4 illustrates a wood scar on the wood deck in NE1c and the appearance of the corrosion product on the zinc surface corresponding to the scar. We believe that the underside surface of the zinc sheeting somewhat touched the wood scar due to the sign of the scar on the zinc surface. Examining it carefully, it is found that the center area of the wood scar was a little higher than the edge area. The height gradually reduced along the annual ring of the scar from the center to the edge. So, if the zinc sheeting contacted the wood scar, the most possible contacting place was the center area. Making a comparison between them, it is noted that the corrosion of the zinc sheeting corresponding to the center area of the wood scar was lighter than that corresponding to the edge area of the wood scar. This may partly demonstrate the influence of the contact situation between the zinc sheeting and the wood deck on the appearance of corrosion products on the zinc surfaces. For our cases, we may say that the corrosion pattern on the zinc sheeting contacting the wood deck or having much small gaps between the zinc sheeting and the wood deck took the type II, while that in the no-contact areas took the type I.

Figure 5 Area of the zinc sheeting contacting a wood scar (left) and the corresponding wood scar in the wood deck (right)

For the areas contacting the wood deck or the areas with much small gaps between the sheeting and the wood, however, less condensation might be expected because of the difficulty of ventilated air reaching those spots and because of the hygroscopic inertia of the wood. The wood deck absorbs the little condensation if any. In these areas, the corrosion rate of the zinc sheeting mainly depends upon the moisture content in the wood deck. Its threshold value to induce zinc corrosion is about 20 % by weight (Building Research Establishment, 1986). Therefore, if the moisture content in a wood is continuously kept below that critical level, zinc does not suffer severe corrosion even contacting the wood. As the moisture contents in the wood deck during the last three years of measurement generally remained lower than 20 %, it is reasonable that less corrosion at the underside of the zinc sheeting in the wood-contact areas occurred in comparison with the no-contact areas.
