The Historic Belfast Timber Truss - A Way To Promote Sustainable Roof Construction

JR Gilfillan SG Gilbert
Faculty of Engineering Queen's University Belfast N Ireland

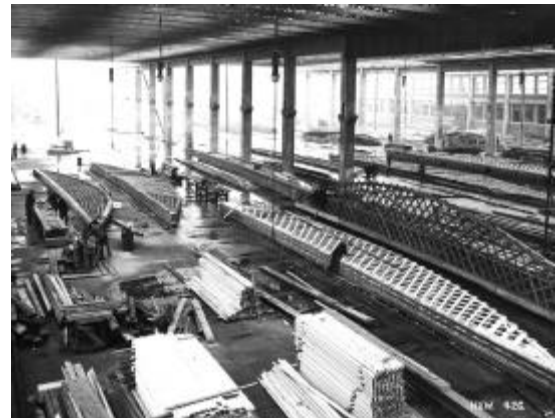
Figure 6. Fabrication of Belfast trusses c1917
(© UFTM no.426)

The trusses were made both on and off site. It is probable that the bigger trusses were made on site. Figure 6 is a good general view of Belfast trusses being fabricated - these are thought to be the same trusses shown in the hangar building of Figs. 2 and 3. It is interesting to note, that the eaves joint detail here differs from that sketched in Fig. 4. In the right foreground of Fig. 6 the lattice members form a solid gusset at the eaves joint and double members are used in the region close to the eaves. This obviously improves the load capacity of the joint and a possible reason for the double members is discussed later.

The most common fabrication method produced initial lack of straightness and induced bending stresses in the lattice members. These were required to bend when crossing adjoining members because, to accommodate the lattice, the bottom chord pieces were separated by twice the member thickness and the top chord pieces by only the member thickness. The consequent lateral displacement is equivalent to half the lattice member thickness, producing a critical bending stress condition for the shorter members and a critical instability condition in the longer members. Later trusses incorporated double lattice members close to the ends, as seen in Figs.2 and 6, to compensate for the incipient weakness in the lattice.
