Non Destructive Waterproofing Remedial Treatment

TT8-252

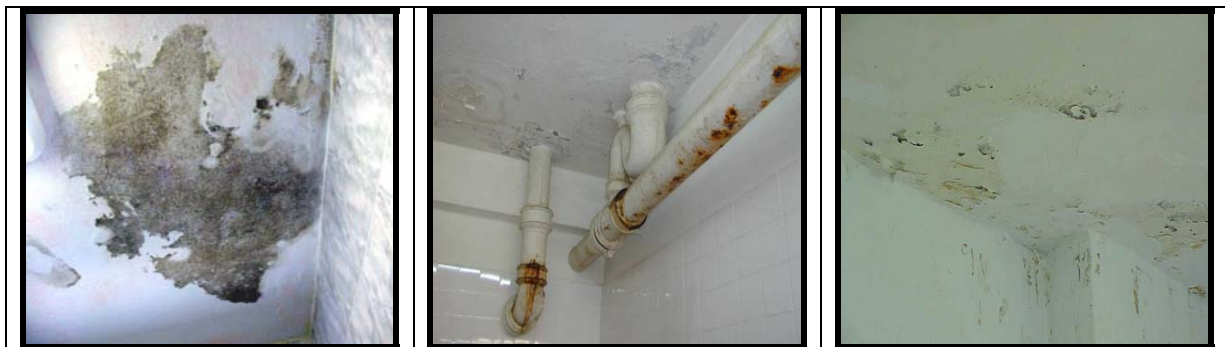
Table1: Interfloor seepage defects

In Singapore, where majority of the building stocks are of full or part masonry construction, key areas experiencing persistent water intrusion defects are interfloor seepages from bathrooms, basements and external wall seepages, with interfloor seepages being the most widespread. Though the percentage of areas occupied by the wet areas (bathrooms and toilets) are usually not more than 10 % of the building gross floor area, the annual maintenance cost for wet areas can range from 35% to 50% of the total maintenance cost of a building (Building Construction Authority, 2000). Typical interfloor seepages are as in Table 1.

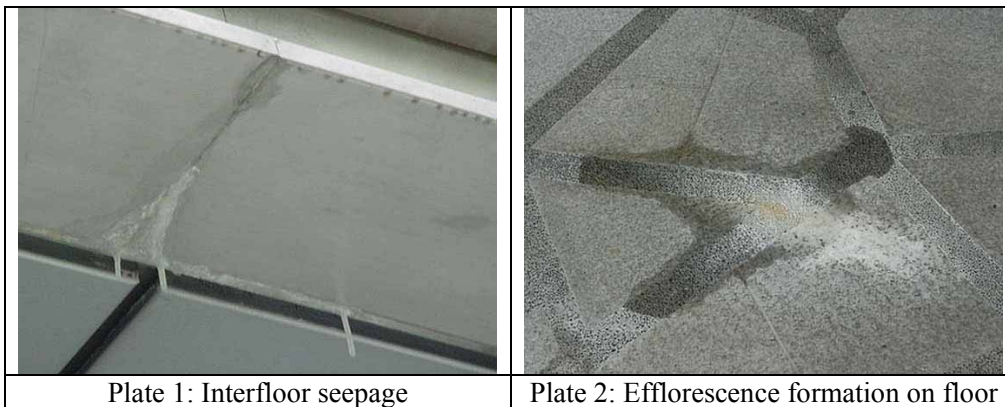
Plates 1 and 2 depict typical signs of interfloor seepage. Works are carried out at existing affected areas with selective drilling locations, coupled with low pressure and gravity, the chemicals were able to penetrate into the cracks and voids without any hacking. Plates 3 to 6 illustrate actual onsite case study of the application of MPI to resolve interfloor seepage. Plates 3 and 5 show application of hydraulic plug to areas where the injected chemical on the top leak out from the underside of the concrete slab. This indicates that the injected chemical has filled up all cracks and void of concrete slab. To complete the system, cementitious waterproofing compound is applied to seal off any large visible cracks and set to cure.
