PRESERVATION OF PRIVATE HOUSES IN FORT OF GALLE, SRI LANKA: A CASE STUDY

This paper reports on a case study of the above project, elaborating on technical implications. Project, having recognised its contribution for preservation of Cultural Heritage, was awarded UNESCO-Asia Pacific Cultural Award 2010 (Merit Award).

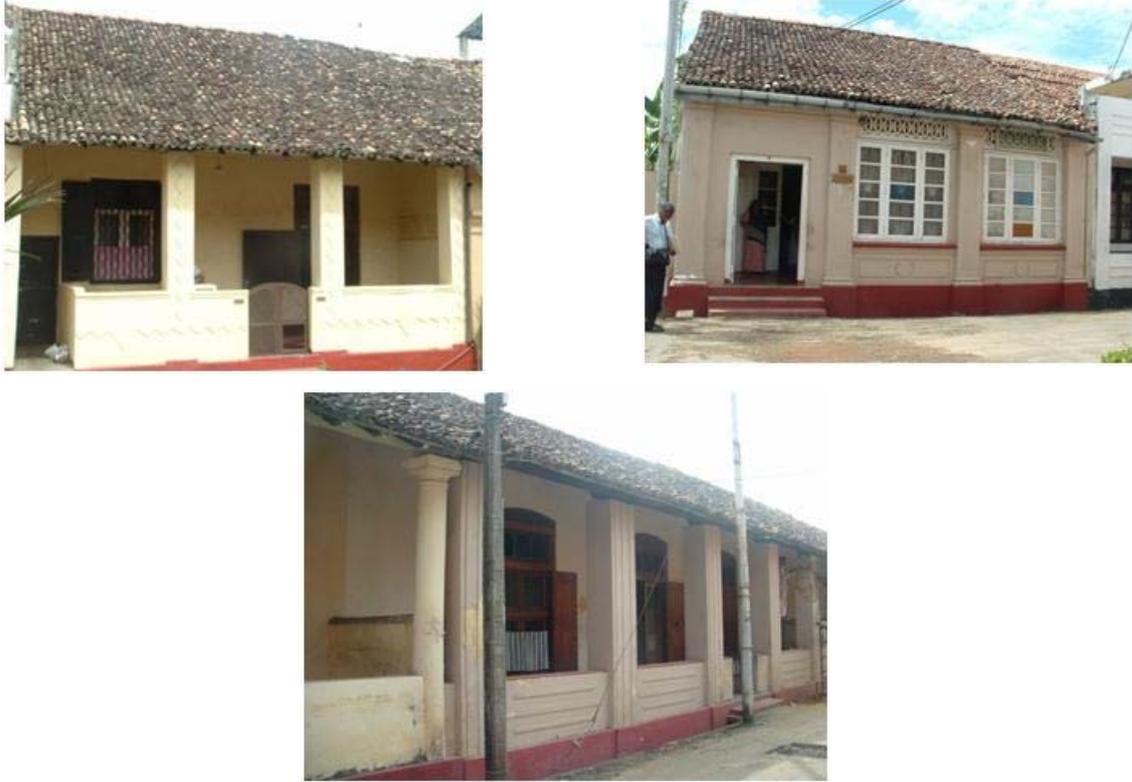
Figure 3: Diverse Building Forms

The large majority of houses that have been studied for refurbishment revealed that they had been either constructed or subjected to major repairs during latter part of British and Early Post-independence Periods. Very few houses could be antedated, but repetitive repairs also have affected their authentic characteristics over the years. None of the houses could be dated to Dutch origin, or early British Period, though they possess some generic characteristics sympathetic to buildings of those periods (Figure 3).

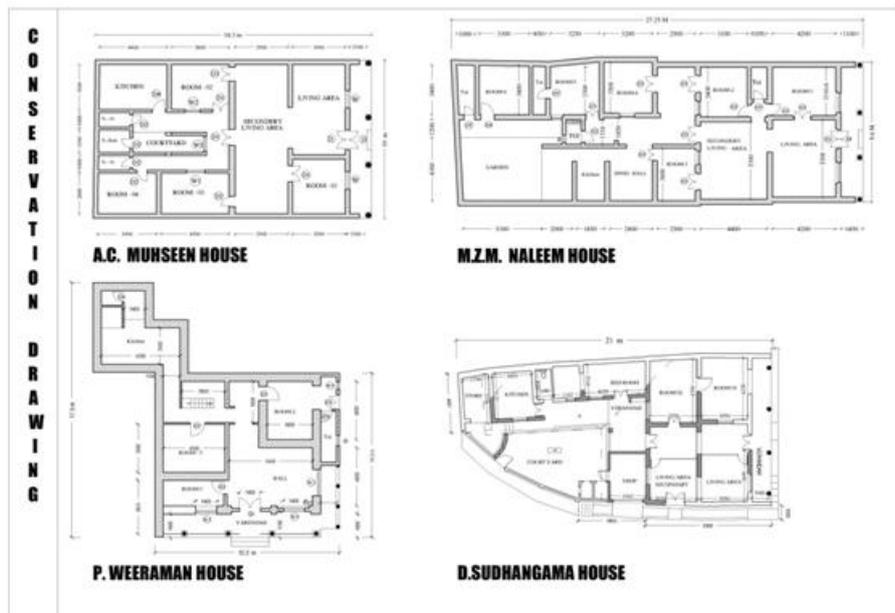
Figure 4: Generic Plan of Townhouse

Irrespective of period of construction, ground plan of domestic buildings within the Fort has some common characteristics (Figure 4). Generic form of the Town House Architecture of a veranda; one or two rows of private and semi-private spaces; a rear veranda; and, utility spaces articulated in a linear form, overlooking an internal courtyard, either enclosed or semi-enclosed.

Generally they had an open veranda, adjoining the street with no open ground space or garden in between them. Veranda is generally colonnaded or arcaded depending on the period of construction and features of the street in which the building is located (Figure 4). Occasionally, a half-high wall, spanning between pillars, protects the veranda. Most common alteration of domestic houses is the encroachment of this open veranda by a high wall up to the roof level, with few windows to bring light and ventilation to the interiors (Figure 4). Occasionally the window or louvers span between the pillars and surmounted on the short wall to convert open veranda into a semi-enclosed veranda.

Behind the veranda is a hall, occasionally divided into two or three different spaces, depending on width the road frontage. Narrow properties have a single space and wider properties the space divided into three with lobby in the centre and two bedrooms symmetrically locating on either sides. The access is provided from the lobby, maintaining the symmetry, and windows are provided on veranda side to borrow lights

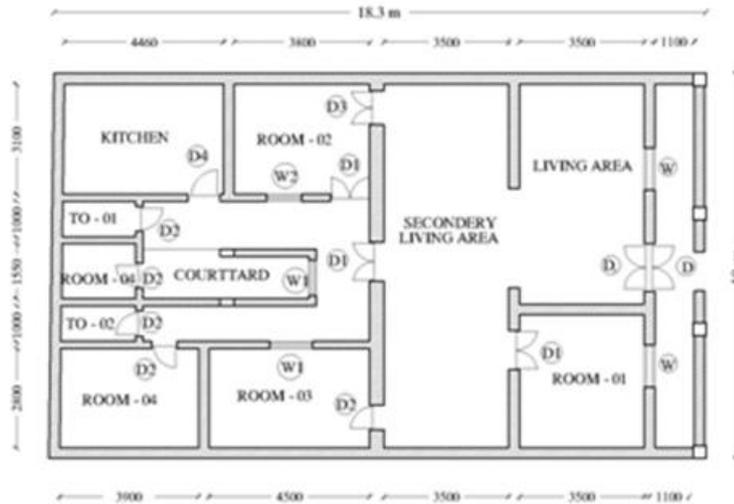
Figure 5: Generic Plan of Two Veranda House

Behind the bedroom layer, in older version of the houses, have a secondary living room, spanning the full width the house, thus ensuring access from other spaces in the second row. In smaller houses as well as in later period houses, the second veranda is missing (Figure 5).

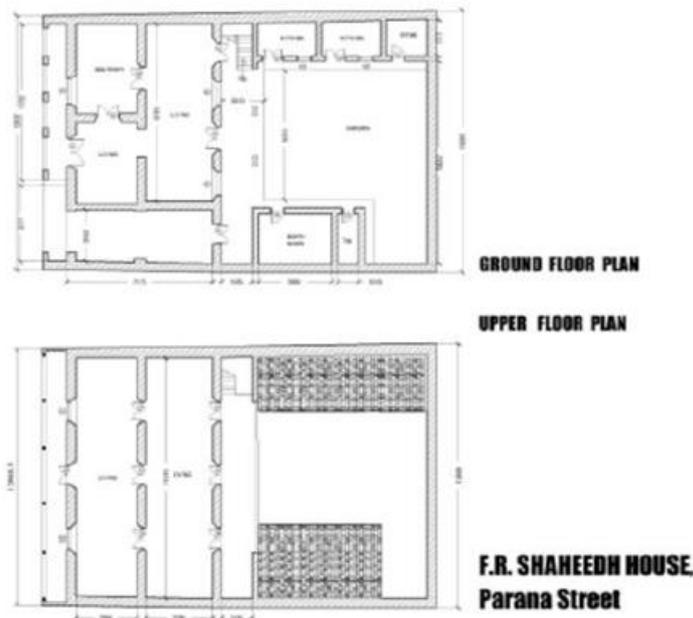
Figure 6: Typical two storied House

In a typical house, one or two rear wings, depending on the width of the property, emanating from the rear veranda and runs up to the rear boundary wall, which is abutting a service alley. In case where there are no rear alleyways, the building ends up with leaving a rear space reservation, around two metres in depth (Figure 6).

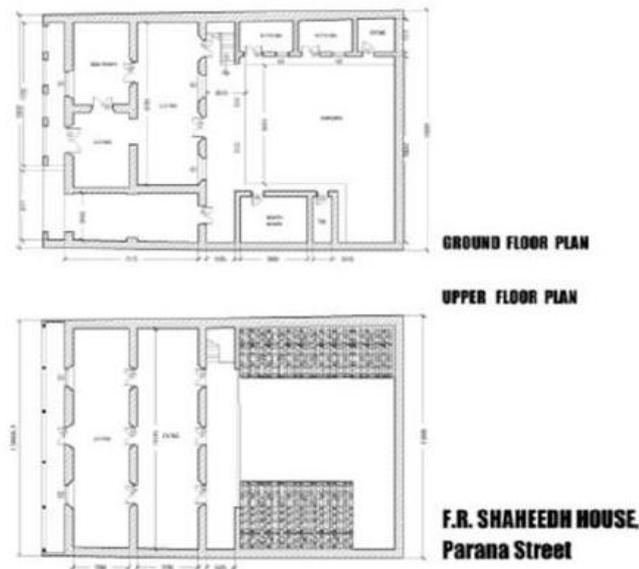
Figure 7: House with Encroachments

In subsequent alterations, mostly illegal, rear space reservation and internal gardens had been encroached. A low pitch roof is constructed over the open space, preventing natural lights and ventilations in to the inner spaces. Though, approval from the local council is necessary for any development within the Fort, occupants are carrying out developments illegally, without informing any institution (Figure 7).

Few residents have encroached into the vertical space too; courtyard is covered by two-storied extension, preventing both natural lights and ventilation into the interiors.

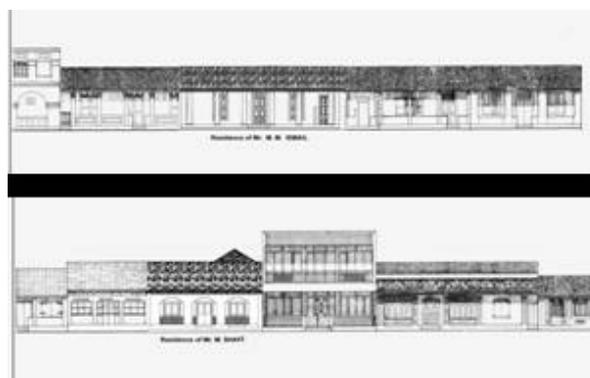
Figure 8: Reintegrated Streetscape

Since funds available for renovation of old houses were limited, main attention was focused on to use them optimally. Project was defined and scheduled as a Rescue Conservation programme. First priority was given for improvements of roof, which was identified as the primary cause for most of deteriorations. Reintegration of the lost streetscape accompanied the improvements to roof. A facade, sympathising with the architectural character of adjoining buildings were introduced to support the renovated roof, and helped in accomplishing the intended task of reintegrating the lost streetscape of fort (Figure 8).

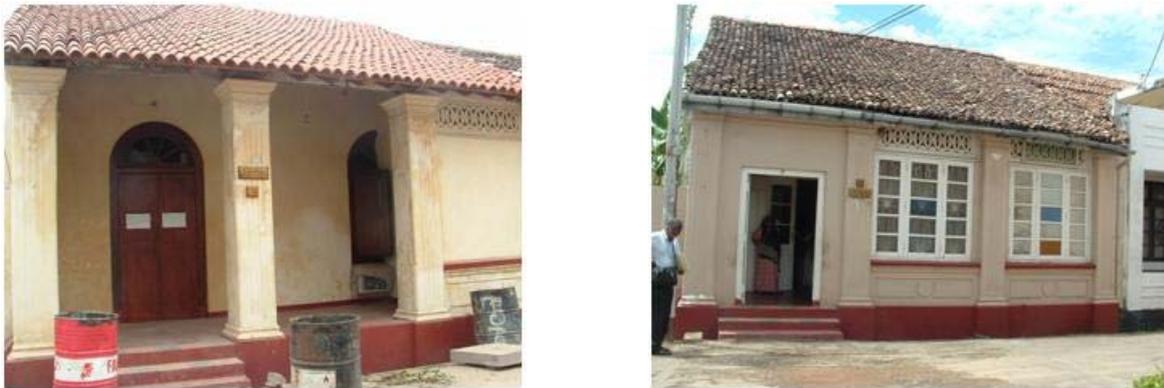
Figure 9: Integration of Timeless Architecture

A timeless style, which resembles Dutch-hybrid architecture of the Fort, was introduced as the key tool for refurbishment works. Though there were initial dislikes, when few houses were refurbished, majority of the residents acknowledged the type of architecture adopted for refurbishments (Figure 9).

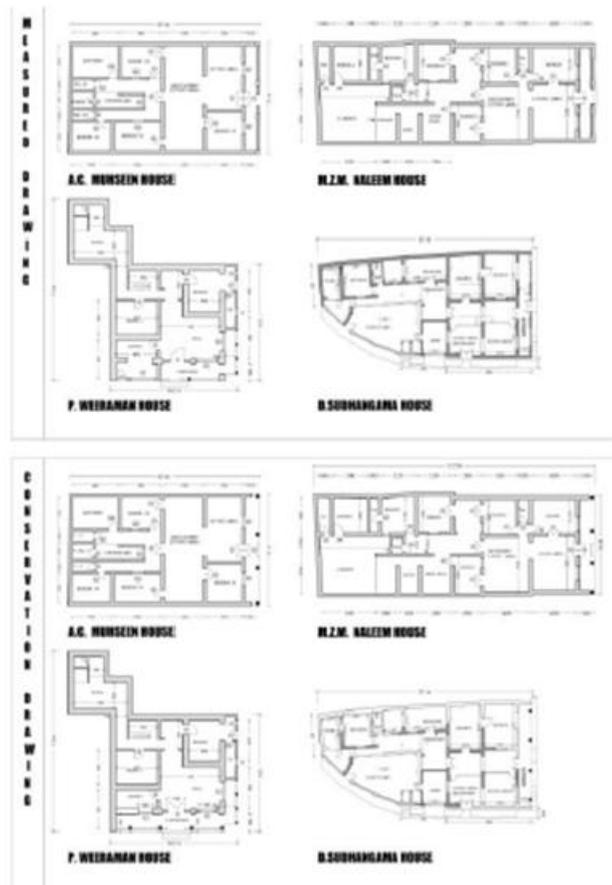
Figure 10: Before and After Veranda Review

Reintroduction of the veranda, which had been one of the key element of Town House Architecture of the Fort of Galle during the foregone period, either fully opened or semi-enclosed, was one of the primary tool used in regeneration of historic atmosphere for streets of the Fort. For this purpose, the existing floor plan of each house was honoured as much as possible, without attempting a complete deviation, except where authentic information available for possible alterations (Figure 10). When the veranda is reviewed, it was guided by the remnants of previous floor plan, for which authentic information could be found from the site itself (Figure 11).
