# Low-Cost Maintenance Approach to High-Rise Buildings: A Critical Appraisal of Low-Energy Refurbishment Scheme in Birmingham

*In an effort to address these issues this paper is being set out to investigate and critically evaluate the modus operandi of low-cost maintenance and refurbishment approach to high-rise buildings in Newtown South Aston area in Birmingham.*

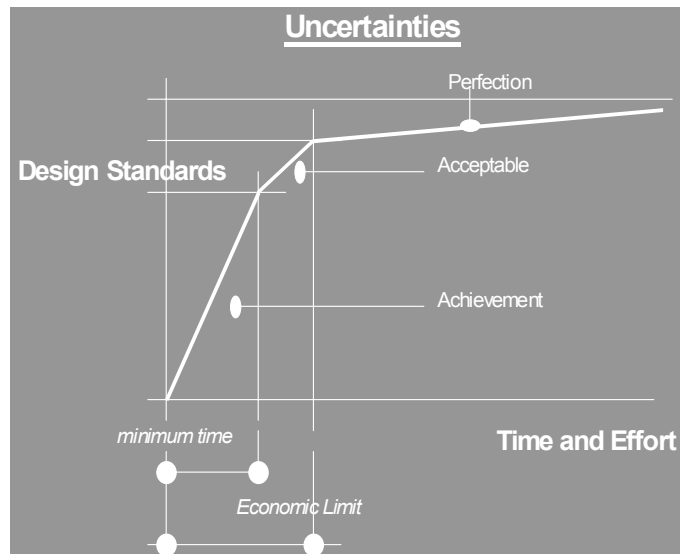
Figure 2: *Acceptable vs. achievable standards*

Clearly there are no absolute standards, which would be equally acceptable, to every over a period of time. The fact is a high-rise building was initially designed and built at lower standards then the standards acceptable at the time when improvement carried out will be more likely to be higher than the initial design standards. There must be an element of improvement to justify such undertaking. It can be argued that such improvement should be performed to bring every part of the building to currently acceptable standards and new way of thinking in the 21 century, which would minimize future maintenance cost.

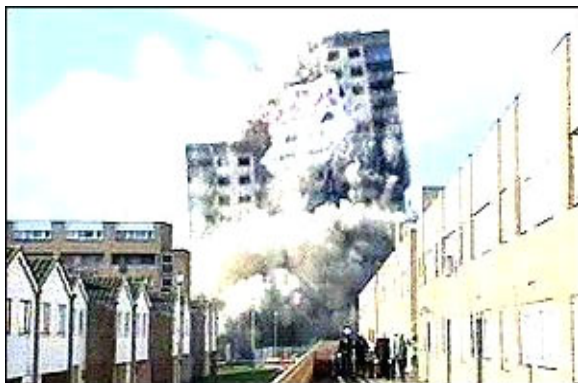
Figure 3: *High-rise has been demolished due to a higher value of the site.*

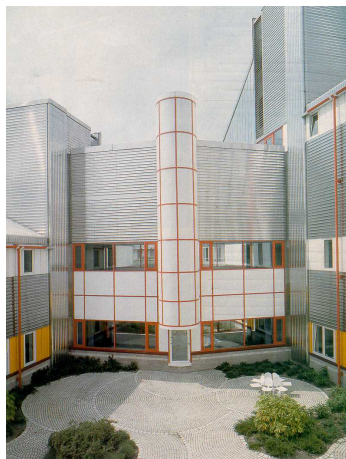
Figure 4: High-tech cladding has a higher capital cost value and might prove difficult to maintain.

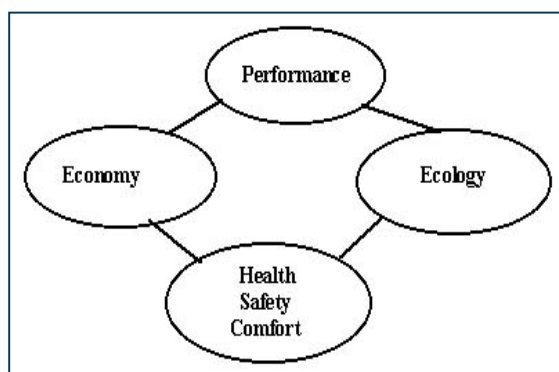
Figure 5: Objectives of low-energy design buildings.

These low-energy design characteristics might include some or all of the following, inter alia,

- Greater reliance on natural means of ventilation including chimney stacks, venting and cooling surfaces.
- Optimisation of natural heating and cooling methods such as thermal mass, solar heating and radiation, ventilated cladding.
- Efficient usage of natural and artificial lighting.
- Flexible use of the building spaces and resources and easiness of upgrading of the building envelope.
- Reuse and recyclability of building materials.
- Use of energy efficient materials and better specification.
