# Condition monitoring and durability assessment of straw bale construction

**ABSTRACT:** The use of straw bales in construction projects is still regarded by many as a novel technique with significant perceived risks. Barriers such as finance, certification and insurance all contribute to further restricting wider adoption. In all of the above cases long-term durability can be considered a prevalent concern. In particular construction industry concerns regarding long-term durability remain a notable barrier to mainstream adoption. Demonstrating the long-term durability credentials of straw bale construction can hence be considered one of the most significant ways of broadening the use straw bale construction within conventional construction markets. This paper presents a review of methodologies for condition monitoring, analysis, and interpretation of results for the short and longer-term assessment of straw bale buildings. The review is supported by research completed at the University of Bath and will help to inform and support future studies whilst also providing new insight into assessment criteria currently being developed.

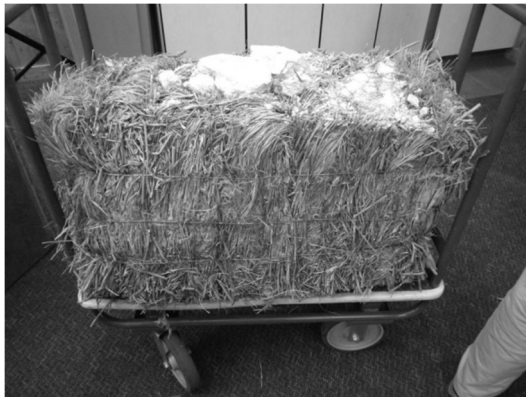
Figure 2. Bale recently removed from Nebraska dwelling built in 1913

It has been suggested that some of the Nebraska buildings may have been built with baled rushes and not cereal crops, which could also have an influence on their durability. Figure 2 shows a bale recently taken from one of these buildings that was built in 1913. This bale was made using twisted wire, was in good visual condition, and is understood to be largely made up from rushes taken from the site of the building though a significant proportion of grasses were also visible.

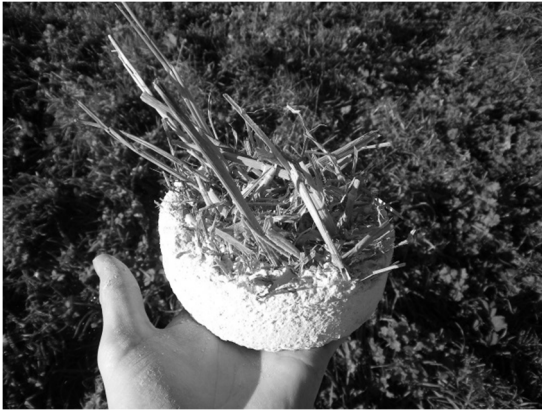
Figure 5. External render core removed from exposure test facility

It is apparent that a significant number of the data points fall above the red threshold for mould growth. It would therefore be expected that a certain level of visual degradation would have occurred within the base of this panel. In order to investigate this further a visual inspection of the straw was made by removing a 150mm diameter core of render at the base of the external face of the panel. This core is shown in Figure 5. It was apparent from inspection of the straw that serious degradation of the straw had not occurred within the base of the panel and the fixity of the straw to the render remained. Some discolouration of the straw was however

apparent which would be associated with previous mould growth. At the time of inspection (November 2012) the gravimetric moisture content of the straw immediately behind the render was 28.4% on a dry basis. Based upon the literature this relatively high moisture content would also suggest that deterioration of the straw would be likely. Nonetheless active signs of decay were not evident beyond a slight dampness to the straw immediately behind the render.
