## **DURABILITY OF PVC ROOFING AND WATERPROOFING MEMBRANES – CASE STUDIES AFTER 40+ YEARS OF EXPOSURE**

PVC membranes have been in use since approximately 50 years. The paper describes three case studies of plasticized PVC sheets in roofing and tunnel waterproofing with exposure durations of more than forty years.

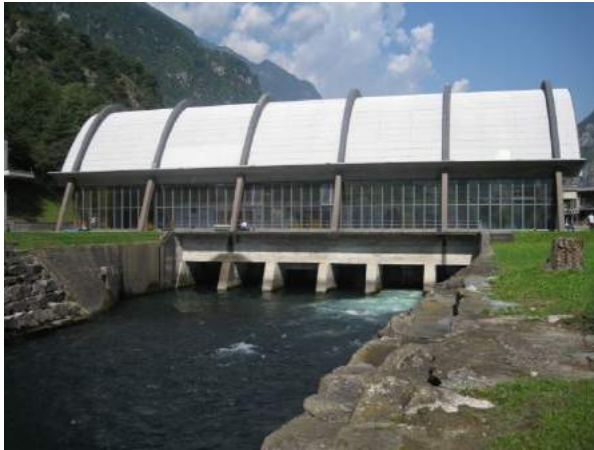
The roof of the hydropower station Nuova Biaschina at Personico/Switzerland was covered with a membrane of plasticized PVC with a fiber glass mat reinforcement. It was produced in 1967 and applied in fully adhered mode with a contact adhesive (Figure 1). A first sampling took place in 2001. The results of the subsequent lab testing were reported earlier [4].

*Figure 1: Hydropower Station Nuova Biaschina at Personico/Switzerland.*

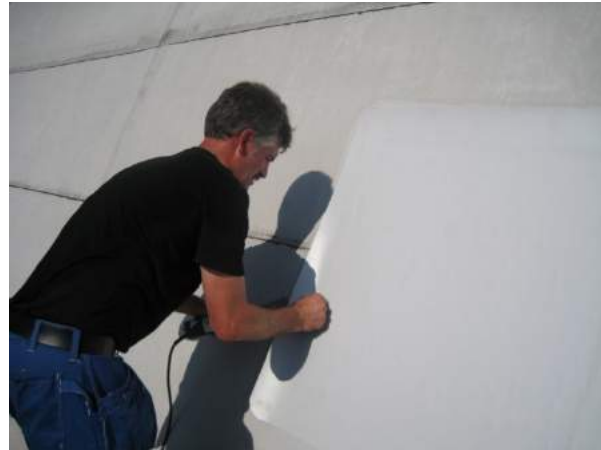
In a second sampling in 2012 pieces of 1m by 1m were cut out and the sampling area was recovered with a freshly produced piece of membrane. Joining the 45 year old membrane with the new one by means of hot air welding was possible without any difficulty (Figure 2).

*Figure 2: Over-welding the sampling area with a new piece of membrane.*

The 45 year old roofing membrane was found to be in a satisfactory state – still fulfilling its waterproofing function without any leakage after this extended period of outdoor exposure. A significant feature is the fact that the sampling area could be closed without difficulty by re-welding a new piece of membrane onto the aged membrane. This is important because it ensures that possible mechanical damages to the aged membrane could be patched.

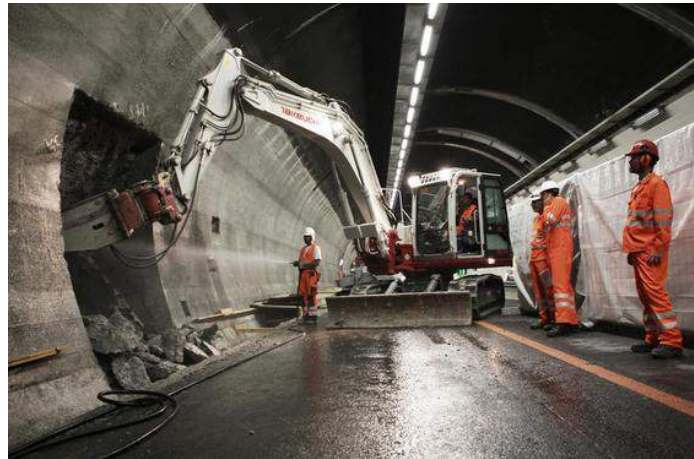
Due to some heavy accidents all the alpine tunnels are being refitted to comply with increased security requirements. One of them is the creation of person escape ports (Figure 10). At the occasion of such excavations the tunnel waterproofing membrane was accessible and samples could be collected.

Figure 10: Excavation of escape port in the Reuss- the Reussportport Tunnel.

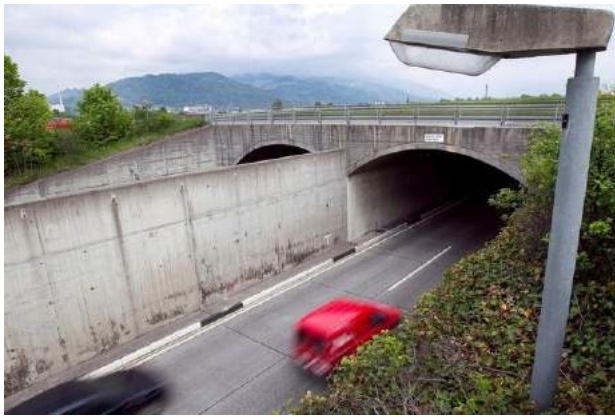
The tunnel Allmend, Thun, is part of the highway A8 connecting the city of Berne with the City of Lucerne (Switzerland). It was built in 1968 in open cut construction mode. It underpasses a military training ground. The tunnel Allmend consists of twin tubes of two lanes each and is 960 m long (Figure 11). Although subject to a first refurbishment in 1991 the tunnel is partially damaged due to its service life of 45 years and requires renovation as well as new security installations. During the planning phase of the refurbishment project samples of the waterproofing membrane were taken by an engineering company to evaluate their actual condition. The engineering consultants handed over membrane samples to the manufacturer for in-depth analyses after 44 years of successful and damage-free service life.

Figure 10: Portal of the Allmend tunnel.

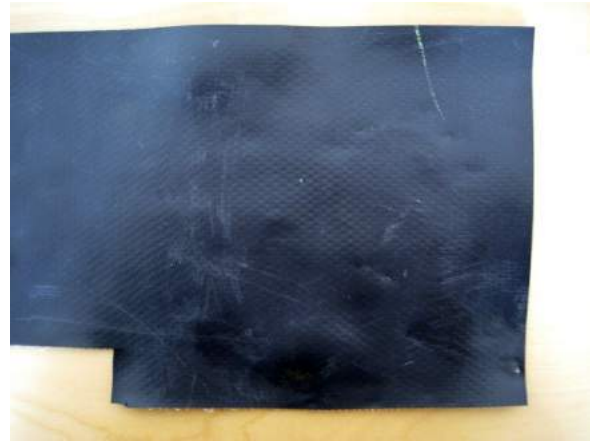
The membrane was manufactured in 1968. It is of black color (Figure 12). As with the Reussport Tunnel a retain sample from that time is available (Figure 7). Six samples of size A3 were received and were tested by the same laboratories as in case study 2 above. The samples are reinforced single ply membranes made of PVC-P, the reinforcement consisting of a fine polyester mesh. They do not show any damage and are in very good and flexible condition.

Figure 11: Sample from the Allmend tunnel.

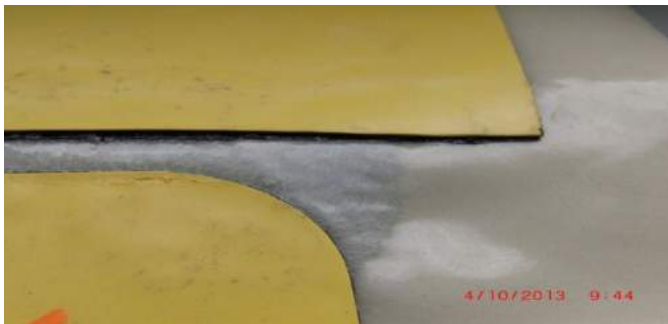
The ability of welding to new membranes was determined by hot air welding samples of PVC membranes from the two tunnels to fresh membrane pieces as actually provided to the market (Figure 12). After cooling down of the seams their strengths were tested by peeling. The criterion of a good seam is that break occurs not within but outside the seam.

Figure 12: Two types of new membranes heat welded to a sample from the Reussport tunnel.
