Analysis of the quality of restoration of buildings with regard to remaining and new thermal bridges

Condensed Report

Report No.: 2-15/2008

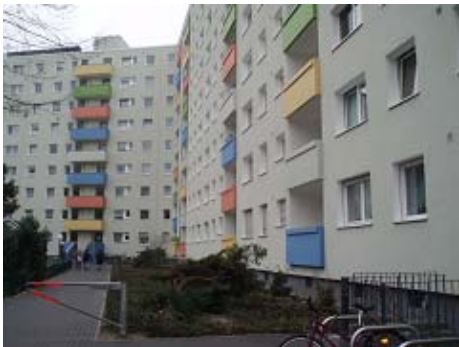
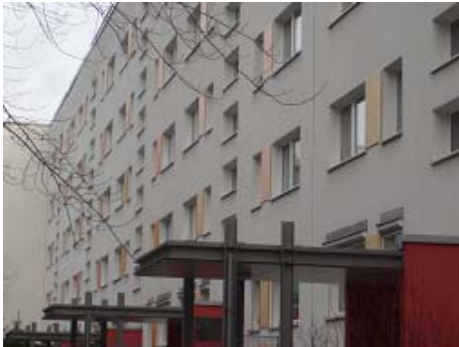
Illustration 1: Selection of representative housing areas and thermograms of a typical thermal bridge

Masonry construction out of hollow-chamber brick

Upper end of building

Panelised structure WBS 70

Lower end of building

The industrially constructed multiple dwelling units were built from the early 1970s until the 1980s and renovated in terms of energy during the period from 2000 to 2006. These are different types of panelised structures. The multiple dwelling units built in the customary manner are masonry buildings out of hollow-chamber and sand-lime brick or solid brick, and were built between 1892 and 1975. The renovation in terms of energy took place from 2002 to 2007 (Illustration 1).

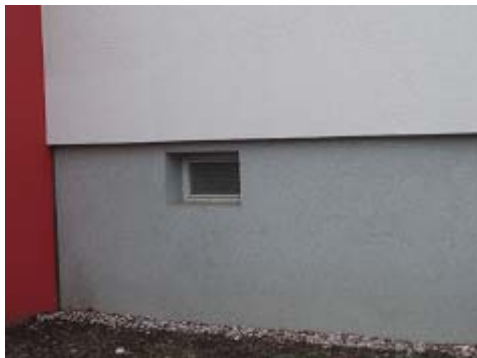
Illustration 2: Thermal bridge with a marked linear thermal-bridge loss coefficient Ψ and relevant conductance L (thermal-bridge loss)

Lower end of building

Photo

Thermogram

Construction

Calculation results

$$f = 0,764$$

$$\Psi = 0,219 \text{ W/(mK)}$$

$$L = 8,14 \text{ W/K}$$

Isotherms

The ascertainment of the effect of thermal bridges after the renovation was the next step in the project. To begin with, a typical multiple dwelling unit (WBS 70) was selected for this, for which all 57 thermal bridges found were calculated by means of acknowledged software (ARGOS). The energy-relevant thermal bridges were probed from the result of these calculations and the comparison with the literature research for this building (10 thermal bridges altogether). All thermal bridges whose percentage of overall thermal-bridge loss was $> 3\%$ were recorded, including overhanging balcony panels, upper and lower building ends and, in addition, under consideration of the window junctions. Deriving from this, 90 comparative calculations were carried out for the remaining multiple dwelling units, only for these energy-relevant thermal bridges. With the software named above, the linear thermal-bridge loss coefficient Ψ (W/mK) and also the temperature factor f for the engineering physical evaluation (mildew formation) were calculated for each individual thermal bridge (Illustration 2).

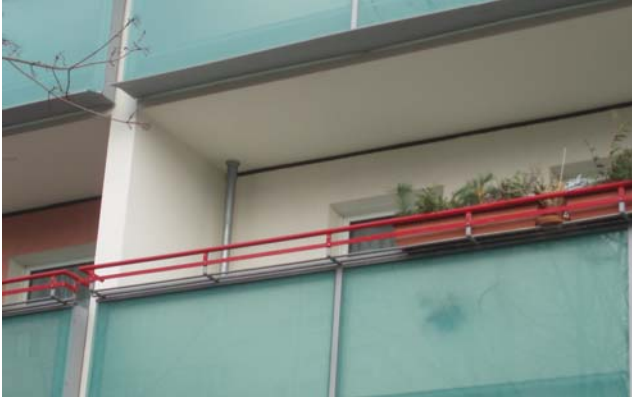
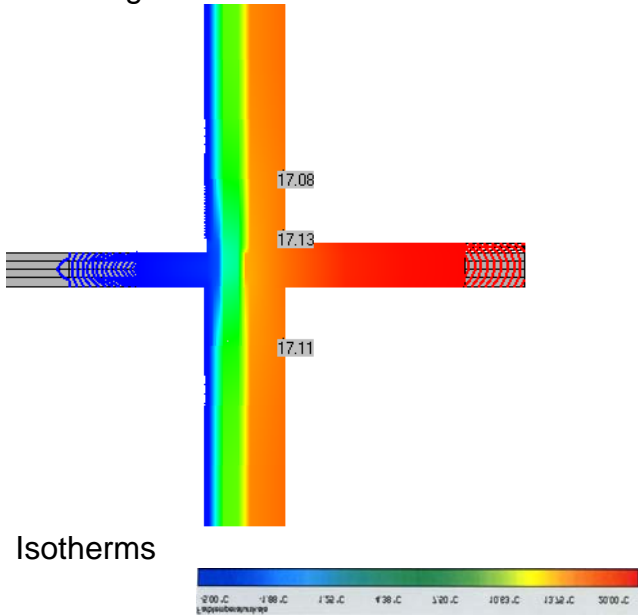
Illustration 3: Thermal bridge with conspicuous linear thermal-bridge loss coefficient Ψ and relevant conductance L (thermal-bridge losses)

Longitudinal exterior wall – storey ceiling with loggia panel

Photo

Thermogram

Construction
Calculation results

$$f = 0,896$$

$$\Psi = 0,213 \text{ W/(mK)}$$

$$L = 35,28 \text{ W/K}$$

Isotherms

The overhanging parts of the existing building represent the most conspicuous thermal-bridge losses in both construction types (Illustration 3). The proportion of the total thermal-bridge loss can be as high as 66 %. When the balconies are newly constructed, thermal-bridge losses via the building parts are present at certain points or are considerably less compared to the remaining housing blocks.
