Wood Corrosion in Historical Roof Constructions

Ascertaining and Classifying the Extent of Damage in Saxony-Anhalt
Developing and Assessing a Rapid Test Procedure (MATE)

Concise Version of the Report

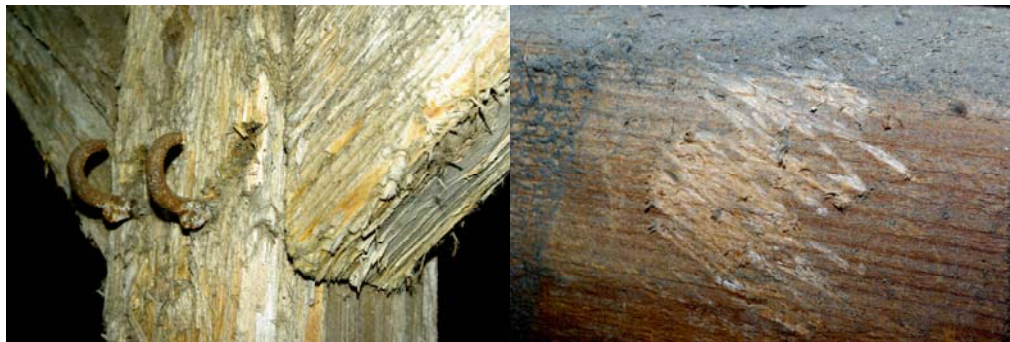
Photo 1 (left) Heavy corrosion

Photo 2 (right) Light corrosion

Wood corrosion refers to fraying in areas of the wood close to the surface. These damage symptoms are found primarily with constructions that were treated with flame retardants.
