Summary Report

**High-precision texture recognition of timber structures
using 3D-ultrasound**

**BAM, Div. 8.2 Non-Destructive Damage Assessment and Environmental Measurement
Methods**

January 2013

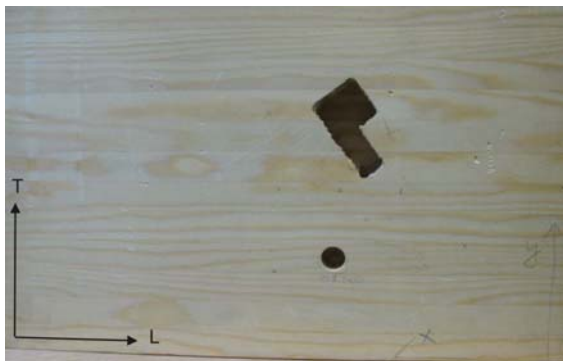
Fig. 1 Large pine wood specimens (specimen X1124) with L-shaped defect (back side)

According to various studies on specimens without defects, an L-shaped defect (dimensions: 7.5 cm x 4.3 cm) was milled in the pine specimens X1124 (dimensions 49.5 cm x 30.1 cm x 14.5 cm) as shown in Fig. 1. The wood specimens were glued together from timber blocks. The measurements using an automated scanner were carried out with a transversal wave sensor with radial wave propagation direction R (radial) with a polarization in direction L (lengthwise or axial)³. The measurement grid was 5 mm.

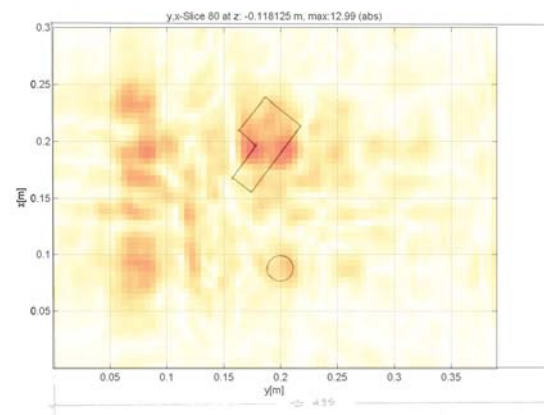
Fig. 2 Surface-parallel section (C-scan, time slice) of a 3D SAFT reconstruction, depth $z = 118$ mm with marked defects location

Fig. 2 shows a surface-parallel section (C-scan) of the SAFT-reconstruction. There, the position of the defects with the reconstruction result is matched. The void is not clearly visible and could not be distinguished from defect indications without prior knowledge.

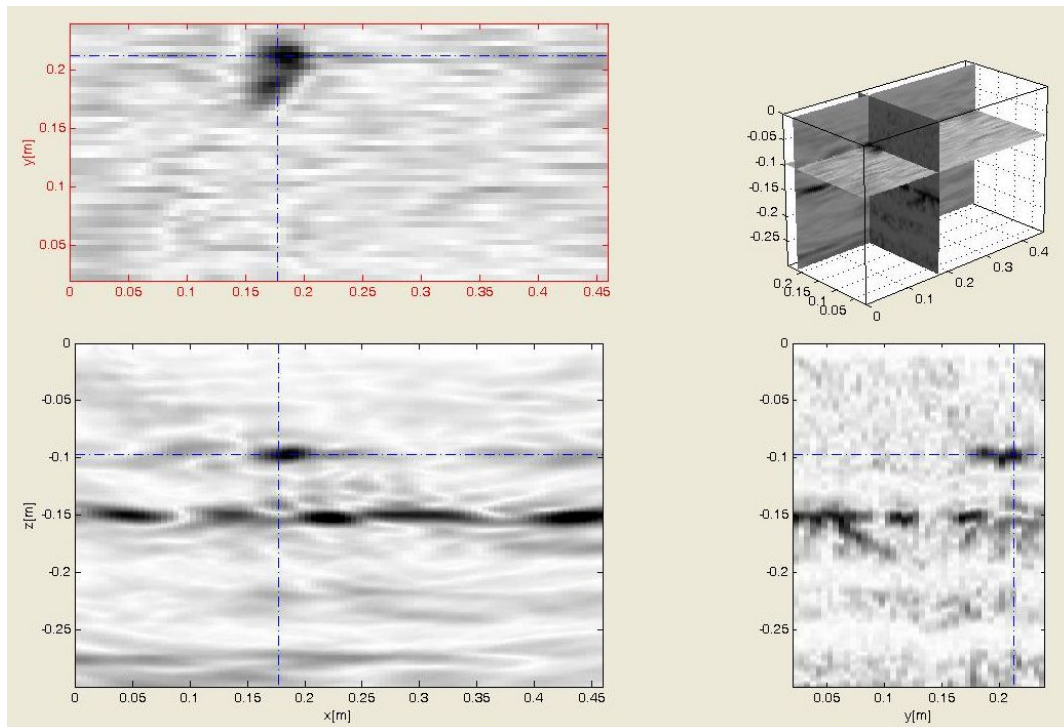
Fig. 5 Pine X1124: Result of the reconstruction bill with experimentally determined velocity profile.

If the calculated velocity profile is considered in the reconstruction calculation, the reconstructed L-shaped defect is displayed as shown in Fig. 5. Here, the position and shape of the defect is clearly visible in the image.

Fig. 5 shows additionally to the reconstruction result of the defect, the 3D representation of the simulation result, too. The planes yx (in Fig. 5, top left), zx (in Fig. 5 bottom left), zy (in Fig. 5, bottom right) as well as the 3-D overall view (in Fig. 5, top right) can be seen. The possibility of a 3-D representation of the reconstructed results of timber components is an important result of the project.

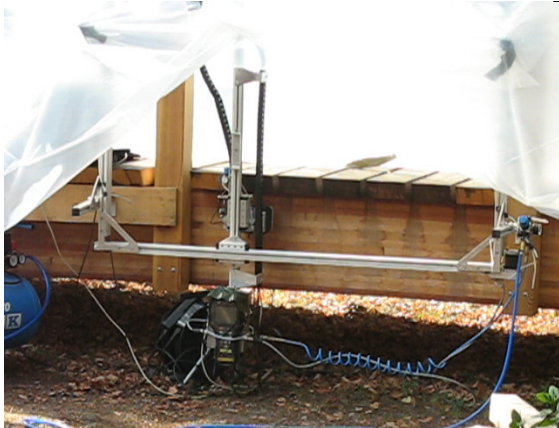
Fig. 9 Automated-scanning system with a commercially available A1220 interface.

The measurements were performed with a scanner (see Fig. 9), in which a transverse wave probe with 1 transmitter x 1 receiver was mounted in TL-polarization. For the SAFT, the velocity was adjusted with an elliptical approach, which was integrated in the evaluation program inter-saft.

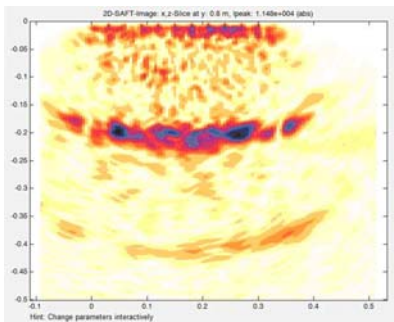
all distances

Fig. 11 Pedestrian bridge made of glulam from Siberian larch. Measurements with the linear array. Left: For the SAFT-reconstruction were used data sets of all 12 probe segments. Right: for the SAFT- reconstruction were used only data sets of probe segments, which had a distance of 12 cm.

Normally, all transmitting and receiving positions are used for the reconstruction calculation as shown in Fig. 11 left. This it means that the half of the matrix of the transmitter and receiver positions is completely selected. Depending on whether less or more different distances are selected for the reconstruction calculation, a more or less good imaging quality of the back wall echo is the
