Development of a methodology for time-resolved 3D mapping of deformation and damage of buildings and structures

Reference Number: **SF-10.08.18.7-10.33 / II 3 - F20-10-087**

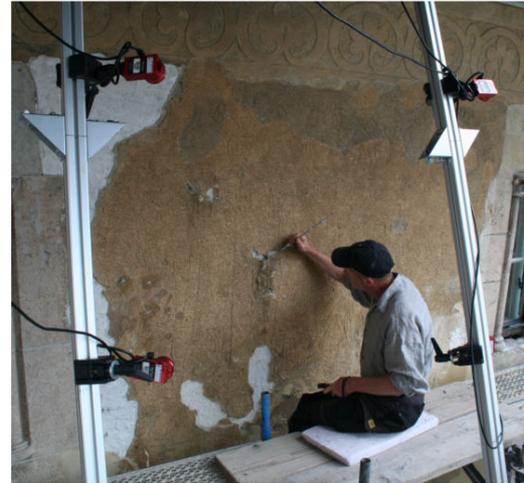
Fig. 1: Tracking system with sensor in use

For mapping of cracks, significantly higher demands are made; i.e. only deviations in the millimeter range can be accepted. To obtain a reliable indication of the actual achievable accuracy of the position, detailed investigations were carried out on the tracking system concerning the accuracy. The different measurements to determine the tracking accuracy have shown that a determination of the positioning of single markers is possible with a precision of ± 0.5 mm. This accuracy can be achieved with a camera set-up as illustrated in figure 1. However, a very good calibration of the camera system is essential.

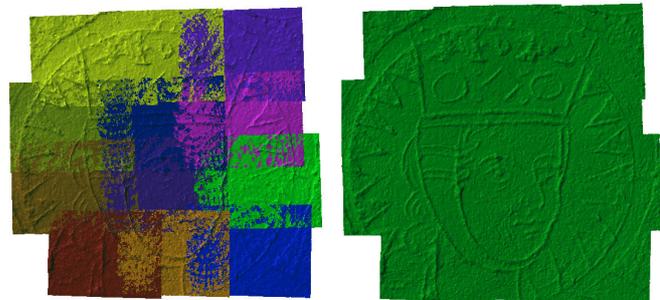
Fig. 2: Results of photogrammetric 3D capturing: Merging of single measurements (left) and the measurement result as 3D data set (right).

An automatic registration was not possible due to the flat topology of the 3D data. Therefore, a manual step for coarse alignment of the data was introduced. For this purpose, corresponding points must be identified and assigned in both data sets, which is facilitated by coloring each texture information of a data set, see figure 2 left. After the manual registration, a fine adjustment is carried out with the "Iterative Closest Point" procedure. In addition, for the registration a fixed overlapping area of the individual images should be set. Here, an overlapping of about 1/3 of the image areas was selected. Finally, using a program the point data were transferred into a triangle mesh, see figure 2, right.

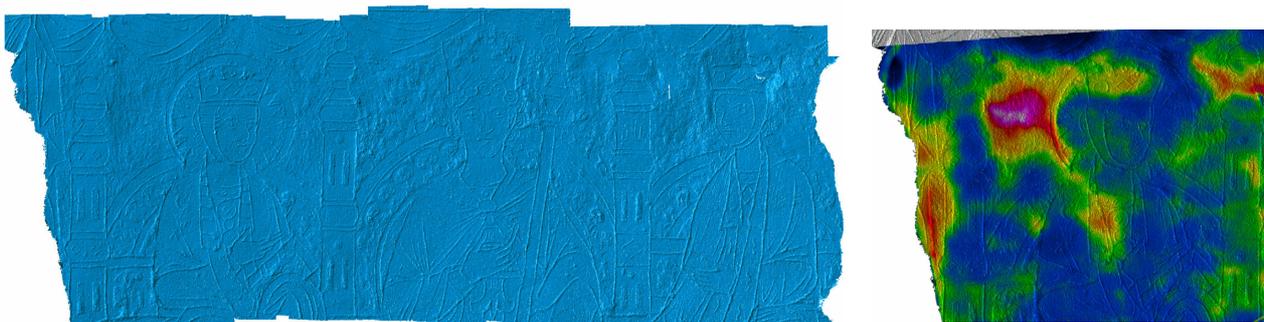
Fig. 6: Visualization of the plaster scratches. Left: triangle mesh as a result of photogrammetry. Right: overlay of a section with a thermogram that was recorded with higher resolution from the scaffold.

The almost complete three-dimensional acquisition of the plaster scratches of the central image was made using the photogrammetric method. Based on the three-dimensional data, visualization methods were tested, allowing a better visibility of the plaster scratches. The measurements were made after the construction of a scaffold on the west facade with very wide walkways. For capturing the central image, a measuring area of 2500 mm x 1000 mm was selected. The sensor was mounted on a tripod in a defined initial height. After each single measurement the tripod was moved horizontally in a pre-defined distance. In addition, care was taken that the sensor was always aligned parallel to the wall. The results of the measurements are shown as visualized 3D data in figure 6, left. A direct overlay of a section of the central image with a thermogram is shown in figure 6 right. The thermogram was taken from the scaffold after heating and therefore shows a much higher spatial resolution than the overview screen in figure 5, right. The larger voids (warmer or red areas) can be easily found from the fusion of the thermogram with the 3D data.
