Solar systems on sloping roofs in the building stock – Summary Account

Reference number: SWD-10-08.18.7-17.08

Short title: Solar facilities on sloping roofs

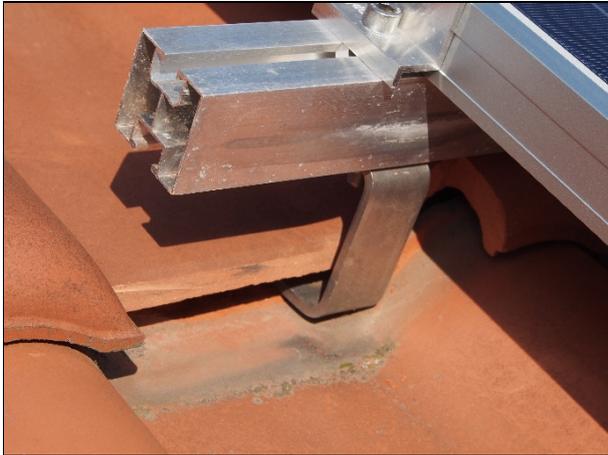
Fastening elements of solar facilities have to go through the roofing layer. As a result, the rain proofing of the material is often unnecessarily diminished.

Fig. 5
The bottom rib of this tile was completely removed, which caused a great gap in the roofing layer.

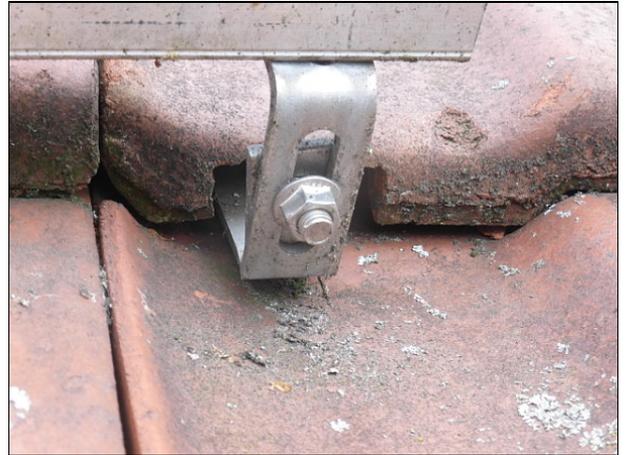
Fig. 6
The bottom rib of this tile was milled off only slightly more than necessary.

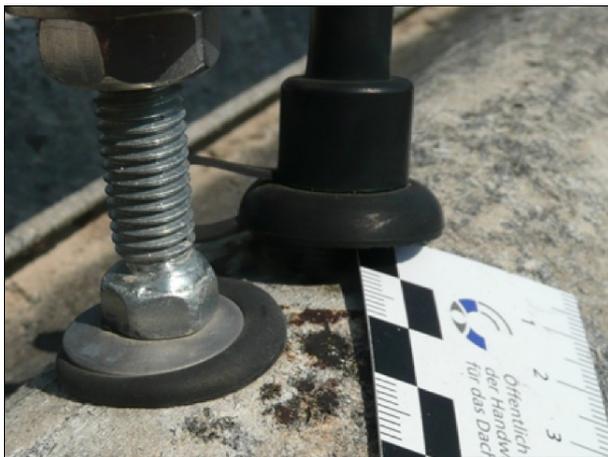
Fig. 7
Due to the new fastening installed closely to the old one, the load was removed from the fixation of the corrugated sheets with the result of leaks.

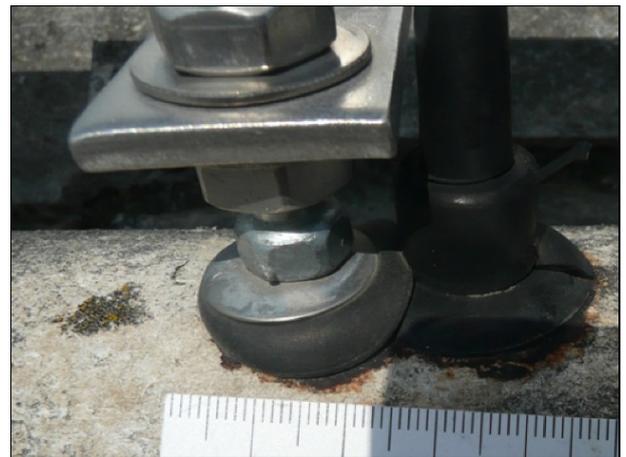
Fig. 8
Waterproofing elements placed one above the other/ screws narrowly fixed to each other led to damage and the risk of breaking
