Case Study of the Cathedral of Aveiro - Defects, Structural Analysis and Rehabilitation Strategies

Abstract

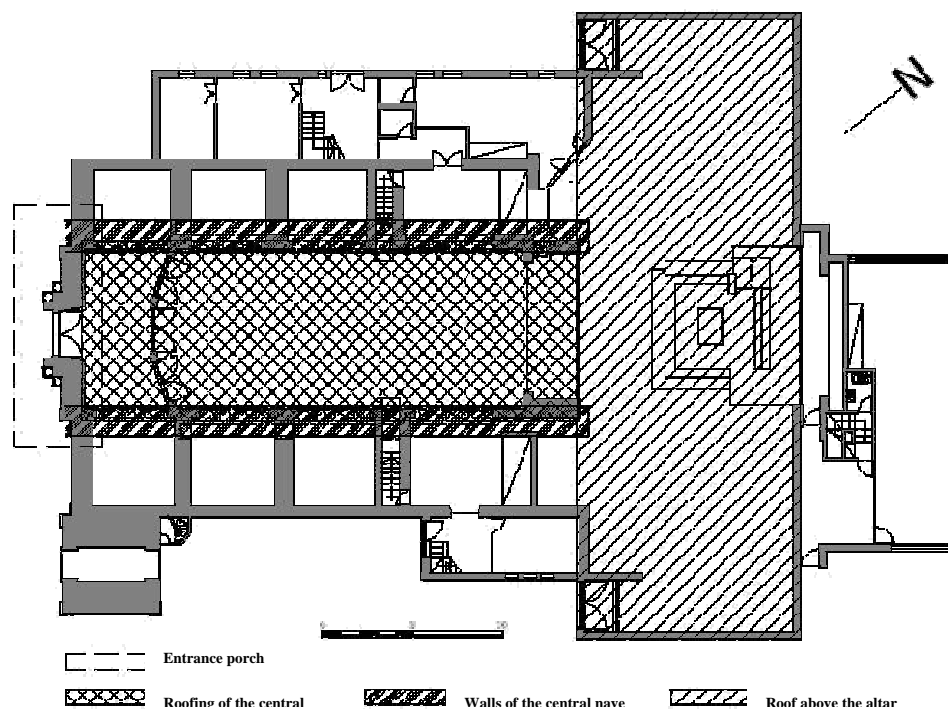
This chapter will detail the main pathologies observed in the building. Figure 2 presents a plan with the location of the different areas of the building where the main problems were observed.

Figure 2: Plan of the building Roof above the Altar entrance porch

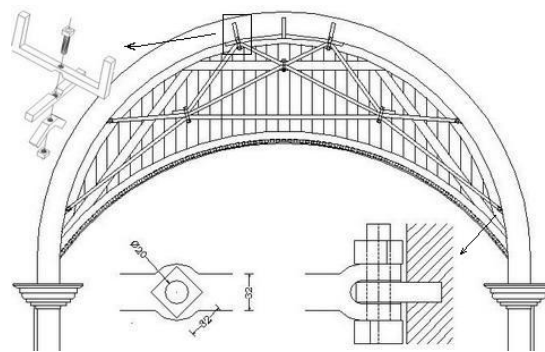
During the maintenance works on the cathedral a structural reinforcement was found in the arch adjacent to the access to the high choir. This structural reinforcement consists of squared iron bars with a cross-section of about 32 mm fixed by 20 mm diameter screws (see Figure 12).

This structural reinforcement might have been built when the access to the high choir was built, or it may have been a later structural intervention to correct the deflection of the arch. This problem is still unsolved and continues to cause cracking. A first analysis suggested this deflection is caused by the progressive deterioration of the arch stiffness due to the creep of the iron structure and loss of the cross-section of the iron bars due to the corrosion over time. The typical cracking generated by the foundation settlements of a masonry wall can also be seen near the access door; it consists of diagonal cracks that initiate and spread from the corners of the door openings.

Figure 13: Structural scheme of the reinforcement of the arch of the lateral chapel
