CIB2007-010

Advances in *ETICS* Behaviour Analysis and Consequences for Planning Maintenance

J. A. Raimundo Mendes da Silva
Jorge G. F. Falorca

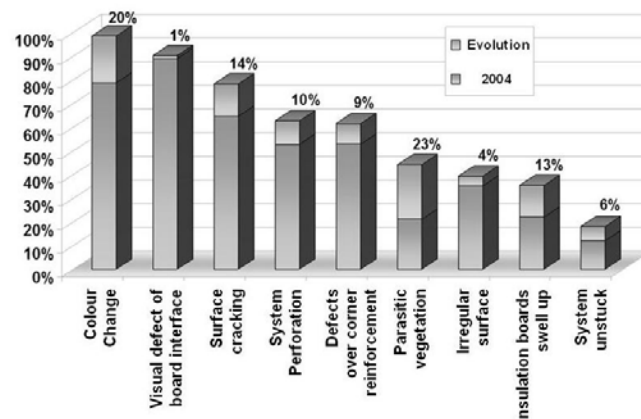
Figure 3.1 General evolution of affected facades by each main defect - case study.

Figure 3.1 presents the general results of the first inspection (2004) and the evolution of the main defects (2006) for all the facades of the selected buildings. Three types of defects affect more than 50% of facades: colour degradation, irregular surface and cracks. Loss of adhesion between insulation boards and the masonry wall is the less observed defect.

The number of facades newly affected by each defect in the last two years is between 1% (for visual defects at the insulation board interfaces) and 23% (for parasitic vegetation) with a mean value of 11%. Also important is the colour change and dirtiness (due to rain water and contamination of atmosphere) that reach almost all the facades after this period of time.

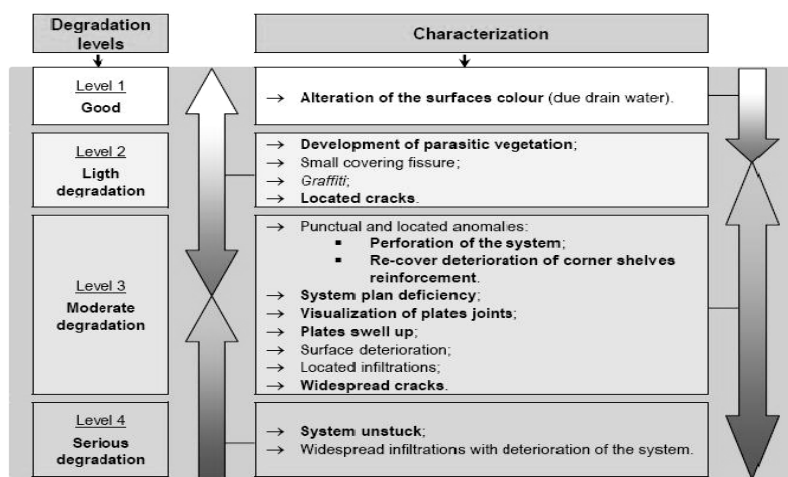
Figure 3.2 Degradation levels, according observed defects (Falorca, 2004).

The harmful effect of these anomalies is not proportional to the percentage of affected facades, since their evolution and their predictable contribution to reduce wall physical performance is quite variable. Based on Gaspar (2002), it was created a graphical scale of anomalies (see Figure 3.2), with four levels of degradation, where each kind of defect is considered.

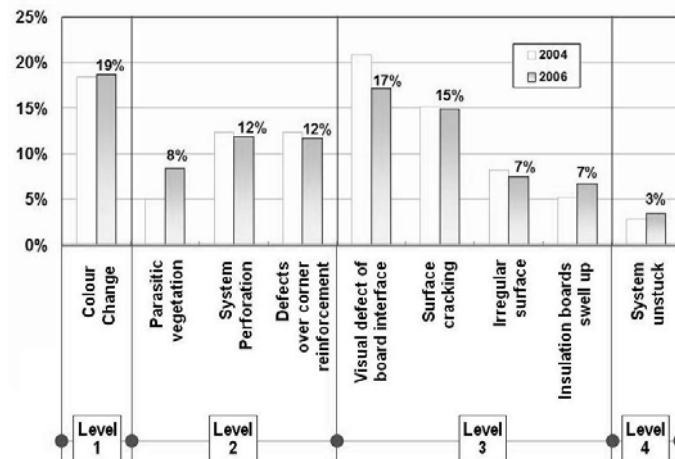
Figure 3.3 Evolution of relative importance of each defect distributed by degradation levels

Figure 3.3 represents the proportion between all nine different main defects, grouped according to these conventional graphical scale of anomalies. In spite of the different evolution for each defect, the general layout is the same for this period of time and it clearly shows that degradation level 4 is quite insignificant, while level 3 groups 46% of detected anomalies.

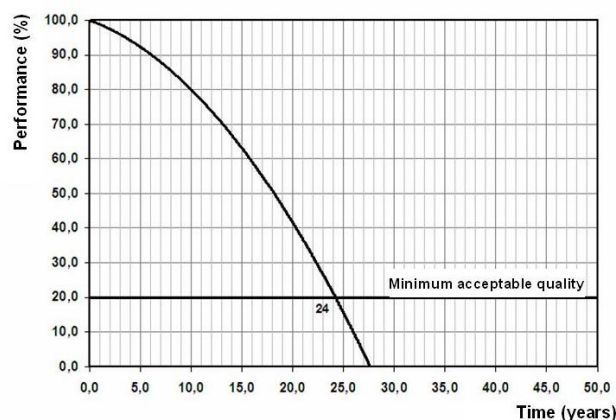
Figure 4.1 Degradation curve proposed for *ETICS* without maintenance (Falorca, 2004).

However, if we accept a conventional homogeneity of the system, some assessment tools (ISO 15686-1,2000; Sjøtrom *et al.*, 2002; Architectural Institute of Japan,1993) are available and, in conjunction with the reference state behaviour, it is possible to suggest a theoretical degradation curve of *ETICS*. Figure 4.1 represents the degradation curve of the system, without any maintenance action - also based on similar models (Flores, 2004) – what leads to a Life Time of 24 years for a minimum performance of 20%, with total failure at 28 years.

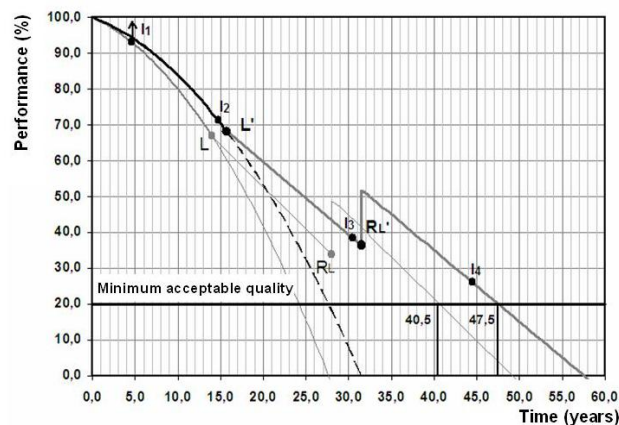
Figure 4.2 Example of degradation curve proposed for *ETICS* under a specific maintenance scenario - (Falorca, 2004)

Figure 4.2 shows the degradation curve for one of the simulated scenarios of maintenance for *ETICS*, according *PIMEC*. In this specific case, a global cleaning action is considered at the 14th year (half of the predictable minimum life time), followed by a light rehabilitation at the 28th year, resulting on 70% increase of predictable life time (reaching, here, 48 years).
