APPLICATION OF FSE DESIGN METHODOLOGY TO THE RESTORATION AND EXPANSION OF A MODERN HISTORIC BUILDING

Yuji Hasemi and Atsuyuki Ida**, and Masatoshi Nakamura**

An application example of the Fire Safety Engineering to the ongoing design of the restoration and expansion of a modern historic building in the central Tokyo is introduced. Design results are compared between the engineering-based strategic design and a straight application of the conventional specification-based fire safety regulation. Use of engineering concepts leads to a full restoration of the interior design of the original building, while direct application of the specification standard has resulted in spoiling the design features of the historic landmark.

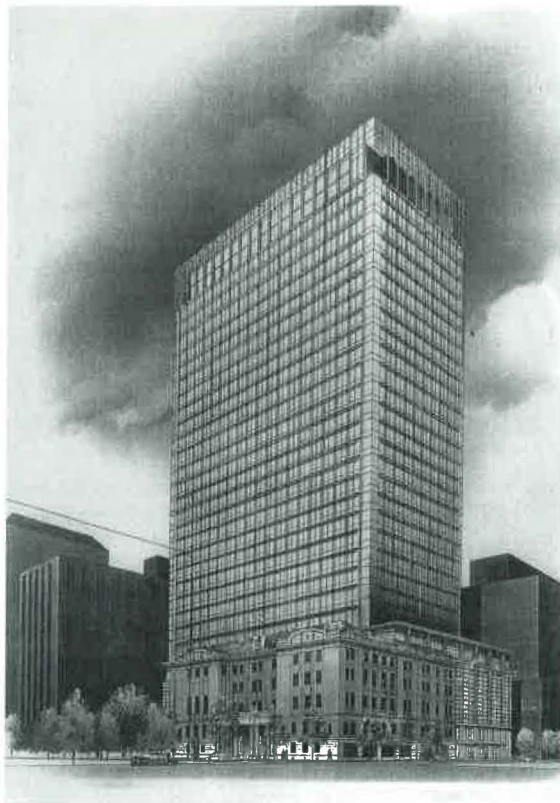
Figure 2 Plan View of the Restoration and Expansion Project

Active movement has been organized by civil and cultural societies and architects to save the building since redevelopment of the block surrounding this building began to be considered in the early 1990s. Partly for the need of seismic protection of the building and partly for the redevelopment of the surrounding block, it has been decided to reconstruct load bearing structural members of the major part of the building and build a high rise office behind the building, while the most interior design of the building has been decided to be restored. The building was closed in early 2000, and the design for the restoration and expansion is going on since 1999. Figures 1 and 2 are the recent view of the building and planned view of the expansion project. Floor plans of the present and renovated building are as shown in (a) and (c) of the Figures 3 through 7. Approximately one fifth of the present building, the part containing the major functions such as main dining room and the auditorium, will be totally restored, and additional around 50% of the present building, including the open stairwell, will be rebuilt for structural reasons but its interior and exterior design are planned to be restored. Rest, 30% of the building, consisting of relatively small compartments behind the open stairwell, will be removed and replaced by a part of the high rise office building.

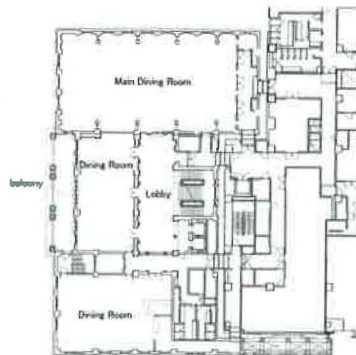
*3rd Floor
Present plan
S 1/750*

*3rd Floor
Designed according to
Specification Regulation
S 1/750*

*3rd Floor
Designed with FSE
concepts and tools
S 1/750*

Figure 8 is a summary of this strategy, and the resultant floor plans are shown in (c) of the Figures 3 through 7. The upper part of the stairwell is planned to function as a smoke reservoir by closing automatically the border on the fourth and fifth floors by the screen shutter when smoke due to a fire on

These should be enough for the evacuation of all those in the lobby to the corridors if they are properly informed of the emergency. Layout of the evacuation staircases has been studied for the economy of the number of staircases since the resignation of the stairwell as the evacuation route may automatically need a substitute staircase. Figure 11 is the result of the rearrangement of the evacuation routes on the 3rd floor, in which even the evacuation routes in the high rise building part is rearranged for the harmonization of the evacuation planning of the restored and newly developed parts of the building. Such rearrangement of the evacuation routes on each floor, without using the stairwell, has finally led to rather decrease of necessary staircases as seen in Figures 3 through 7.

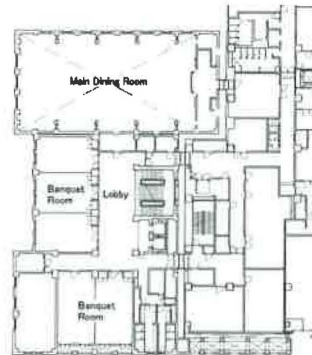
4th Floor
Present plan
S 1/750

4th Floor
Designed according to
Specification Regulation
S 1/750

4th Floor
Designed with FSE
concepts and tools
S 1/750

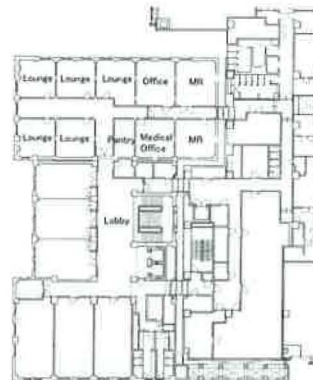
5th Floor
Present plan
S 1/750

5th Floor
Designed according to
Specification Regulation
S 1/750

5th Floor
Designed with FSE
concepts and tools
S 1/750

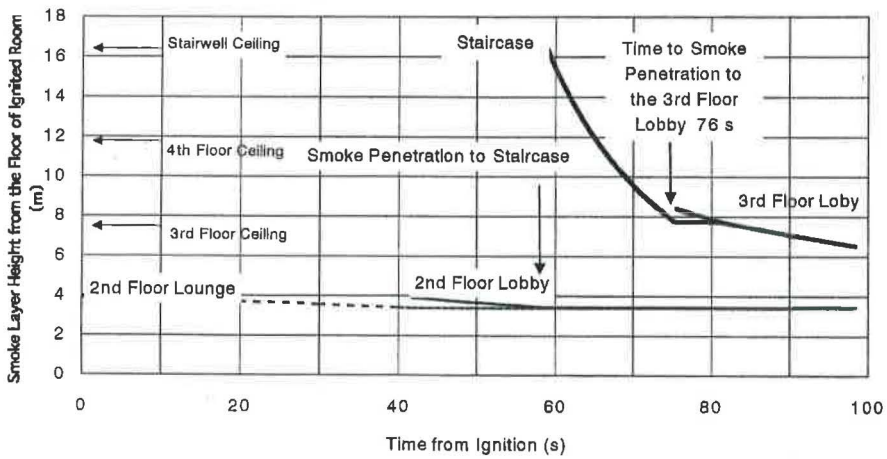
Figure 9 Predicted Smoke Filling in the Stairwell due to a Fire in the Lounge on the 2nd Floor

Figure 9 is a result of smoke filling calculation using a two-zone model for the stairwell and the adjacent lobbies assuming a fire source on the second floor and no-smoke extraction in the stairwell. A standard fire source which has been used for FSE oriented fire safety design in Japan, as shown in Figure 10, is assumed, as the fire load in the 2nd floor lobby is rather limited. Even if the smoke extraction in the stairwell does not operate, penetration of the smoke to the 3rd floor lobby occurs only 76 seconds after the initiation of the fire and the height of the smoke layer on the 3rd floor reaches 2m from the floor at around 100 seconds.
