## **Experiences of the Durability of Wooden Houses in Finland**

### **J. Heikkilä**

University of Oulu, Department of Architecture  
Box 4100, FIN-90100 UNIVERSITY OF OULU, Finland  
[jari.heikkila@oulu.fi](mailto:jari.heikkila@oulu.fi)

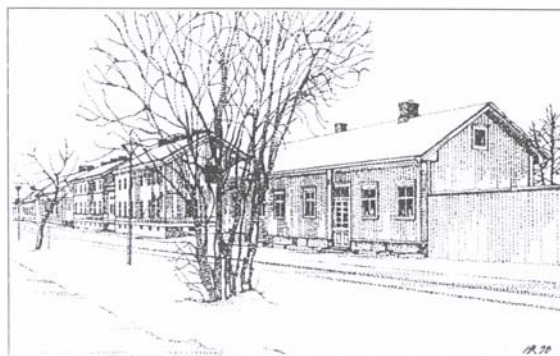
**Figure 1. Log houses of wooden towns are one- or two-storey. Their roofs are steep, facades are boarded over, and they have a high base.**

The traditional Finnish wooden house has been a log house, in which horizontal logs have simultaneously comprised the load-bearing structure of the walls, thermal insulation and, often, the interior and exterior cladding. Log houses contained a timber-framed floor that had a ventilated crawl space; for insulation of the floor, natural materials such as moss were used at first, later sawdust. The ceiling has been similar in structure. It must be remembered that originally there were no wet areas at all in these buildings. The sauna and related washing facilities in traditional construction have always been located in separate outbuildings. Log houses have been wood-heated; fireplaces that generated strong ventilation were built into the rooms. Efforts were also made to make log houses air proof. That is why people began to coat the interior with cardboard and wallpaper and cover the exterior with boards. These log houses have proven to be long-lived if their roof is kept in good condition. Damages have been found in the crawl space when ventilation has been insufficient or surface water has gone under the house or the ground has been exceptionally wet. This way of building prevailed in Finland until the beginning decades of the 1900s. [Heikkilä 2003], [Kääriäinen *et al.* 1998].
