Salt Crystallization Tests on Brick Masonry Reinforced by CFRP Textiles

ABSTRACT

Brick masonry, FRP repair, durability to salt solutions

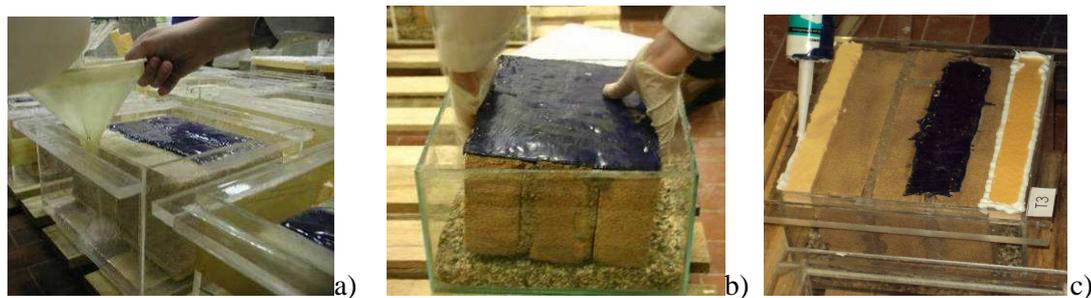
Figure 3. Details of the test: a) salt solution addition b) positioning of the specimen on sand, c) sealing of the box,

The test was carried out according to the Recommendation RILEM MS A.1 [RILEM MS A1, 1998]. The wallettes (approx. 250x200x120 mm), were put in contact with their bottom side with a 10% (w%) Na_2SO_4 solution (anhydrous Na_2SO_4 reagent grade, Fluka)(Fig. 3a) and then stored over a layer of dry gravel in a plastic container (Fig 3b) open at the top, sealed along the borders (Fig.3c) with the upper face exposed to the environment (controlled laboratory environment of 20°C and 50% R.H.).

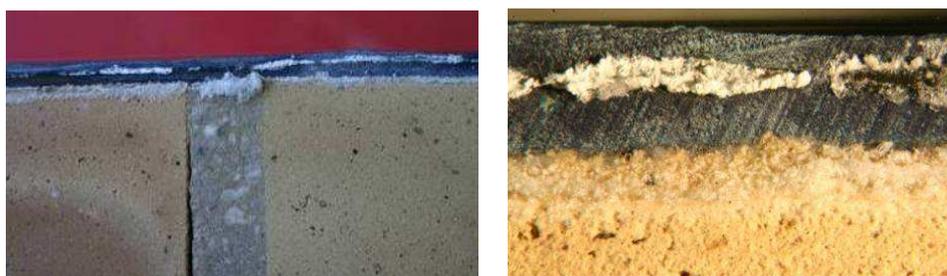
Figure 10. A vertical section of the specimen upper surfaces. Subefflorescence at the depth of penetration of the primal into the brick and within the FRP strip

Specimen S5a was cut in order to check the results of thermography (Fig.9) It is possible to see that the salts crystallise underneath the external surface causing a double damage: a) at the penetration depth of the primal and b) within the FRP itself with its delamination and detachment from the masonry specimen.
