# Settling and acceptable size of gaps in loose-fill thermal insulation in walls

J. Cammerer & M. H. Spitzner & G. Treiber & H. Schmitt & S. Heinz FIW München, Forschungsinstitut für Wärmeschutz e.V. München, Gräfelfing, Germany

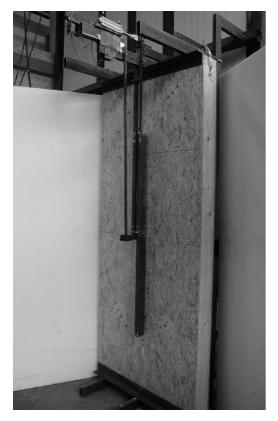
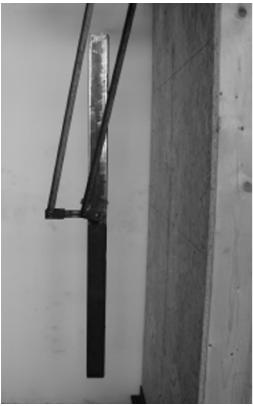
Figure 1. Pendulum test rig with wooden wall.

The pendulum consisted of a metal pipe with rectangular cross section filled with sand. The kinetic energy of the pendulum resembled that of a standard house entrance door with a weight of 60kg which hits the door frame at a speed of 0.5 m/s. This test condition is also used for durability tests of doors and hatches according to DIN EN 1191 [4]. The pendulum was pneumatically displaced in a movement parallel to the wall surface and hit the wall surface perpendicular with the area of contact having a height of 1.5m. A strip of cellular rubber between on the pendulum surface simulated the rubber damper within the door frame.

The test was automatically repeated 33.000 times corresponding to roughly 9 years of usage with 10 hits a day. The tests were carried out both on previously transported and on newly filled walls. A photograph of the test rig is given in Figure 1.

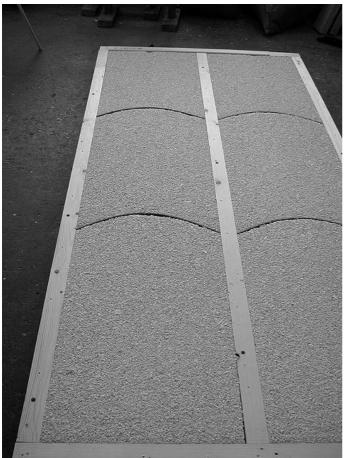
Figure 3. Opened wall with wood shavings after tests.

The two walls tested were filled and delivered to the institute by the manufacturer. In order to reduce the load on the insulation material in the lower part of the wall due to its own weight two plywood panels have to be used to separate the insulation chamber into three nearly equally sized compartments. Immediately below the panels and the upper wooden frame the material settled approximately 5mm. The density of the material was well within the limits set by the techical approval. Figure 3 shows the opened wall after the experiments.

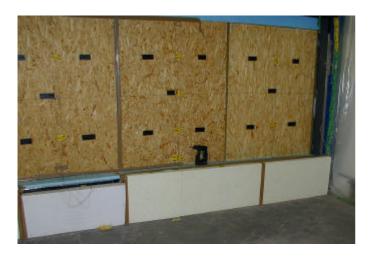
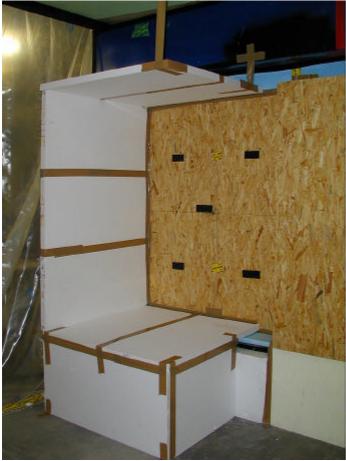
Figure 4: Top: 3 wall elements in double climate chamber (seen from warm side). Bottom: simulated corner (ceiling, wall, floor).

Wooden pre-fabricated walls with various insulation materials were tested in a double climate chamber under stationary temperature difference (+20°C front side, -15°C rear side; see Figure 4) in order to study the effect of gaps in the insulation on surface temperature and to assess the risk of water vapour condensation and mould growth [5]. The walls were on purpose equipped with various holes in the insulation layer to simulate gaps from settling and bad filling. The temperatures on the warm side wall surface and within the walls were monitored by means of thermocouples and with infrared photography.

In order to study the effect of gaps in the insulation combined with increased interior surface resistance (in corners, behind cupboards) in a number of tests the wall elements were equipped with additional panels simulating the adjacent wall, ceiling and floor, see Figure 4. In a number of experiments empty wall elements were placed immediately next to the inside surface of the walls under test to simulate cupboards.

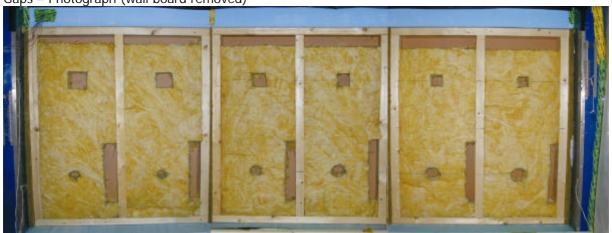
Gaps - Photograph (wall board removed)

Figure 5 gives an example of the experiment documentation with the size of gaps within the insulation layer and with the effects on surface temperature. The photograph at the top of the page shows the 6 compartments under test from the warm side before the experiment; the inside board is removed (for the experiment the inside board is replaced). The size of the gaps differs in all compartments: the horizontal gap at the top of the compartments and the round hole in the insulation in the bottom part of the wall get bigger from left to right; the vertical gap at the right edge of the compartments and the square hole get smaller from left to right.
