OBSOLESCENCE AND DEMOLITION OF LOCAL AUTHORITY DWELLINGS IN THE UK – A CASE STUDY

Helen Bowes (Telford Institute Of Environmental Systems, University of Salford, UK), and Bryn Golton (Faculty of Architecture, University Vasco de Gama, Portugal)

The demolition of the Jespersen Street flats, part of the St. Mary's Estate in Oldham, North West England, began in June 2000. The 132 flats were contained in a five storey pre-cast concrete framed block, erected in 1967.

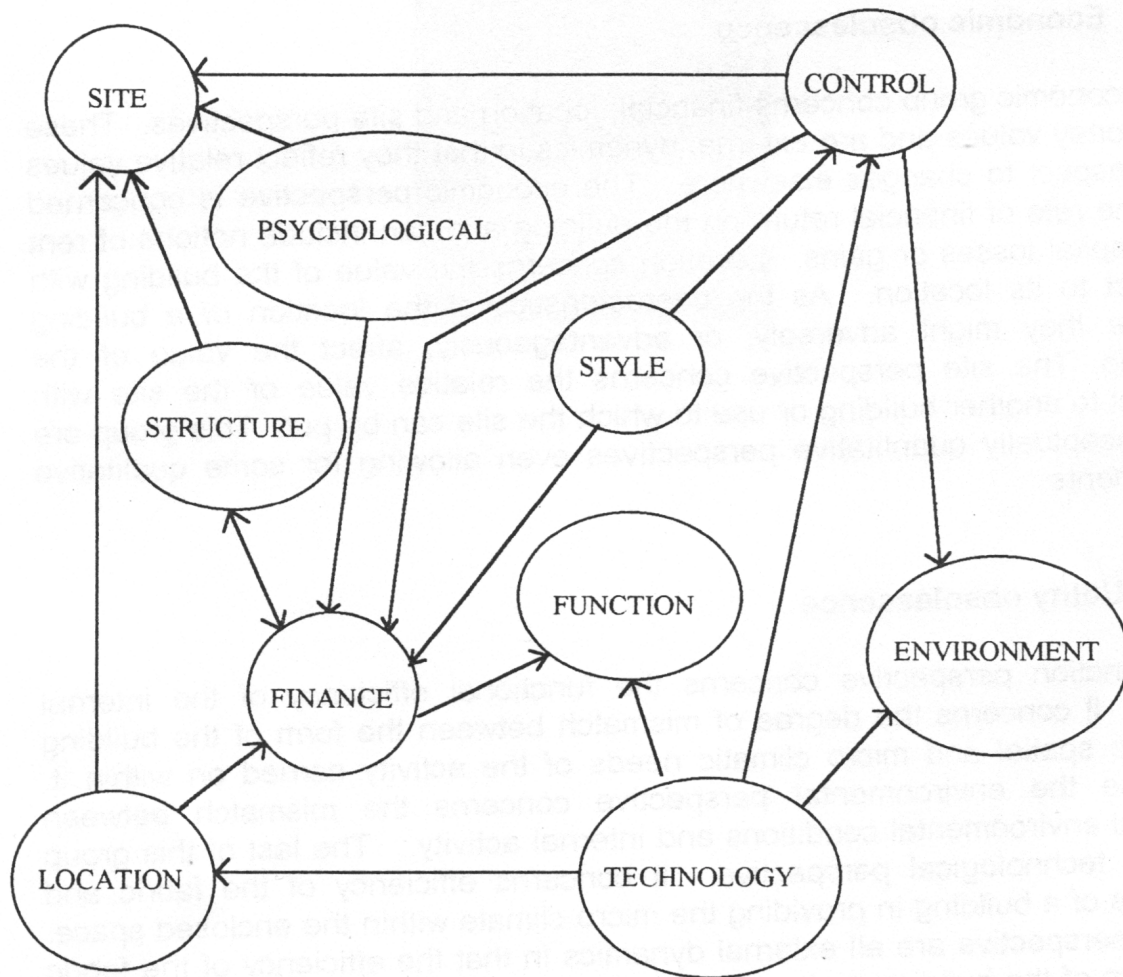
Figure 1. A taxonomy of building obsolescence [2]

The taxonomy suggests that there are ten perspectives that are interrelated and can be categorised into four groups of perspectives. Changes in one perspective iterate through other perspectives. They are dependent variables whose groups are; Structure that sits alone; the Economic perspectives of finance, site and location; the Utility perspectives of function, environment and technology; and the Social perspectives of psychology, style and control.

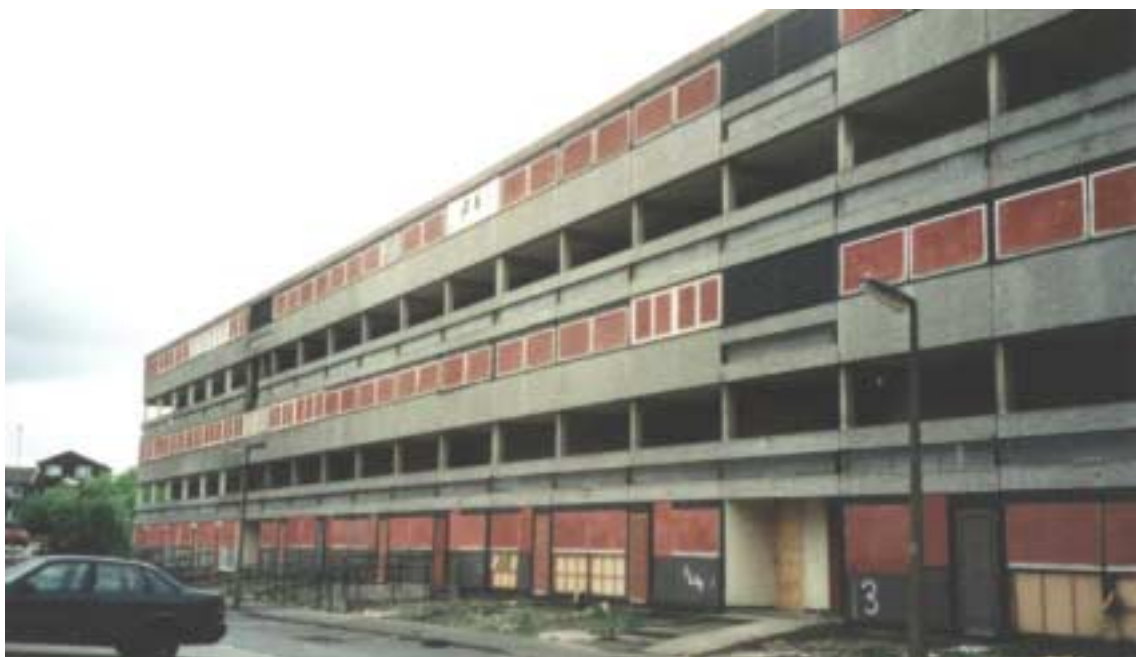
Photo 1. A section of the north elevation of Jespersen Street before demolition.

When the St. Mary's Estate was redeveloped in 1967, Jespersen Street was one of a number of low-rise blocks of flats that were built alongside terraced houses. The blocks of flats were originally linked with 'sky-bridges' to provide easy access from one to another. At the time of this demolition, all other flats had already been removed as part of previous demolition projects, and Jespersen Street stood isolated. The terraced houses are still occupied and there are no plans to demolish these in the foreseeable future.

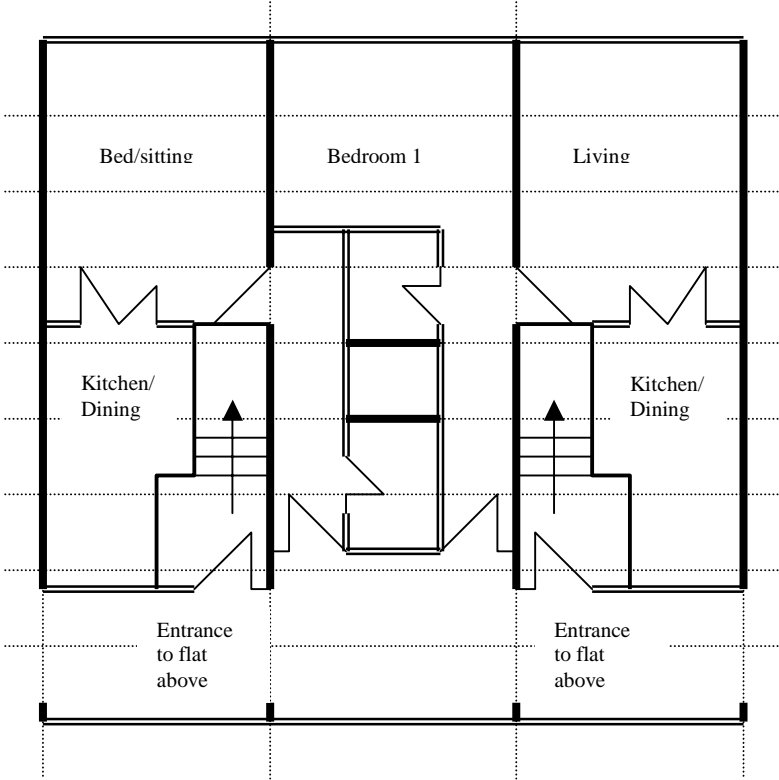
Figure 2. Typical flat layout on access deck level. Left: Bed-sitting room flat. Right: 1 bedroom 2 person flat. (Not to Scale)

The overall dimensions of the building were 200m long by 11m deep. To achieve this depth nine floor panels and five wall panels (four large and one small) were used per structural bay. Jespersen Street comprised 50 structural bays, containing 5 staircase/refuse bays and 45 accommodation bays, (the accommodation bays provided two flats per level for every three structural bays, see Figure 2 below)

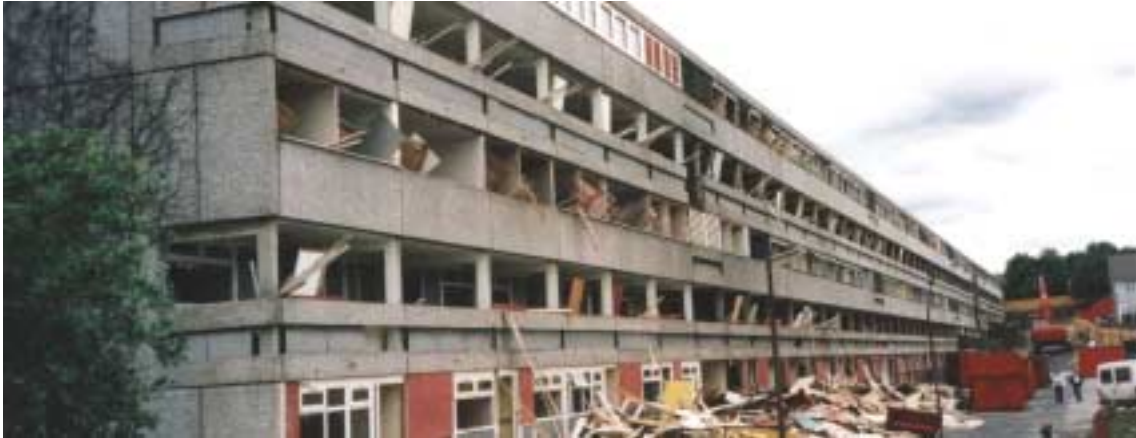
Photo 2. Materials stripped from flats are left on access decks for sorting.

Some of the infill panels on the deck fascia of the flats turned out to be good quality timber with insulation behind. Once the insulation was stripped from these panels they were sent for chipboard. Polystyrene tiles from above the deck were removed with a hoe and bagged as work progressed to prevent the wind taking them. This proved to be quite a time consuming job, and could only be carried out after materials stripped from the flats had been removed from the deck (see photo 2), and sorted into the appropriate skips.

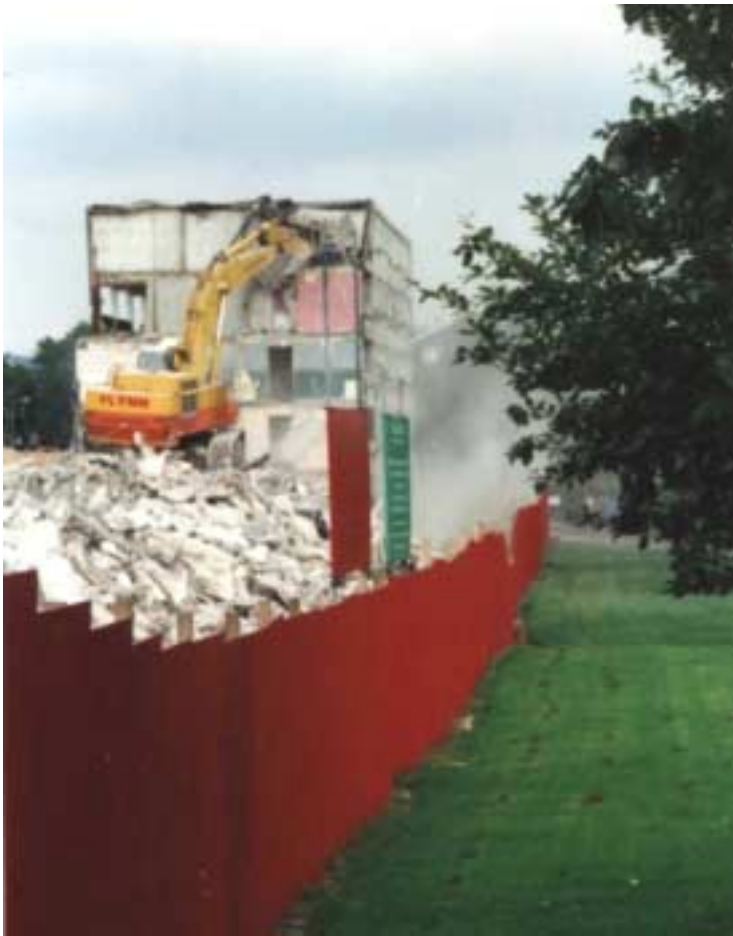
Photo 3. The 75 tonne excavator gains the height it needs using the debris pile.

When the demolition doubled back, the 75 tonne excavator could be used. All the concrete was going to be crushed offsite but was initially stockpiled on the site. This debris pile was banked up so that it would give the smaller excavator the height it needed to reach the top of the building. See Photo 3 overleaf:
